15.0 Salt Lake City, Utah, Disposal Site

15.1 Compliance Summary

The Salt Lake City Disposal Site, inspected on June 23, 2003, was in good condition. Because of continuing activities on the adjacent Envirocare of Utah, Inc., (Envirocare) property, access to the disposal site is impeded. Due to restricted areas around the site, inspectors must be escorted by Envirocare personnel to gain access to the site. At the request of the inspectors, Envirocare repaired a section of damaged fence along the south boundary of the site. Ground water monitoring is not required at this site. There was no requirement for a follow-up or contingency inspection.

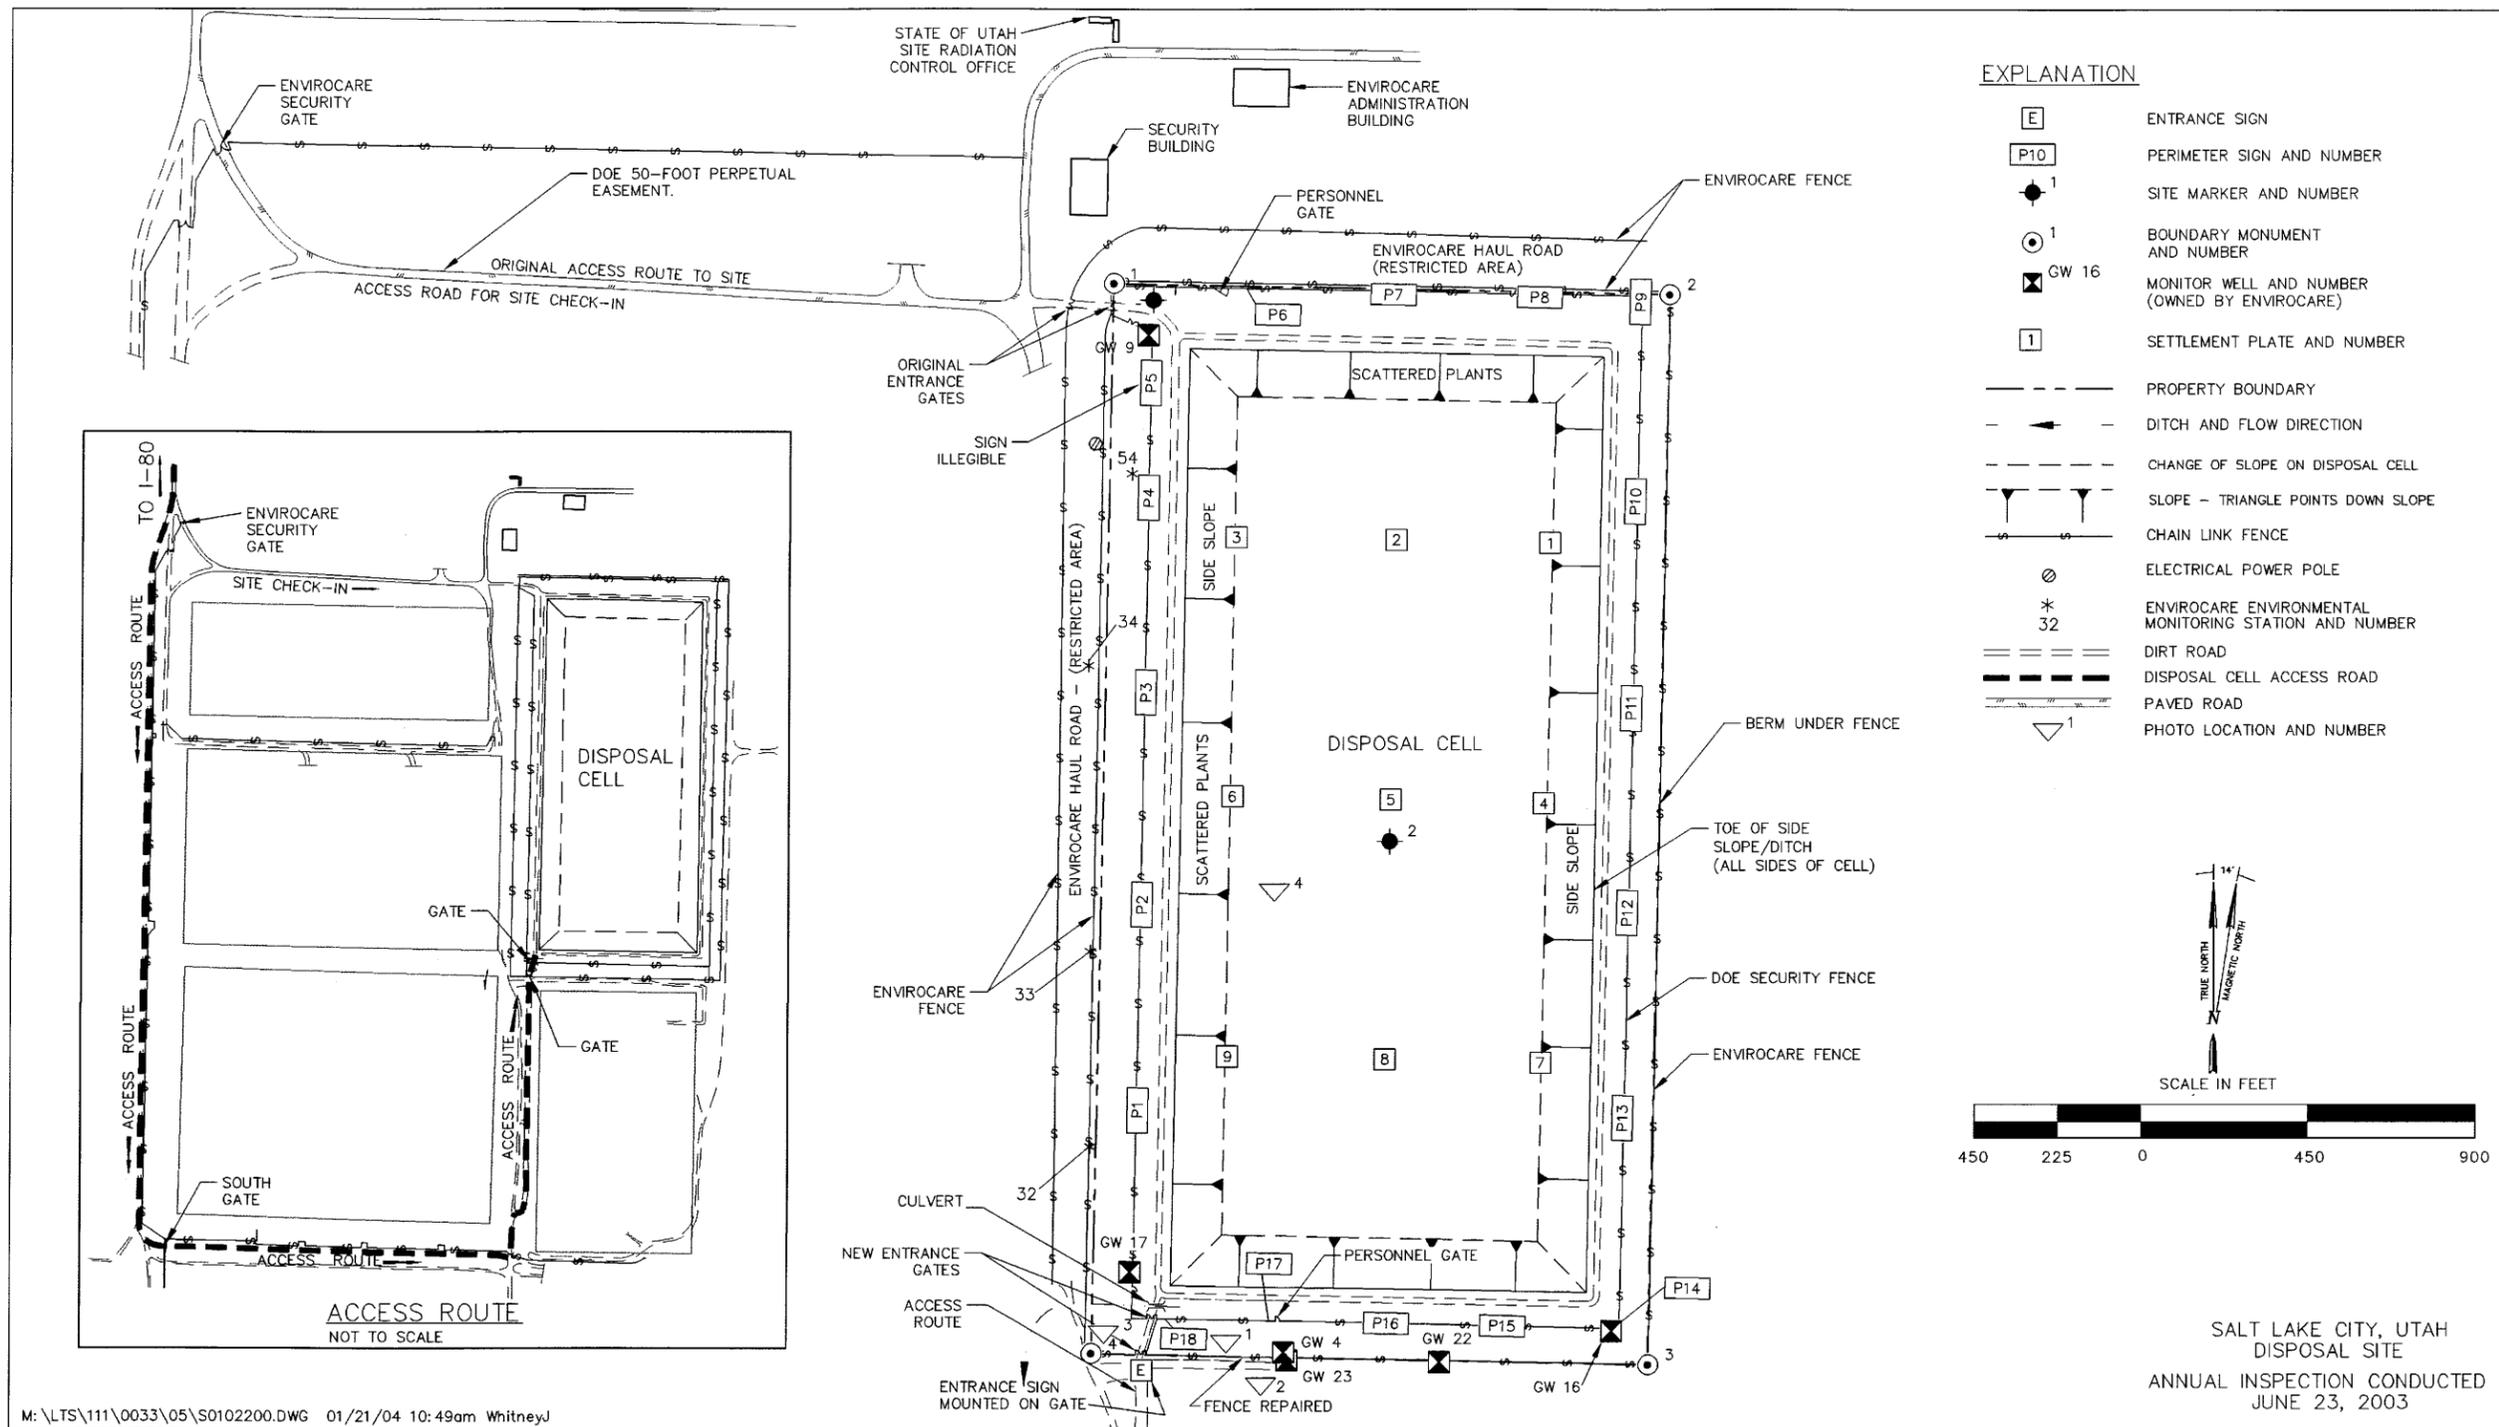
Figure 15-1. 2003 Annual Compliance Drawing for the Salt Lake (South Clive), Utah, Disposal Site

The site, located 85 miles west of Salt Lake City, Utah, was inspected on June 23, 2003. Results of the inspection are described below. Features and the photograph locations (PL) mentioned in this report are shown on Figure 15-1. Numbers in the left margin of this report refer to items summarized in the Executive Summary table.

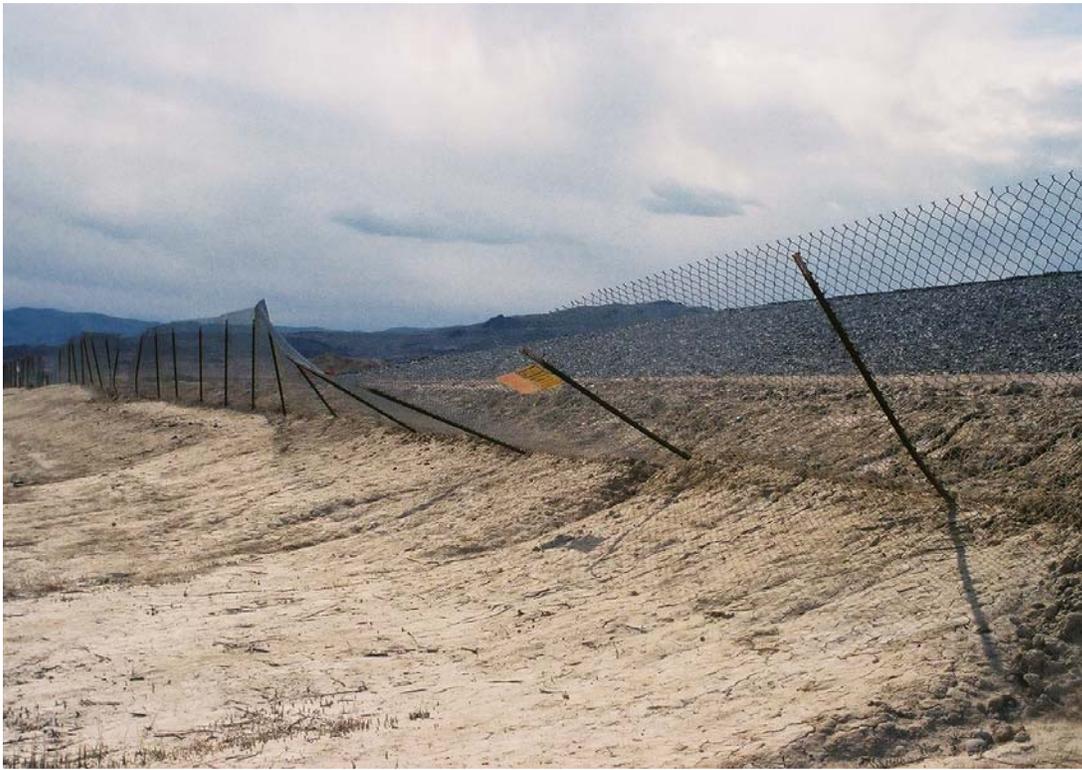
15B DOE's chain link security fence, set inside the property boundary by distances of 13 to 114 feet, was in good condition. Envirocare has a chain link fence on or just outside the site property boundary, and an additional fence on the other side of their haul road along the north and west sides of the site. A section of Envirocare fence along the south boundary was damaged and, at the request of the inspectors, subsequently was repaired by Envirocare (PL-1 and PL-2).

SLC 6/2003. PL-1. Envirocare fence damage.

No maintenance was required in 2003. Envirocare repaired a section of their fence along the south property boundary.

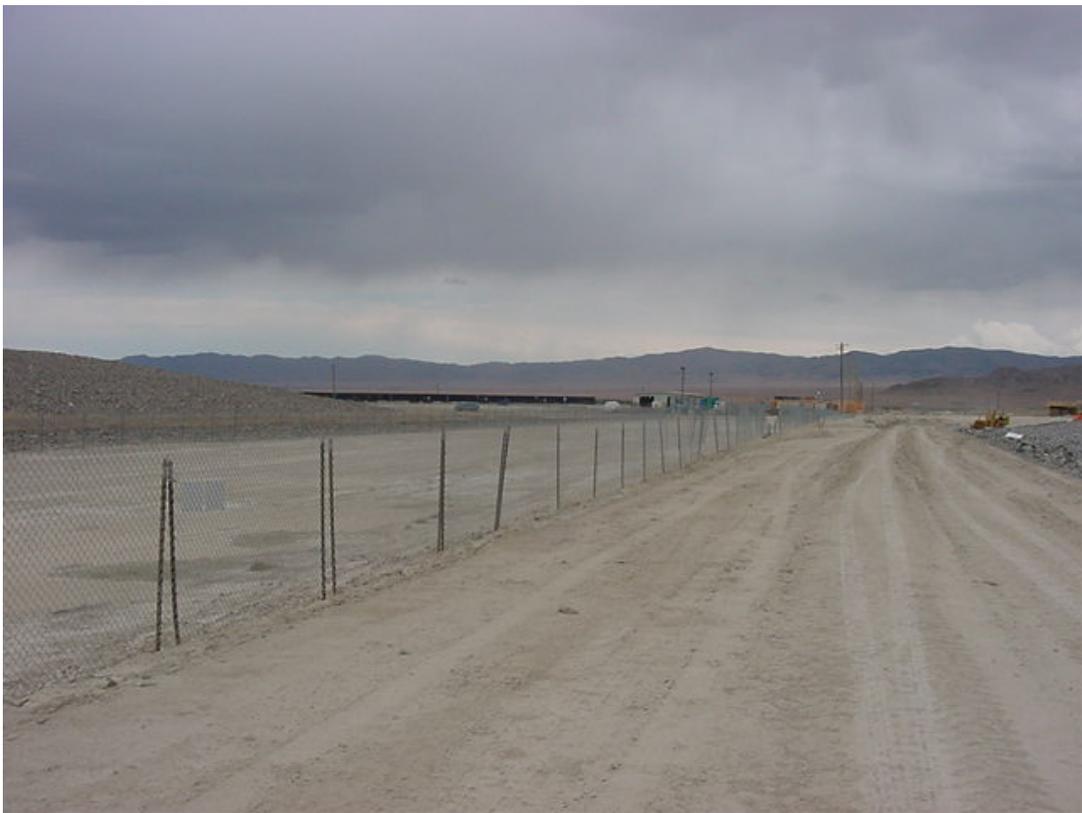
SLC 6/2003. PL-2. Repaired Envirocare fence (photo provided by Envirocare).

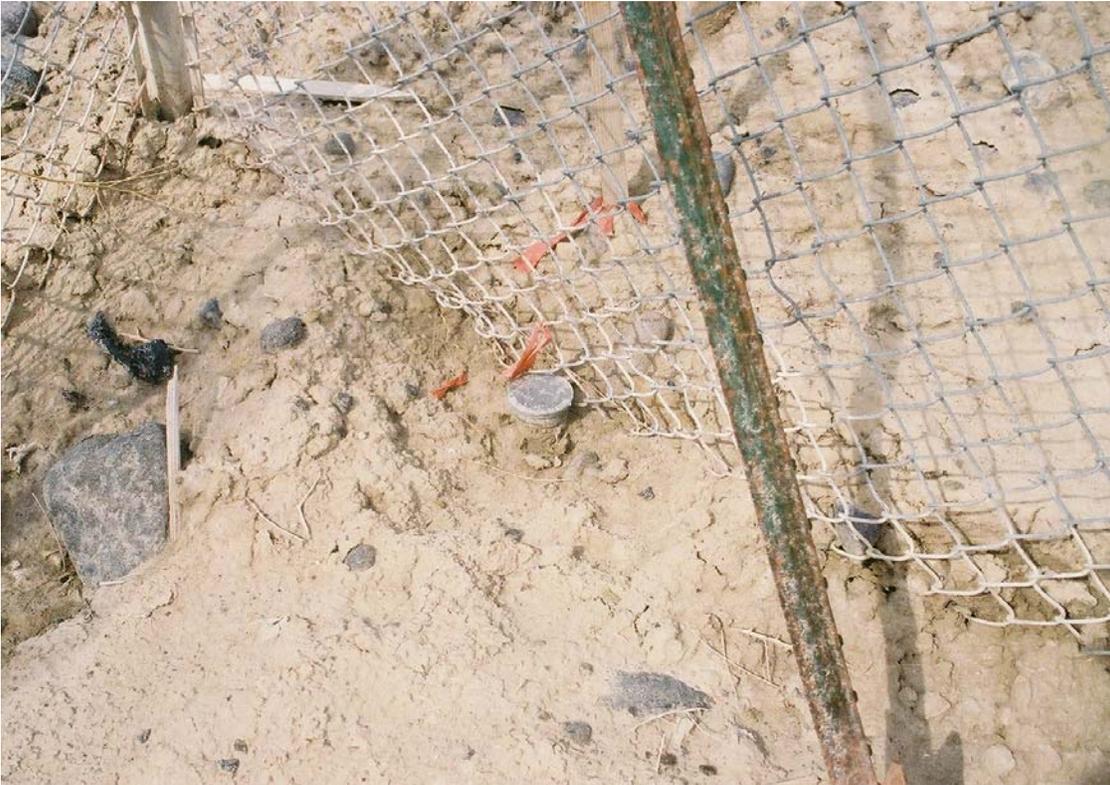
Site Markers and Monuments—Both granite site markers were in excellent condition. All four boundary monuments were in good condition. Boundary monuments BM-3 and BM-4, noted during the 2002 inspection as buried by several feet of fill by Envirocare's site activities, had subsequently been uncovered by Envirocare (PL-3).

SLC 6/2003. PL-3. Boundary monument BM-4 uncovered by Envirocare.

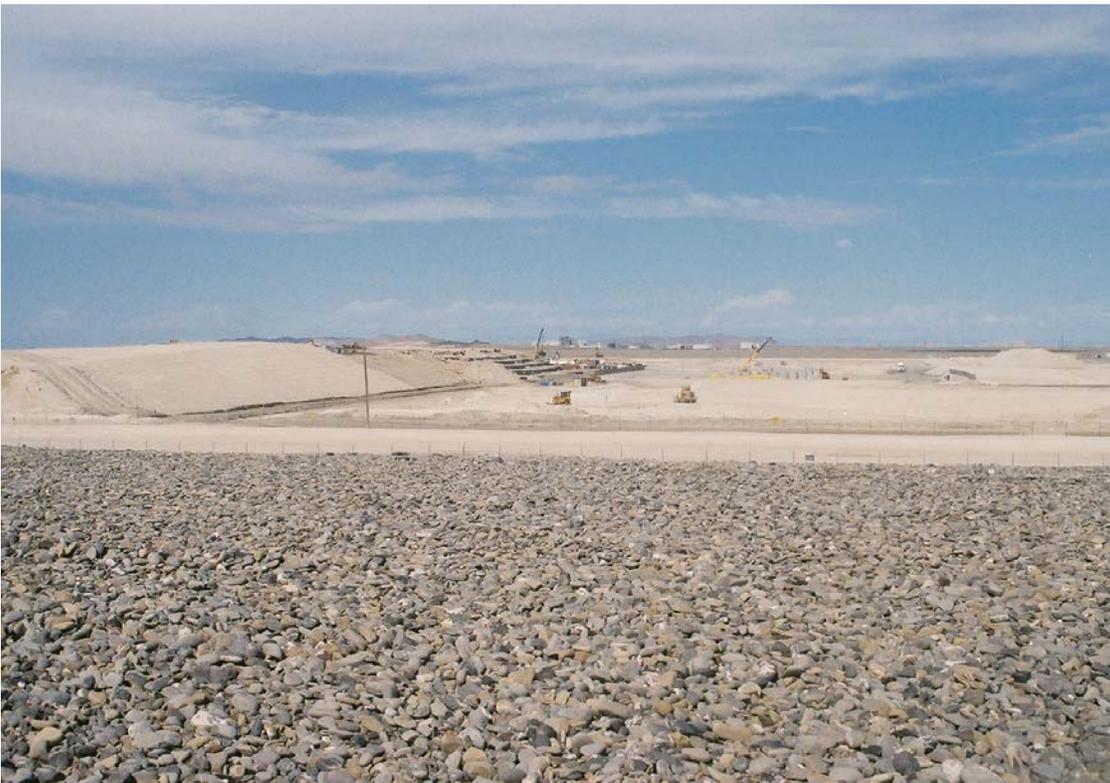
Outlying Area—This transect extends from the Envirocare fence to 0.25 mile beyond the site boundary. Outside the site boundary are a variety of features and activities managed by Envirocare. On the east side of the site, incoming wastes are unloaded from rail cars and transferred to haul trucks. Disposal cells are in the process of being built or closed on the south and west sides of the site (PL-4). Directly to the south is a low-level radioactive waste disposal cell, and to the southwest is a waste disposal cell containing 11e.(2) material regulated under the Atomic Energy Act of 1954. With the exception of a corridor at the southwest corner of DOE’s disposal site where the site access has been relocated, all areas surrounding DOE’s property are restricted due to radiological hazards.

SLC 6/2003. PL-4. Envirocare Class A cell under construction west of the DOE disposal cell.
