2004 Annual Inspection Report for the Grand Junction, Colorado, Defense Decontamination and Decommissioning Program Site

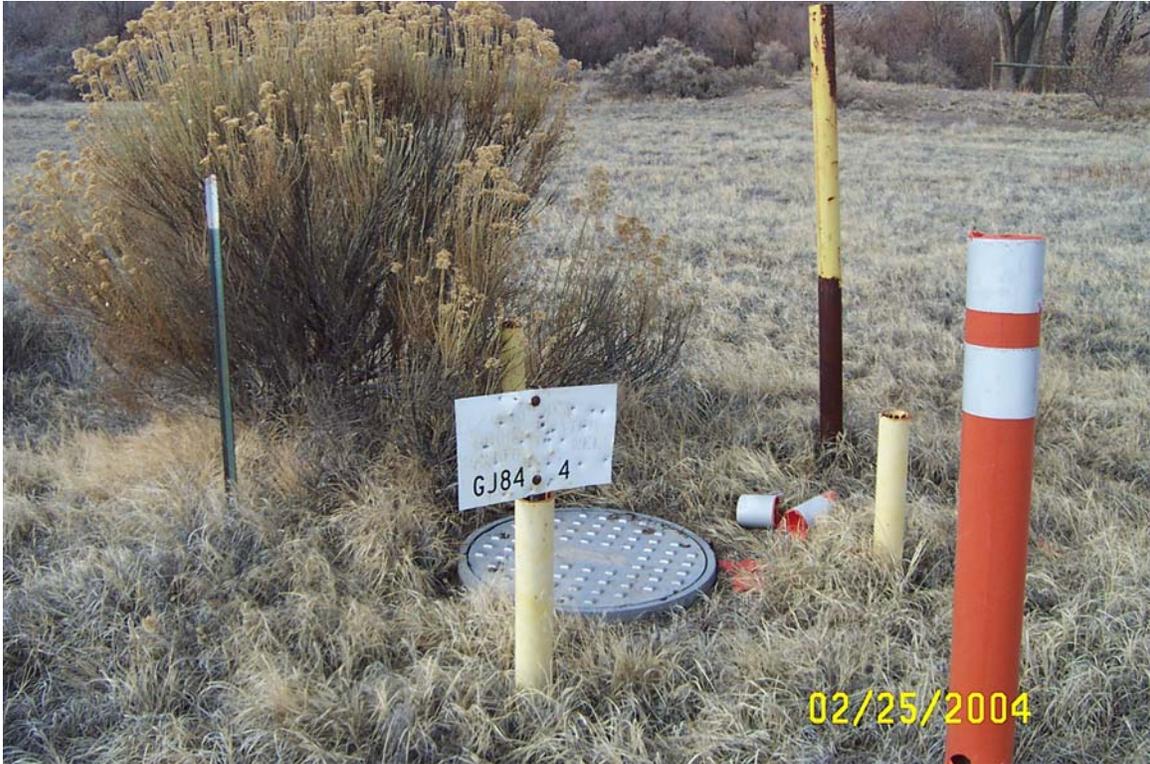
Four of the flush-mounted wells (11-1S, 14-13NA, GJ01-01, and GJ01-02) do not have visible identification numbers. Flush-mounted wells 10-19N and GJ84-4 have their identification numbers marked on metal signs next to the wells. The sign for GJ84-04 has bullet damage but is still legible (PL-1). DOE will apply permanent identification numbers on all the flush-mounted wells.

GJO 2/2004. PL-1. Bullet-damaged identification sign at monitor well GJ84-04.

Recommendation: Identification numbers will be die-stamped or engraved on all flush-mounted monitor wells.

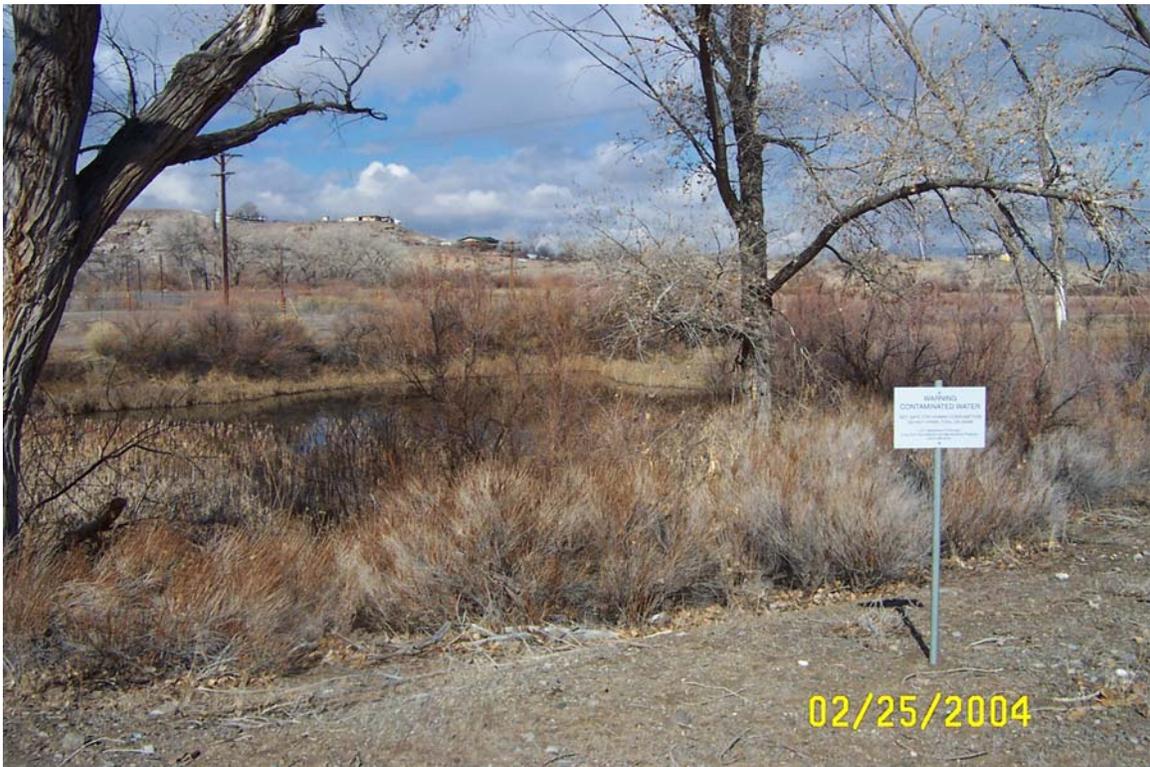
Warning Signs—Thirteen warning signs installed on galvanized steel posts are positioned around the surface water areas so the warning will be visible to a person approaching from any direction of reasonable access (PL-2). Dense vegetation or fences block access to portions of the surface water occurrences. All signs are in excellent condition. The signpost for warning sign S9 is loose and will be reset in concrete. Metal caps will be installed on the signposts to inhibit rusting and prevent freeze damage.

GJO 2/2004. PL-2. Warning sign S7 near North Pond.

Recommendation: Metal caps will be installed on the signposts.

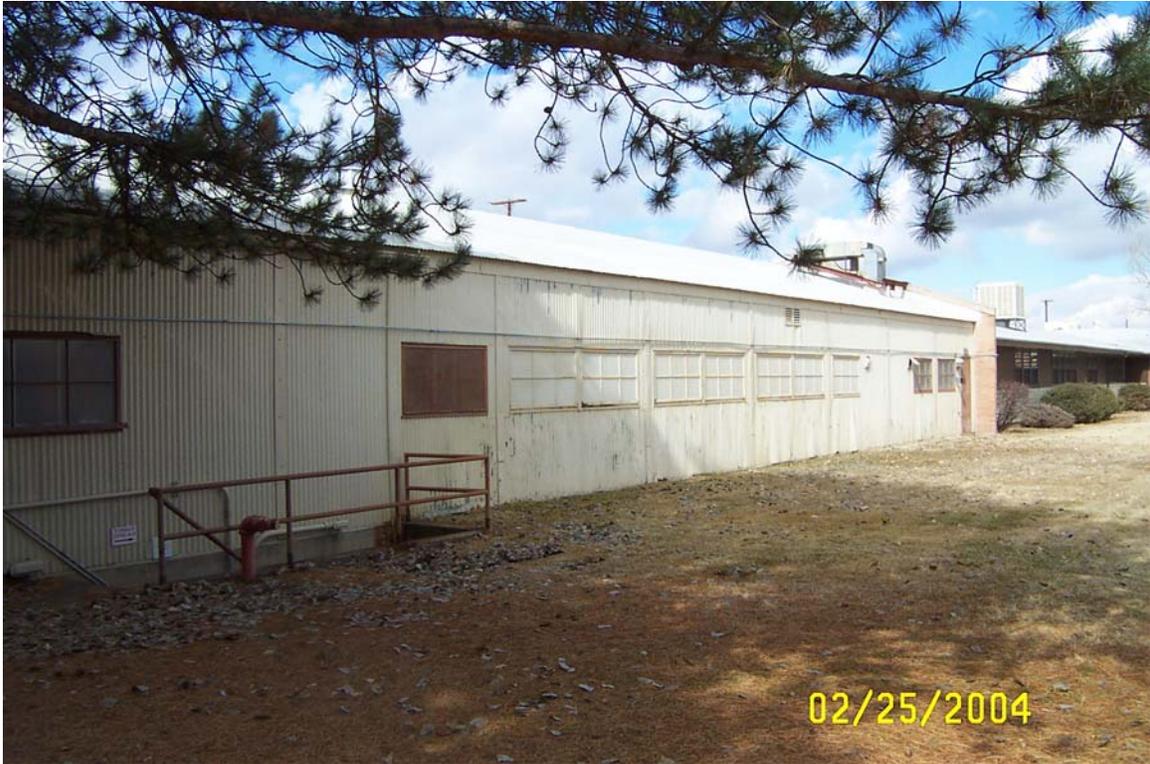
Inspectors entered Buildings 12 and 20 to inspect the floors above the contamination. There was no evidence of recent floor penetrations in the affected areas. Likewise, the exterior areas opposite the contaminated media have not been disturbed (PL-3 and PL-4). The current site owner controls maintenance activities in the exterior areas near the contaminated soil and DOE contractor personnel observe these exterior areas during normal working activities.

GJO 2/2004. PL-3. East side of Building 12 outside the area of buried contamination.

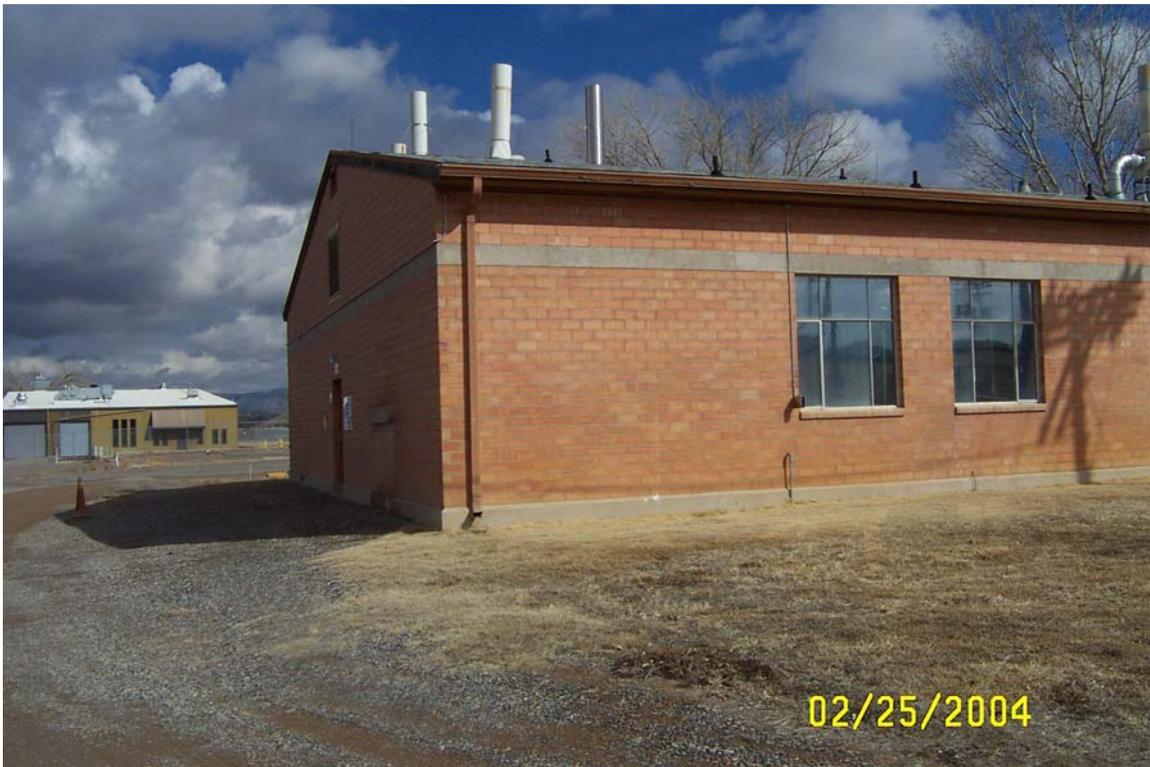
GJO 2/2004. PL-4. Southwest corner of Building 20 outside the area of buried contamination.
