# **2004 Annual Inspection and Status Report for the Hallam Nuclear Power Facility, Hallam, Nebraska, Decontamination and Decommissioning Program Site**

## **Summary**

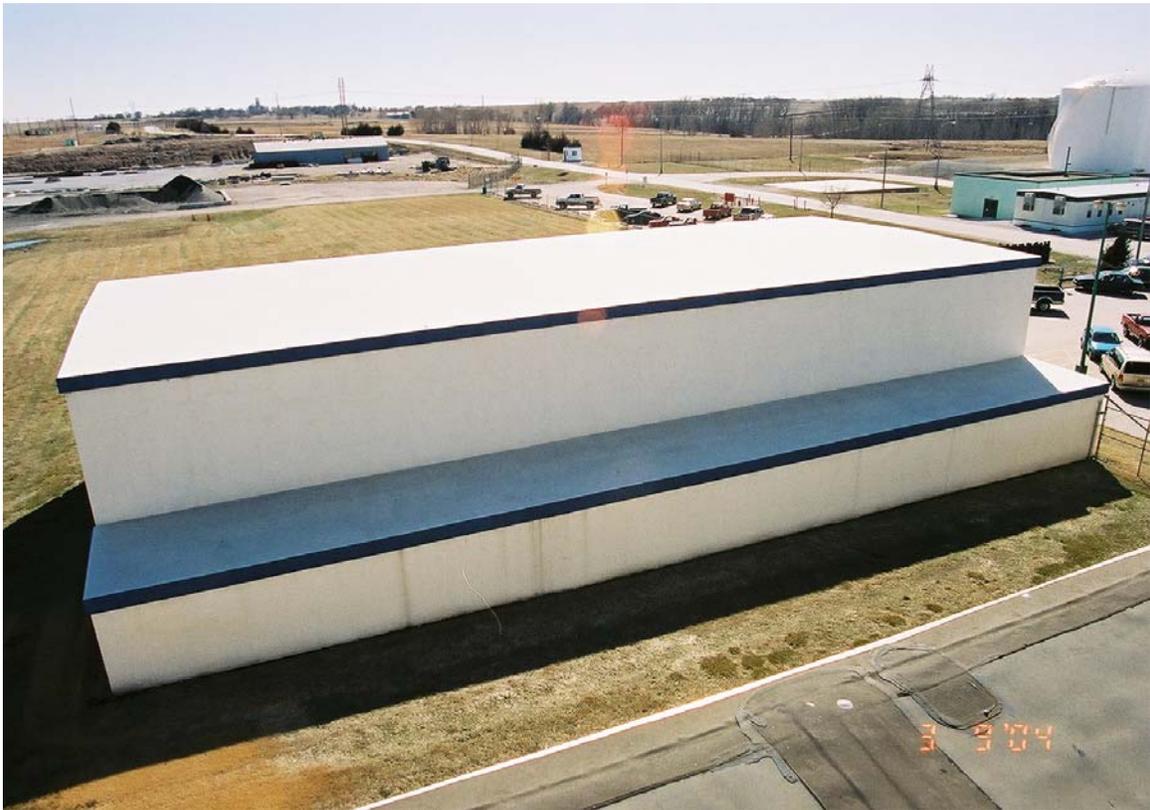
The IHX is a massive block-like concrete sarcophagus, about 40 feet by 80 feet on a side, at the north end of the former HNPF (PL-1 and PL-2). On the south side, it is two stories (about 25- to 30-feet) high. On the north side, the structure is one-story high. The roof on the two-story part is slightly crowned; the roof on the one-story part is sloped to drain. Repairs to the roof and walls made in 2001 remain adequate. Inspectors noted a minor rust stain and cracks in the blue-painted cornice on the north side.

HAL 3/2004. PL-1. Intermediate Heat Exchanger containment building, north side and roof.

1. Inspectors noted a minor rust stain and cracks in the blue-painted cornice on the north side of the IHX building (page 2).

**Recommendation:** Continue to monitor building condition.

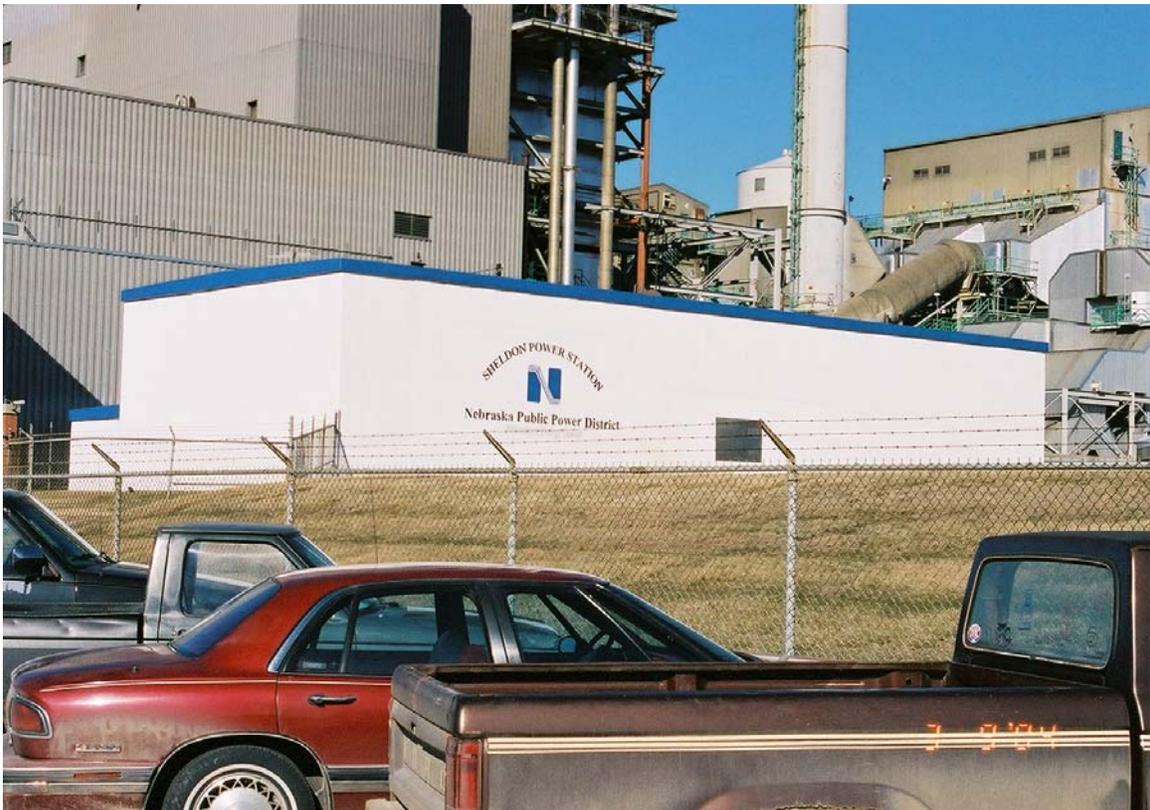
HAL 3/2004. PL-2. Intermediate Heat Exchanger containment building, west and south sides.

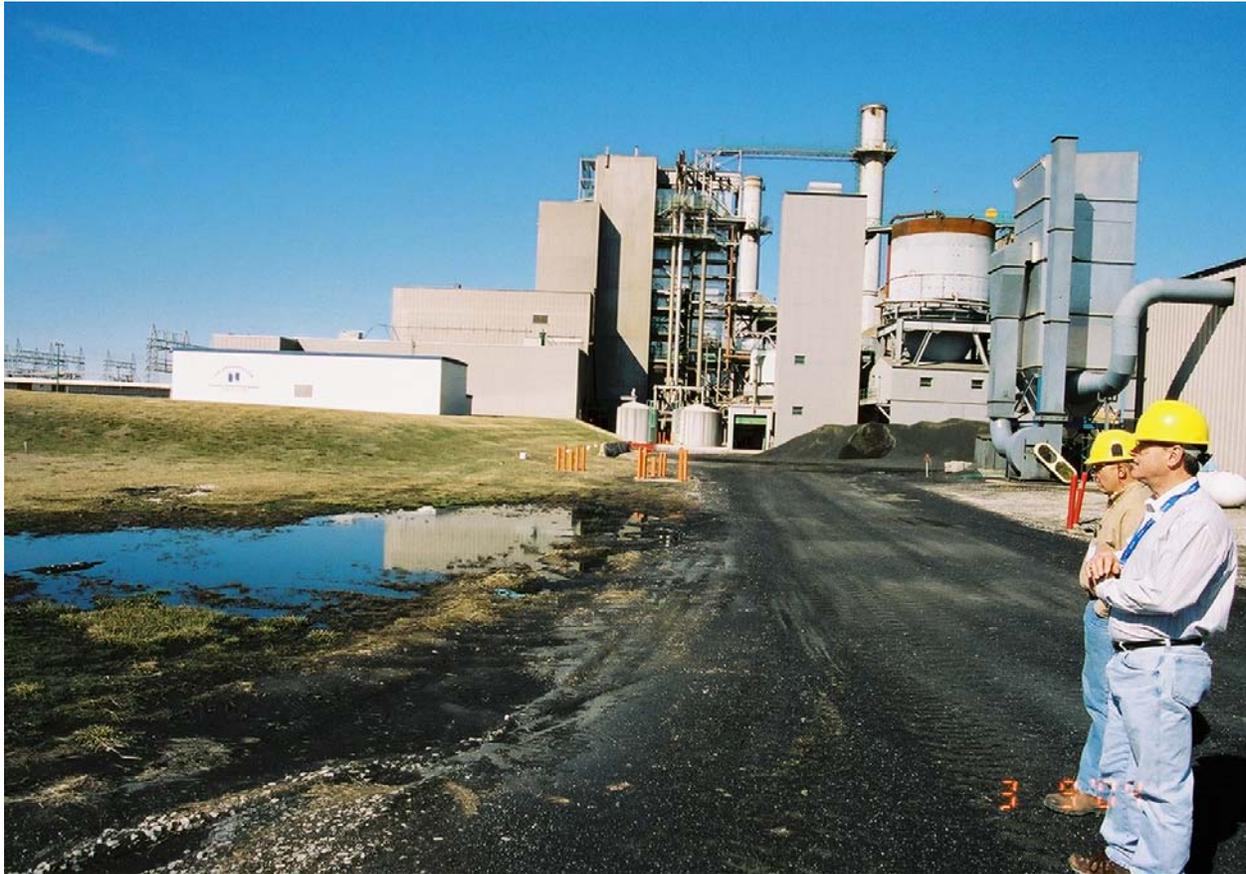
The old reactor foundation is buried beneath a waterproof membrane, soil, and grass. Today the buried structure appears as a low, flat-topped, grass-covered mound, 1.4 acres in extent, immediately south of the IHX. The grass is a well-established lawn, and generally is in good condition (PL-3). NPPD reseeded grass on the side slope of the northeast corner of the mound that appeared to have died as a result of last year's drought and it now looks healthy. Gravel found on the east side slope of the mound in 2003 was removed and the grass restored. Inspectors saw no evidence of recent erosion or other concerns.

HAL 3/2004. PL-3. East side of grass-covered mound.

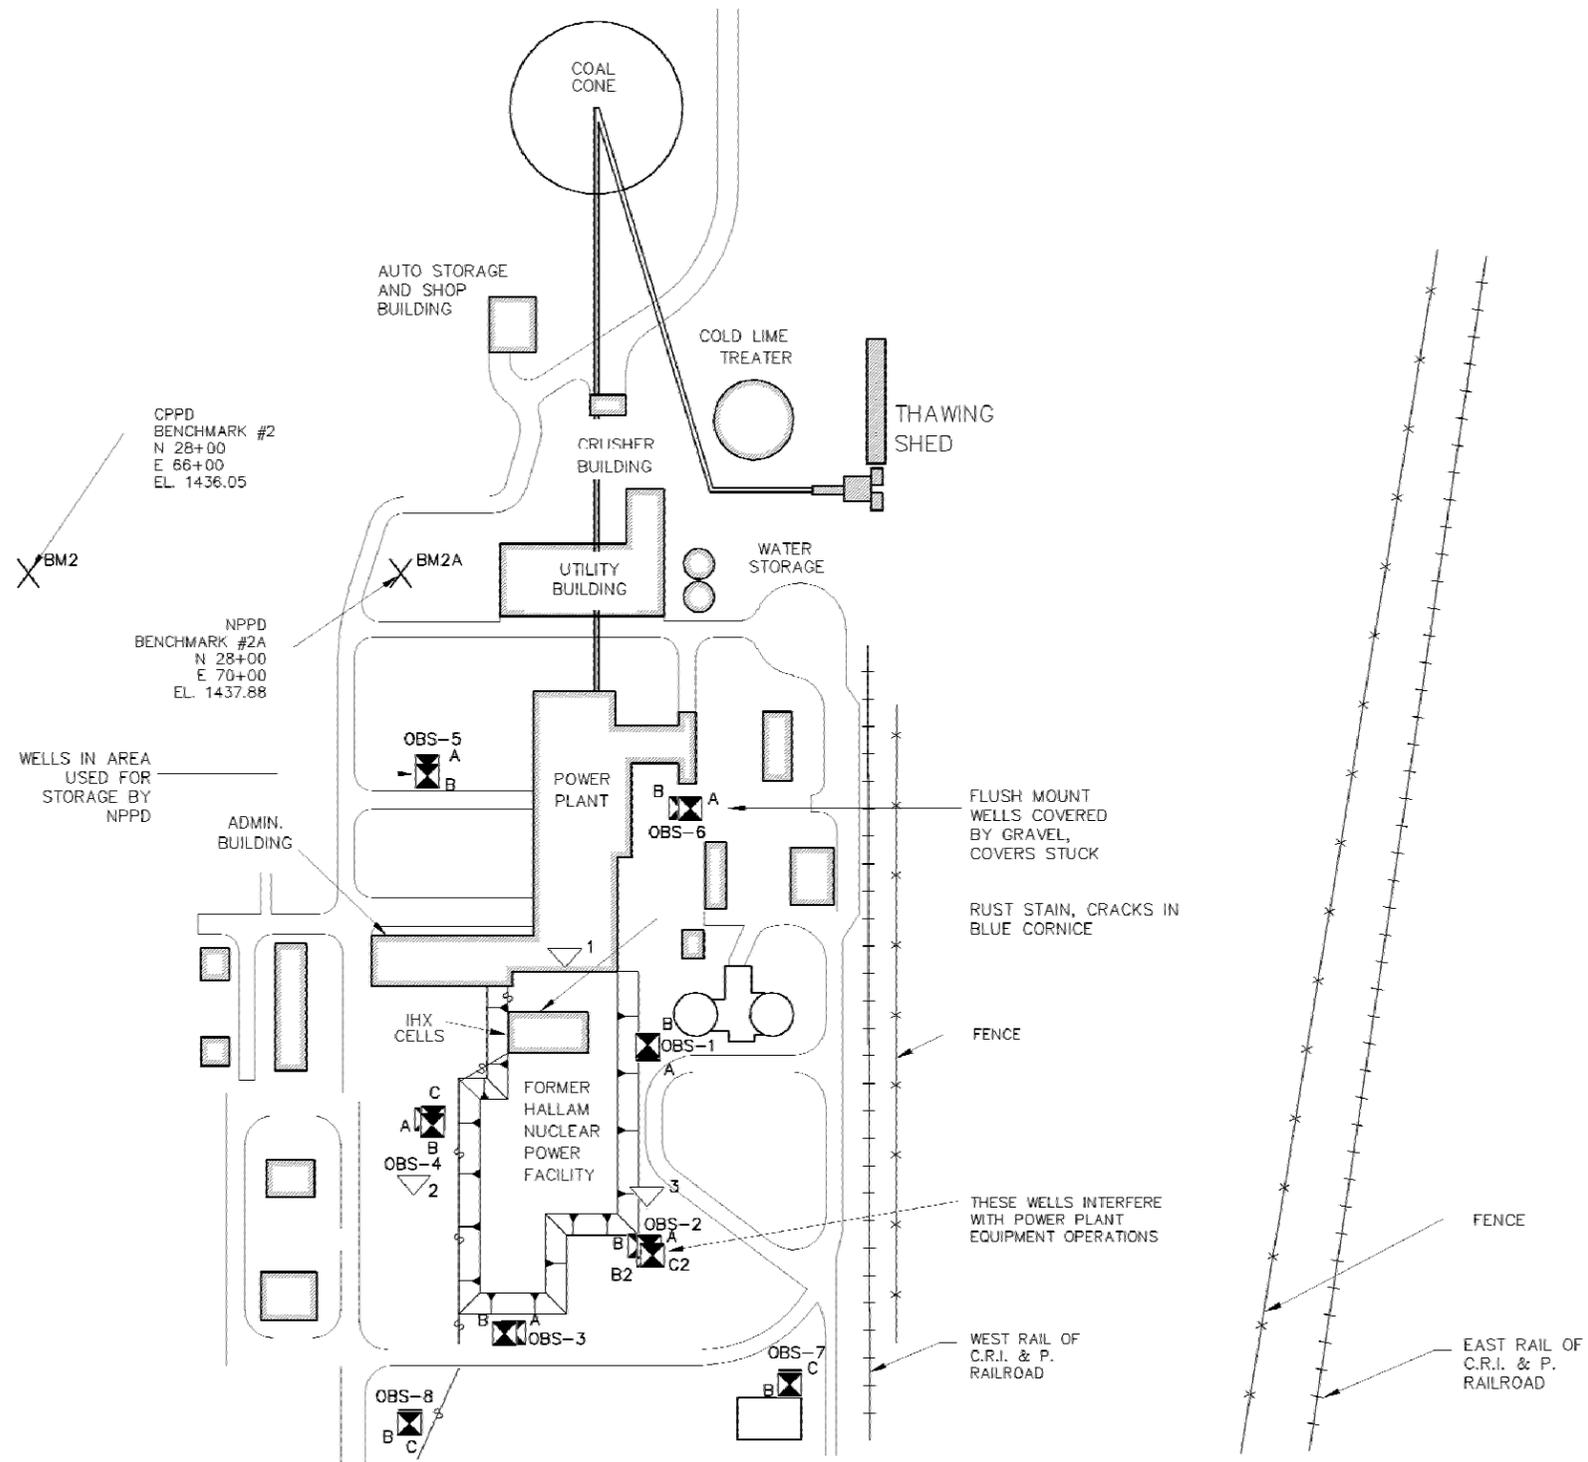
U.S. DEPARTMENT OF ENERGY GRAND JUNCTION, COLORADO	Work Performed by <b>S.M. Stoller Corporation</b> Under DOE Contract No. DE-AC01-02GJ79491
2004 ANNUAL INSPECTION DRAWING HALLAM NUCLEAR POWER FACILITY HALLAM, NEBRASKA	
DATE PREPARED: APRIL 6, 2004	FILENAME: S0098000

There are 19 wells in the monitoring network. DOE monitors the wells annually. Water levels are measured in each well. Samples are collected at all wells that produce sufficient water. Flush mounted wells in high traffic areas (e.g., OBS 6A and OBS 6B) are covered with gravel and are difficult to locate. The covers on these wells were not removed during the 2003 sampling event because they are cracked and wedged tight with coal dust. The inspector obtained manufacturer information to replace the covers. If the regulator concurs that monitoring can be discontinued, DOE should not replace these covers. Otherwise, sampling crews should be prepared to replace the covers on the next sampling event.

During this and previous inspections, inspectors noted that many of the DOE wells are in or along traffic patterns associated with the current operation of the Sheldon Power Plant. In 2003, NPPD personnel inquired about the possibility of eliminating monitor wells OBS 2B and 2C because of their location in the work area. NPPD believes that it is just a matter of time until a piece of heavy equipment collides with this pair of wells.

**Recommendation:** If the regulator concurs that monitoring can be discontinued, DOE should not replace these covers. Otherwise, sampling crews should be prepared to replace the covers on the next sampling event.

**Recommendation:** Stoller will work with DOE to determine if decommissioning of these wells is appropriate.
