2004 Annual Inspection and Radiological Survey for the Piqua Nuclear Power Facility, Piqua, Ohio, Decommissioned Reactor Site

Summary

1.0 Introduction

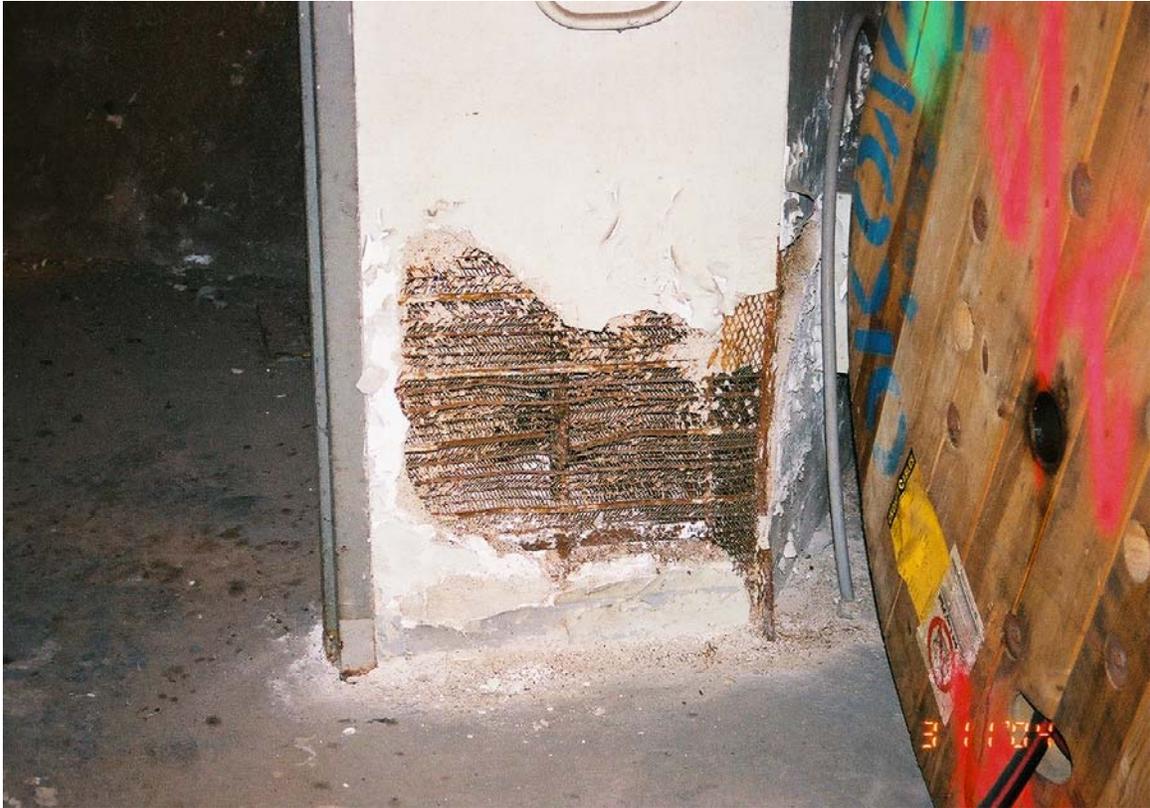
The reactor containment building and an associated auxiliary building are used by PPS as office, shop, and storage space. The inspectors walked around the outside of the facility to examine the exterior condition of the PNPF. The concrete decking between the auxiliary building and the reactor containment building that had significant deterioration during the 2003 inspection has been repaired. The inspectors also examined the facility interior looking for evidence of structural deterioration. Inspectors observed falling plaster and peeling paint at the bottom of the spiral staircase on the 56-foot level of the containment building (PL-1) as well as on the 79-foot

level wall of the auxiliary building (PL-2), which might be evidence of water damage. This damage has been noted on prior inspections and the condition remains unchanged. Peeling paint was observed on most areas of the interior dome walls; this condition also has been noted on prior inspections and the condition remains unchanged. During the 2003 inspection it was noted that on the 111-foot elevation of the reactor containment building insulation had fallen off piping components and could be potentially friable asbestos. PPS removed the existing plenum structure and piping insulation and converted the area to a storage location with shelving and a new stairwell for access. No evidence of activities that might affect the integrity of the PNPf was observed either on site or off site in the immediate surrounding area. No follow-up inspection is required.

PIQ 3/2004. PL-1. Water damage at base of spiral stair well.

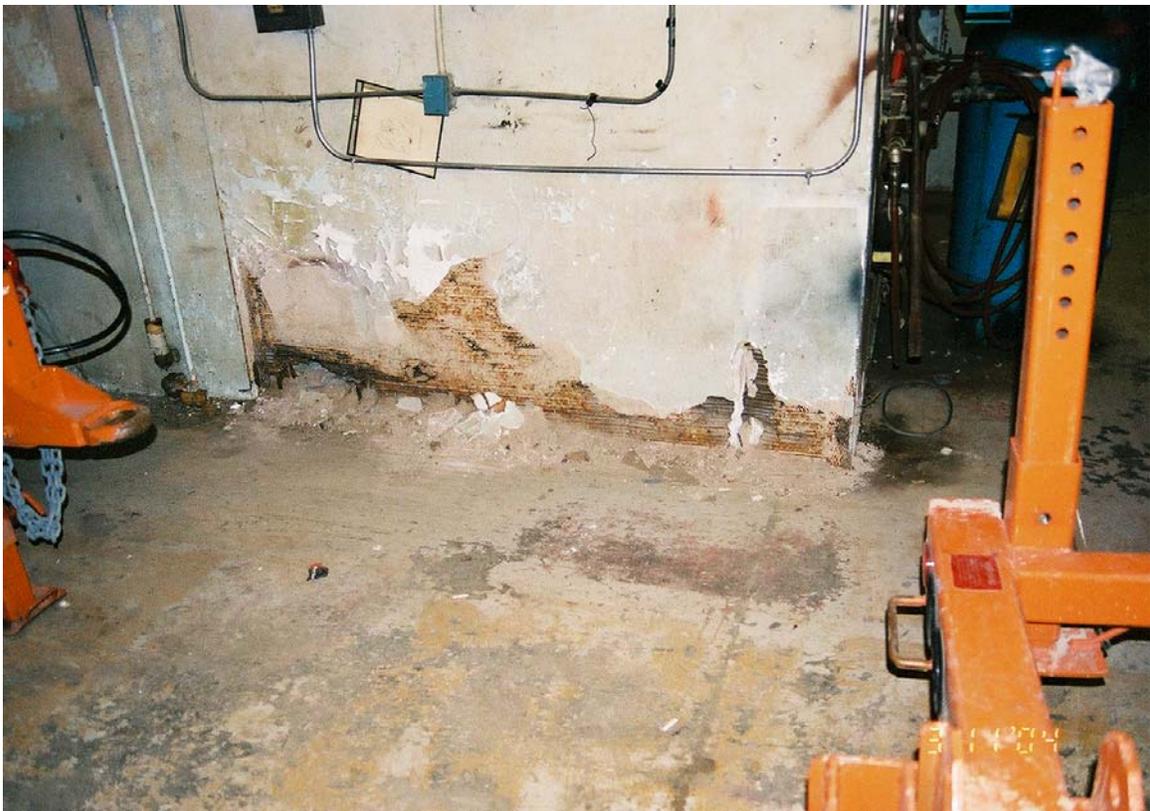
PIQ 3/2004. PL-2. Water damage in auxiliary building.

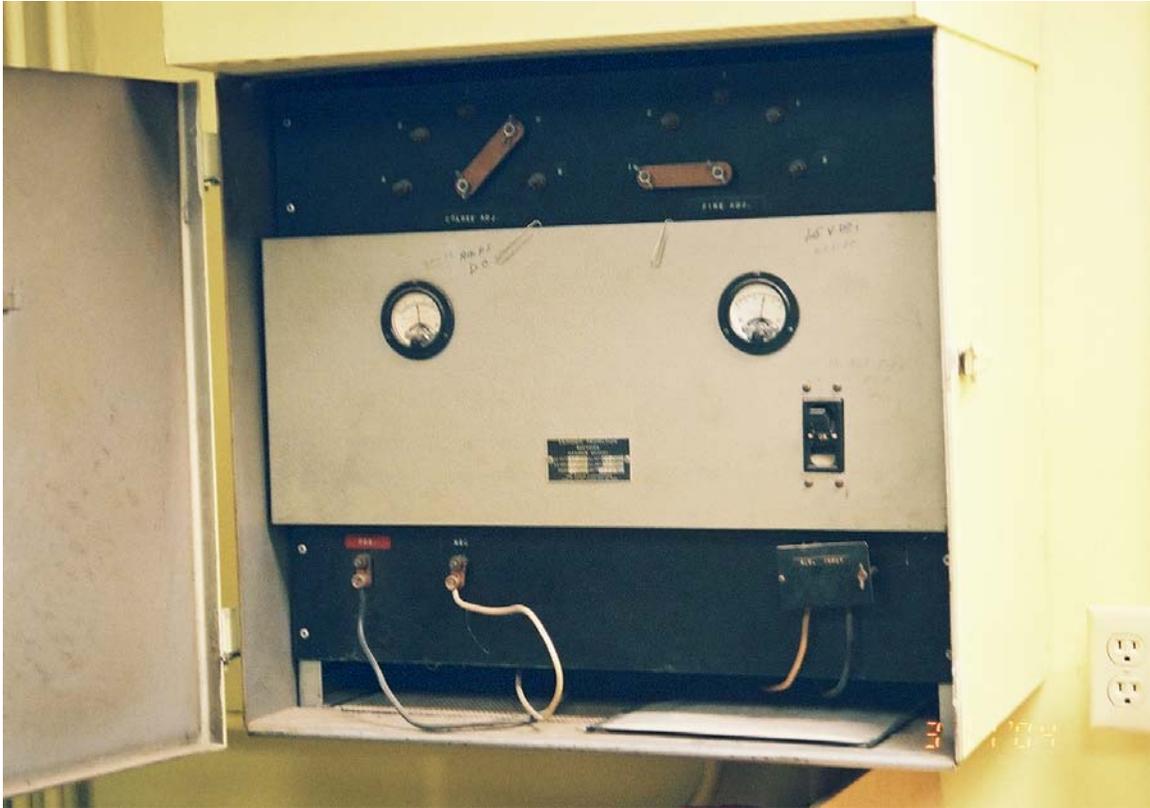
The system consists of 10 carbon (graphite) electrodes, buried radially approximately 10 to 20 feet from the building foundation, and a rectifier unit (PL-3) for providing DC current. The rectifier unit is mounted in the break room south of and outside the airlock on the 100-foot level. Each carbon electrode is 3 inches in diameter and 60 inches long. The electrodes are connected to the rectifier unit by a header cable; splices are protected in flush-mounted boxes (PL-4). A structure contact point for monitoring potential can be found on the shell associated with each electrode; some of the contact points also have cables remaining from an abandoned zinc anode protection system. The system also includes reference electrodes and test holes.

Inspectors found that output from the rectifier unit was recorded monthly. Mr. Sommer had received notification that the system was due for inspection and he intended to request budget for that purpose the following year. DOE will request a copy of the inspection results.

PIQ 3/2004. PL-3. Cathodic protection system rectifier.

1. Cathodic protection system is due for an inspection by a qualified service provider (page 2).

Recommendation: Mr. Sommer (PPS Director) had received notification that the system is due for inspection and he intends to request budget for that purpose. DOE will request a copy of the inspection results.

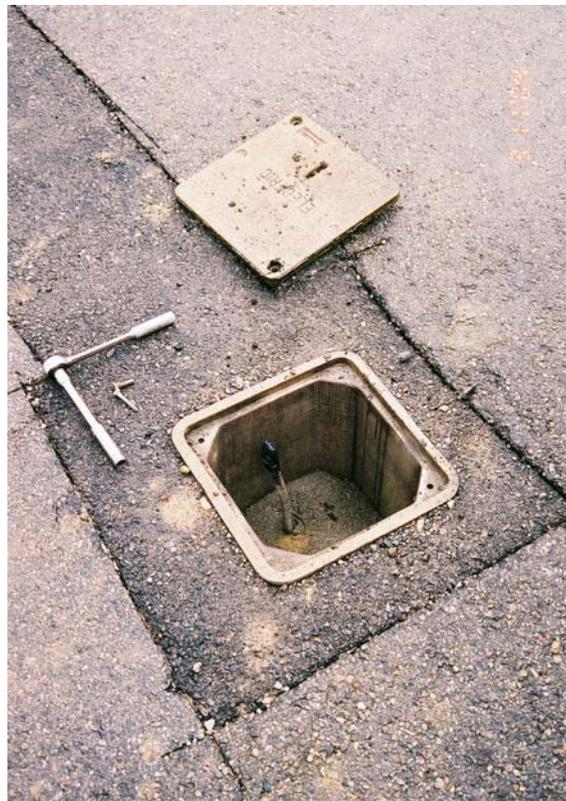
PIQ 3/2004. PL-4. Box containing electrode splice.
