4.0 Durango, Colorado, Disposal Site

4.1 Compliance Summary

The site, located southwest of Durango, Colorado, was inspected on June 17, 2003. Results of the inspection are described below. Features and photograph locations (PLs) discussed in this report are shown on Figure 4–1. Numbers in the left margin of this report refer to items summarized in the Executive Summary table.

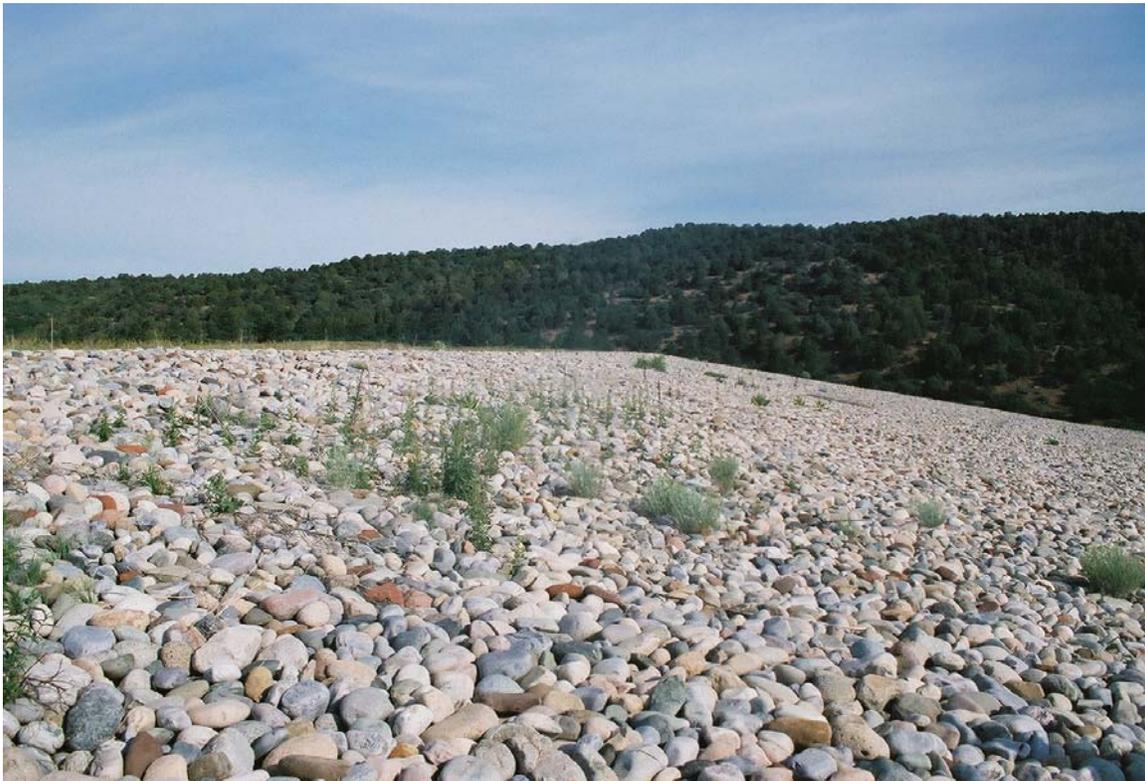
Vegetation continues to encroach on the side slopes of the cell, particularly on the east and southeast sides (PL-1). The species included deep-rooted shrubs and trees and several noxious weeds that require control by the state or La Plata County (Canada thistle, musk thistle, and houndstongue). The woody trees and shrubs were cut and herbicide was applied to their stalks. Herbicide was applied to the Canada thistle and houndstongue later in the month and again during the fall.

DUR 6/2003. PL-1. Vegetation, including Canada thistle, on the east side slope of the cell.

4C The damaged entrance sign and a missing perimeter sign were replaced. Woody species on the cell side slopes were cut and their stems were treated with herbicide. Beetles and weevils were released for the second consecutive year to control musk thistle. Other noxious weeds identified at the site were treated with herbicide during summer and fall applications.

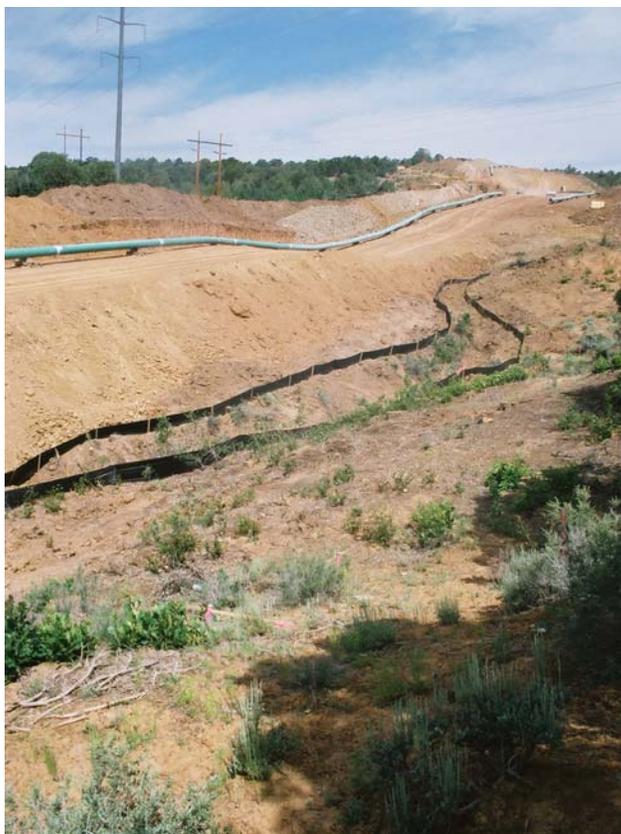
4B **Outlying Area**—The area beyond the site boundary for a distance of 0.25 mile was visually inspected for signs of erosion, development, or other disturbance. The U.S. Bureau of Reclamation has begun the multi-year construction of the Animas-La Plata Project. A water intake and pumping plant structure is being constructed at the Animas River on the site of the former raffinate ponds. The pipeline to the reservoir being built southwest of the disposal site will be adjacent to County Road 211 and pass just south of the cell. Pipelines that are within the footprint of the reservoir are being rerouted parallel to County Road 212 on the west side of the disposal site (PL-2). Heavy construction traffic is present on County Road 212, and recreational use of the area is expected to increase substantially upon completion of the reservoir project.

DUR 6/2003. PL-2. Utility construction along the west side of the property.
