12.0 Mexican Hat, Utah, Disposal Site

12.1 Compliance Summary

Figure 12-1. 2003 Annual Compliance Drawing for the Mexican Hat, Utah, Disposal Site

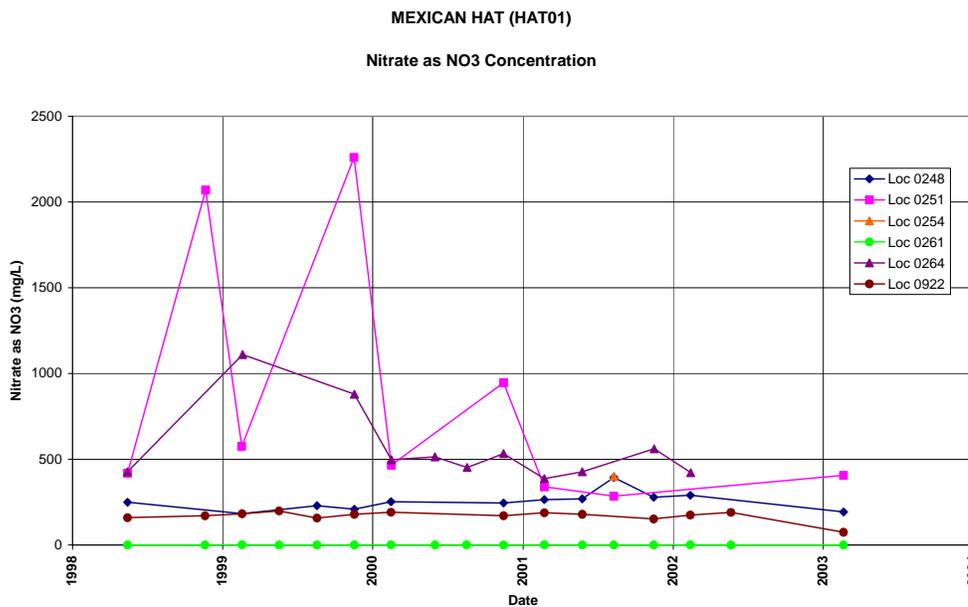
Figure 12–2. Time-Concentration Plots of Nitrate (as NO₃) in Seep Water at the Mexican Hat, Utah, Disposal Site

Concentrations of nitrate have been variable in the two North Arroyo seeps for the past several years and have declined substantially from greater than 2,000 mg/L to less than 500 mg/L in the past 3 years (Figure 12–2). Nitrate concentrations have remained relatively stable in the Gypsum Creek seeps for the past 5 years ranging from 150 to 400 mg/L. Concentrations in the background seep remain below 1 mg/L.

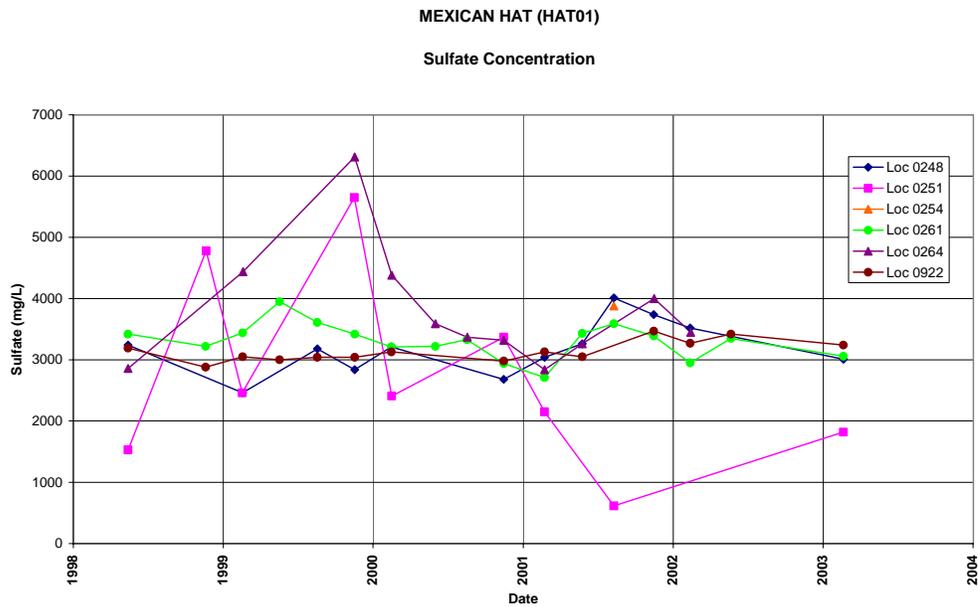
Figure 12–3. Time-Concentration Plots of Sulfate in Seep Water at the Mexican Hat, Utah, Disposal Site

Sulfate concentrations similarly have decreased in the two North Arroyo seeps from greater than 6,000 mg/L to less than 4,000 mg/L since early 2000 (Figure 12–3). Concentrations in the Gypsum Creek seeps and the background seep have remained relatively steady between 3,000 and 4,000 mg/L during this time.

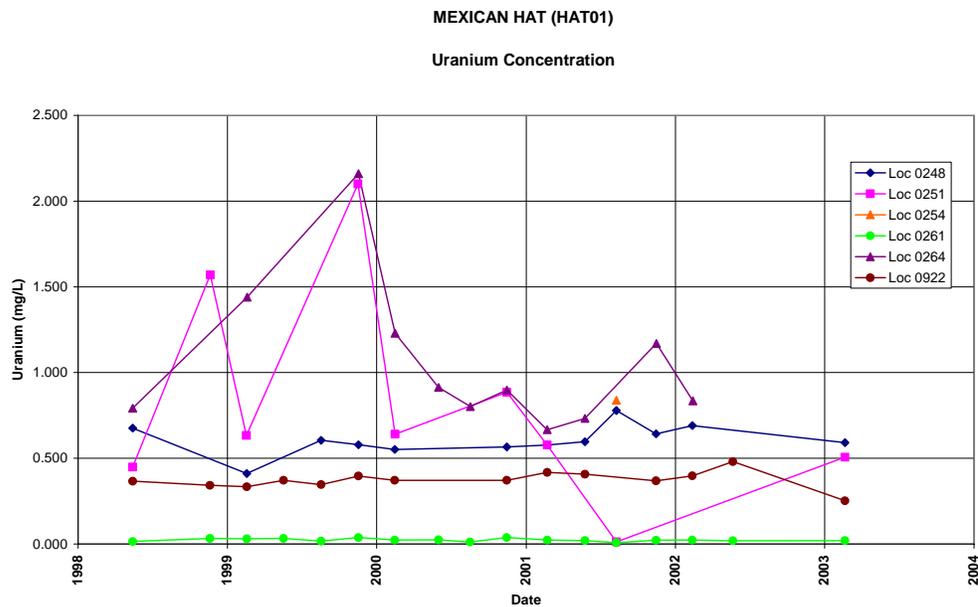
Figure 12–4. Time-Concentration Plots of Uranium in Seep Water at the Mexican Hat, Utah, Disposal Site

Concentrations of uranium in the North Arroyo seeps have decreased from greater than 2.0 mg/L to less than 1.0 mg/L since November 1999 (Figure 12–4). Concentrations remain relatively constant in the Gypsum Creek seeps at approximately 0.5 mg/L. Background levels at seep 0261 averaged 0.024 mg/L for the past several years.

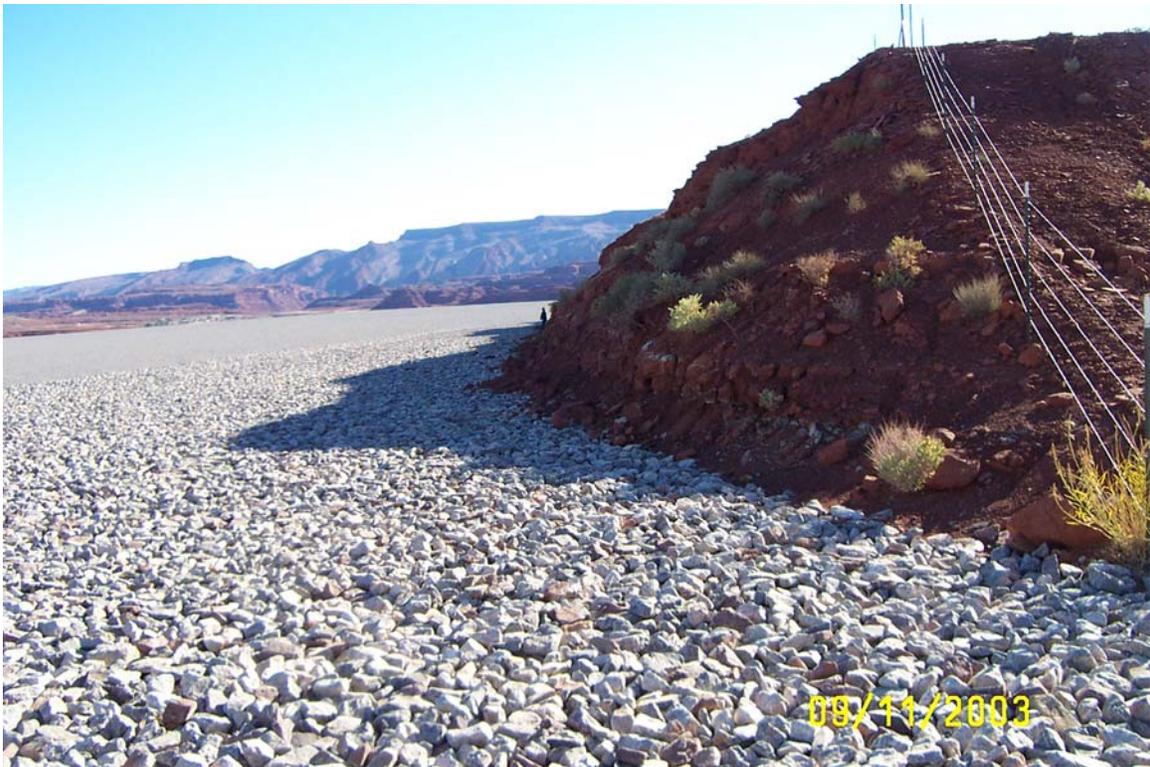
The sloughing of red country rock and soil along the south apron did not increase significantly during the past year; the accumulation remains approximately 18- to 24-inches high against the base of the adjacent hill slope (PL-1). As in previous years, inspectors did not find evidence of channel erosion in this area, and the sloughed material does not appear to have filled the void spaces in the riprap beyond the toe of the hill slope. A photograph will be taken for the record annually until conditions stabilize.

HAT 9/2003. PL-1. Baseline location photograph of sloughing hill slope materials along the south apron.

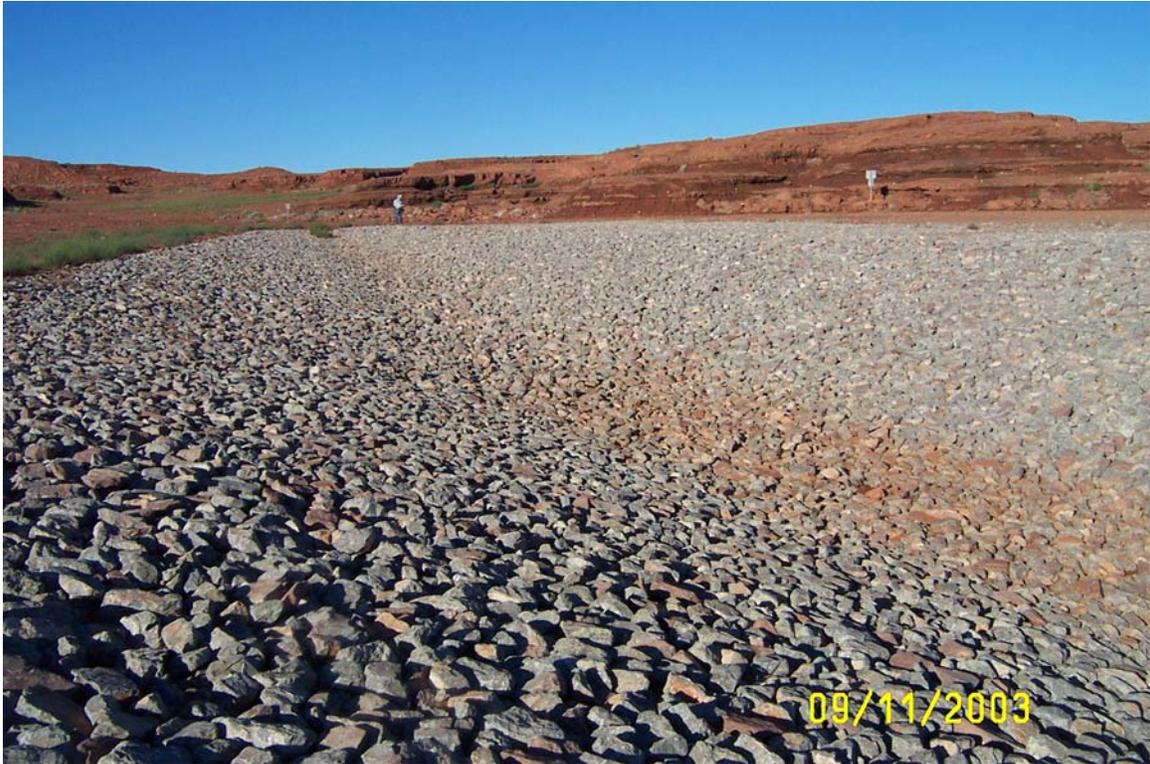
12C Substantial erosional damage to the upper section of the West Ditch caused by a severe storm in 2002 was repaired following a geotechnical evaluation of the damage. Another severe storm totaling 1.25 inches of rainfall in the town of Mexican Hat occurred on September 9, 2003. The repaired washout area of the West Ditch was intact (PL-2), and no evidence of erosion, settling, or slumping was observed on the side slopes or in the diversion ditches. Some sediment and weeds were present in the lower end of West Ditch but do not affect the performance of the diversion ditch.

HAT 9/2003. PL-2. Repaired washout area at the head of West Ditch.
