## 9.0 Lakeview, Oregon, Disposal Site

### 9.1 Compliance Summary

The Lakeview Disposal Site, inspected on June 25 and 26, 2003, was in good condition. A revised Long-Term Surveillance Plan, which includes a recalculated median diameter of the side slope riprap (the minimum size required to protect the cell from erosion by storm runoff), is pending U.S. Nuclear Regulatory Commission (NRC) concurrence. Results of the fifth annual gradation test on the west side slope indicate that the median diameter of the riprap remains substantially above the recalculated minimum size. A damaged perimeter sign was replaced and broken strands of the perimeter fence were repaired. No need was identified for a follow-up or contingency inspection.

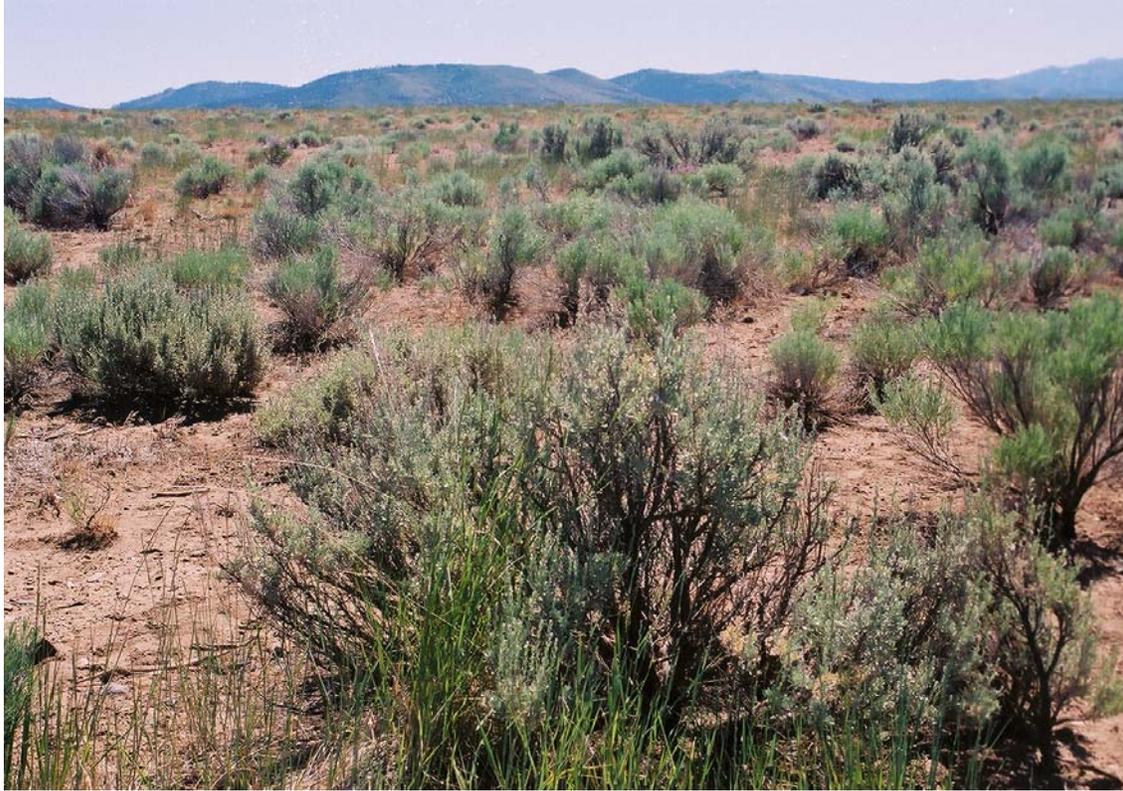
**Top of the Disposal Cell**—The design for the top of the disposal cell has produced conditions that favor the growth of deep-rooted plants. The top slope was seeded with grasses, but the low water-storage capacity of the thin (nominal 4-inch-thick) topsoil layer has limited grass growth to scattered patches of deeper-rooted wheat grasses. Movement of precipitation through the riprap and bedding layers and into the radon barrier favors the growth of shrubs. Many mature rabbitbrush plants and sagebrush plants grow on the top of the disposal cell (PL-1), and shrub density currently exceeds that of the native plant community adjacent to the site.

Deep-rooted plants have the potential to increase the hydraulic conductivity of the radon barrier, allowing meteoric water to leach contaminants from the encapsulated tailings and into the underlying soil and ground water. In contrast, an increase in plant cover indicates an increase in transpiration rate, which removes water from the root zone and reduces the probability of saturation and leaching of contaminants.

*LKV 6/2003. PL-1. Shrubs growing on the top slope of the disposal cell.*

- 9C DOE, in collaboration with Sandia National Laboratories, continues to conduct a risk-based performance evaluation of the cell cover to determine how biointrusion affects infiltration through the radon barrier. Fieldwork in 2003 focused on developing scenarios and sequence of processes or events that describe possible future conditions at the disposal cell. Soils and vegetation at locations around the disposal cell site were characterized. These sites, selected as disposal site analogs, represent a reasonable range of wet and dry future climate scenarios. Soil physical properties, plant community characteristics, and leaf area index were measured at the analog sites. The saturated hydraulic conductivity was measured with air-entry permeameters (PL-2). These analog site data will be used to conduct performance calculations and sensitivity/uncertainty analyses using the Framework for Risk Analysis in Multimedia Environmental Systems model developed by Pacific Northwest National Laboratory. Results of the analyses, expected to be completed in 2004, will be presented in a separate report.

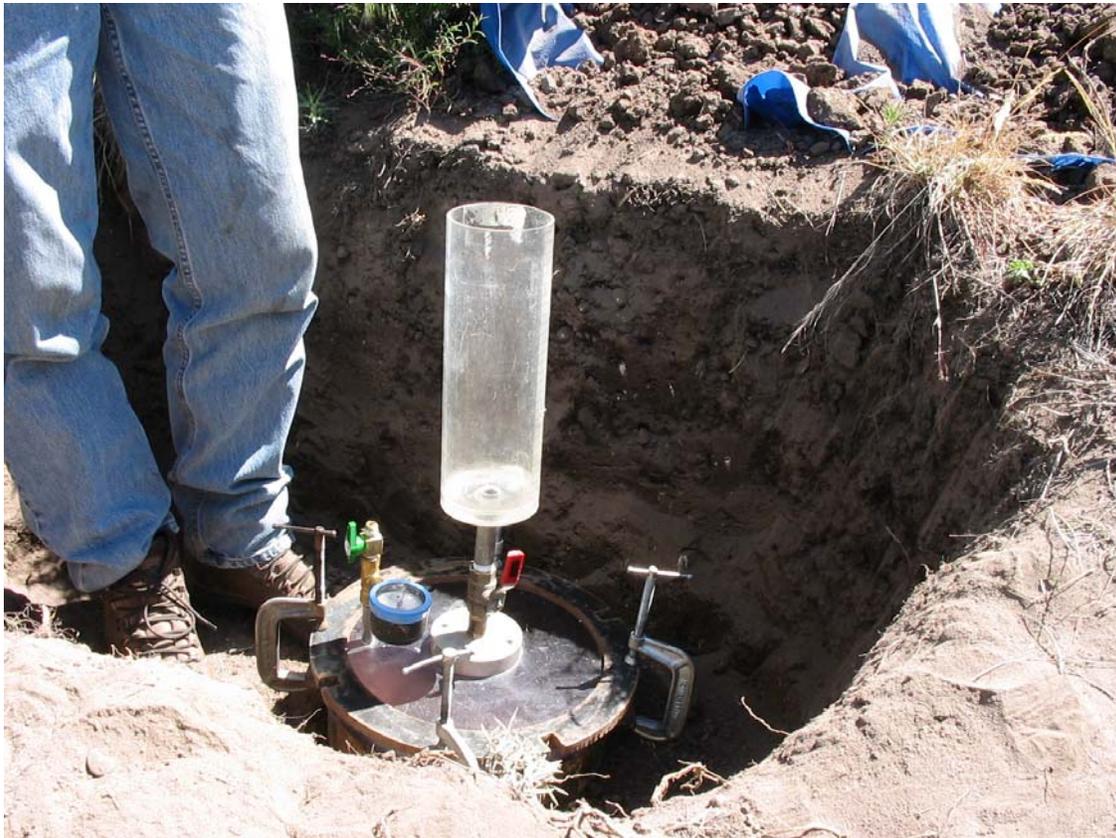
*LKV 6/2003. PL-2. Air-entry permeameter test at a soil analog site.*
