11.0 Maybell, Colorado, Disposal Site

The site, located northeast of Maybell, Colorado, was inspected on August 5, 2003. Results of the inspection are described below. Features and photograph locations (PLs) mentioned in this report are shown on Figure 11-1. Numbers in the left margin of this report refer to items summarized in the Executive Summary table.

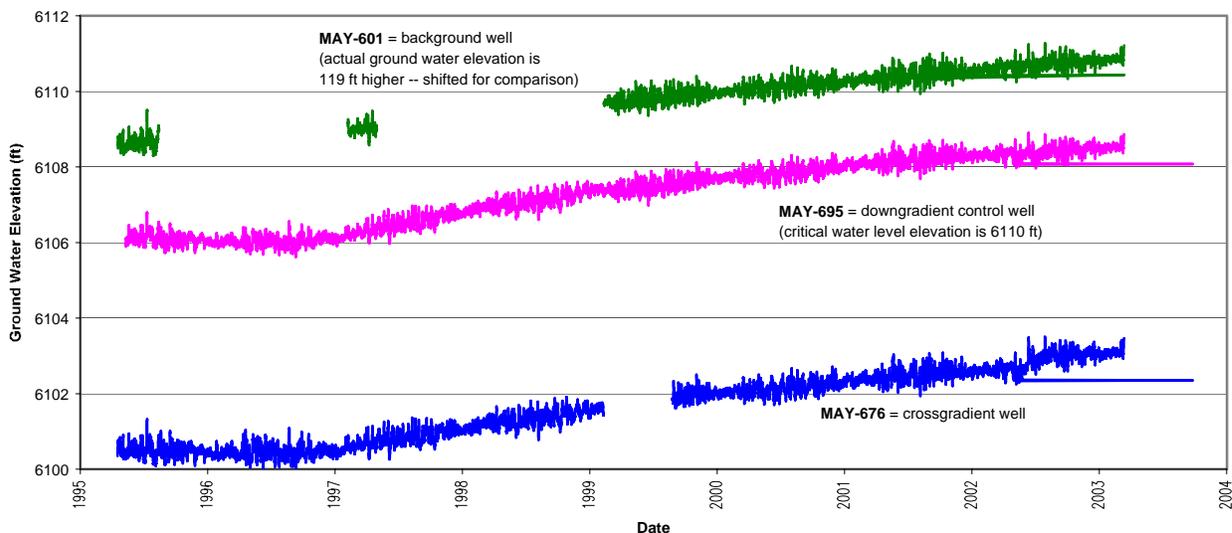
Figure 11–2. Water Level Measurements at the Maybell, Colorado, Disposal Site

11D As a best management practice, DOE performs continuous ground water level monitoring downgradient from the disposal cell for the purpose of measuring changes in ground water levels that may be related to transient drainage caused by disposal cell construction. Evaluation of datalogger information from monitor wells MW-0695 (downgradient control well), MW-0676 (crossgradient well), and MW-0601 (upgradient/background well) from November 1995 through September 2003 shows a slight increasing trend of ground water levels since mid-1997 (Figure 11-2). Because the ground water level in the upgradient well is increasing at approximately the same rate as that in the downgradient wells, it is probable that the change in water level is related to regional causes rather than being directly related to disposal cell performance. The decision to discontinue ground water level monitoring and decommission the monitor wells will be based on evaluation of datalogger information over a 5-year period (through mid-2004).

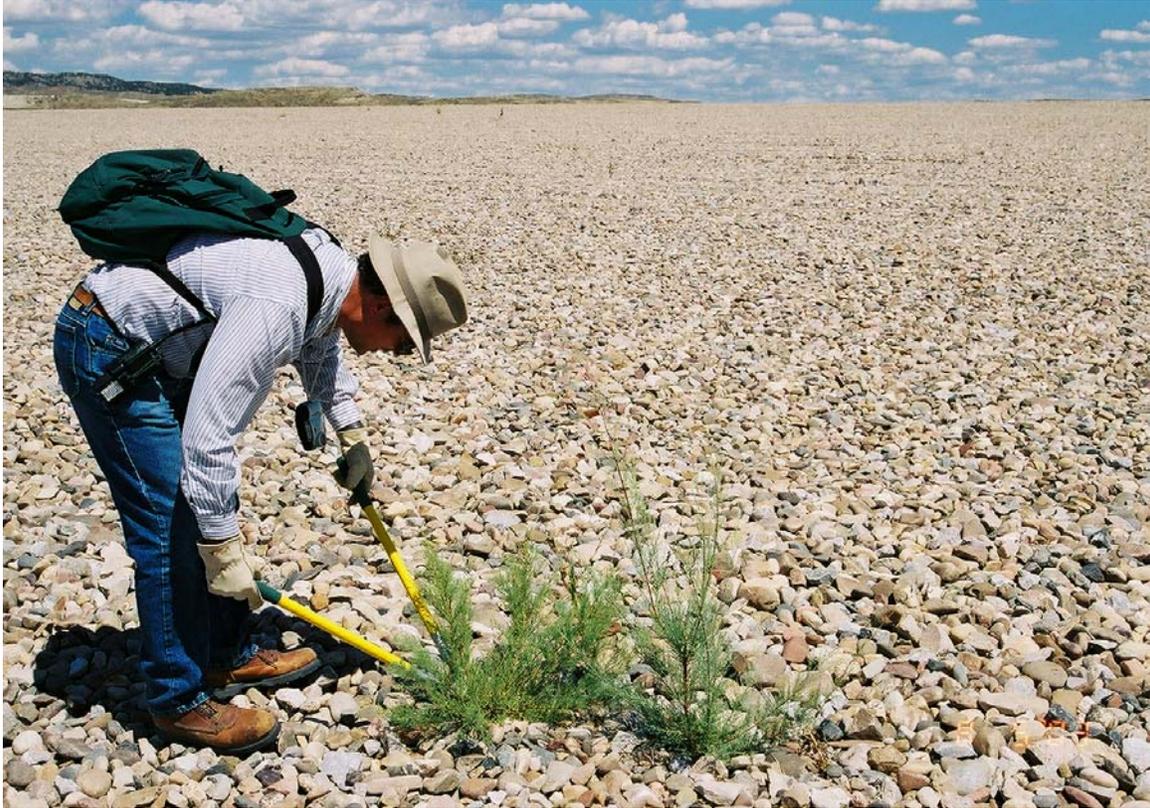
11C Occasional plants consisting of deep-rooted species, grasses, and annual weeds were observed on the cell top and side slopes. Deep-rooted plants (tamarisk and rabbitbrush) were cut and their stems were treated with herbicide (PL-1), and patches of unidentified thistle were sprayed with herbicide.

MAY 8/2003. PL-1. Tamarisk on the cell top being cut.

A damaged perimeter sign was replaced, the fence was tightened at several locations, cracks in the concrete base at a site marker were sealed, and deep-rooted plants on the cell top were cut and treated with herbicide.

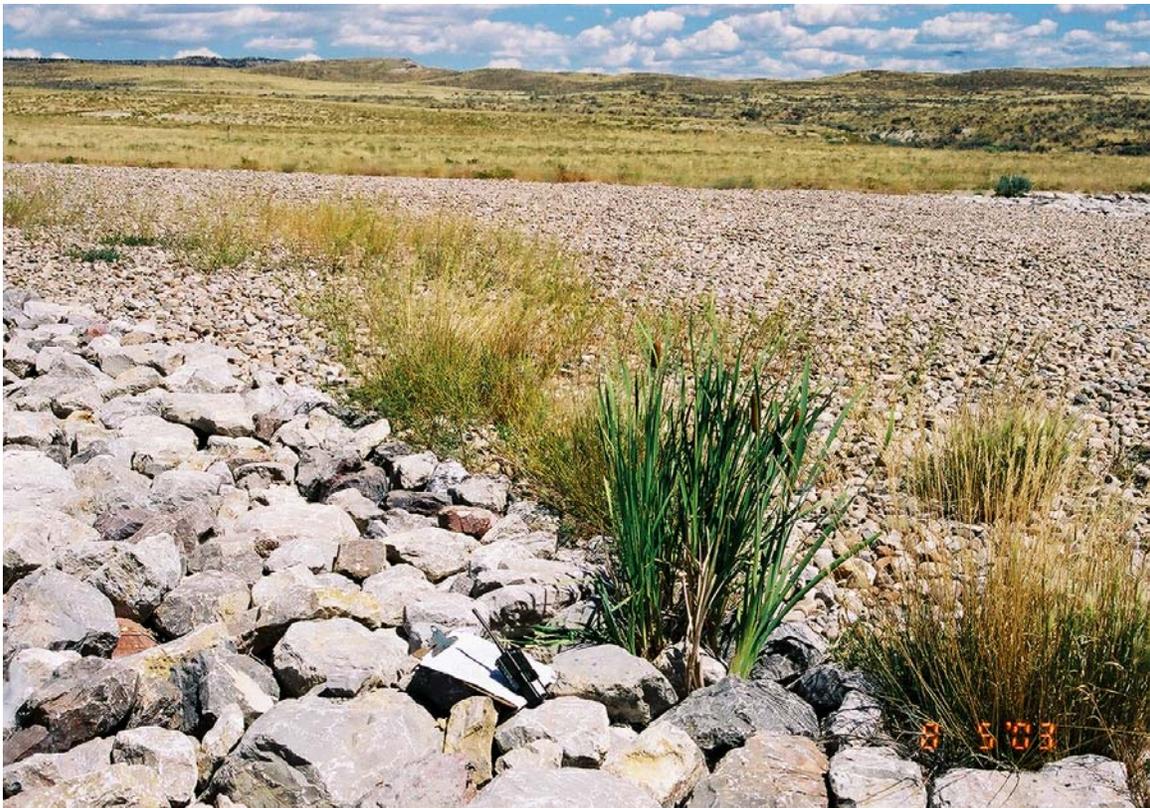
In accordance with the Long-Term Surveillance Plan, inspectors looked for seeps on the east corner and southeast side slopes because large quantities of slimes were encapsulated in this portion of the cell. The east corner of the cell is a topographic low point for draining a portion of runoff from the cell. No moisture was evident on the surfaces of the side slopes, but tamarisk (cut and treated with herbicide), cattail, yellow sweet clover, grasses, and annual weeds were growing on the cobble blanket at the toe of the east corner (PL-2). Standing water often is present in the apron at this location, and evaporite deposits have formed on the apron riprap (PL-3). A sample of the evaporite minerals was collected for laboratory analysis, and no analytes attributable to the cell contents were present.

MAY 8/2003. PL-2. Vegetation in the cobble blanket at the east corner toe of the cell.

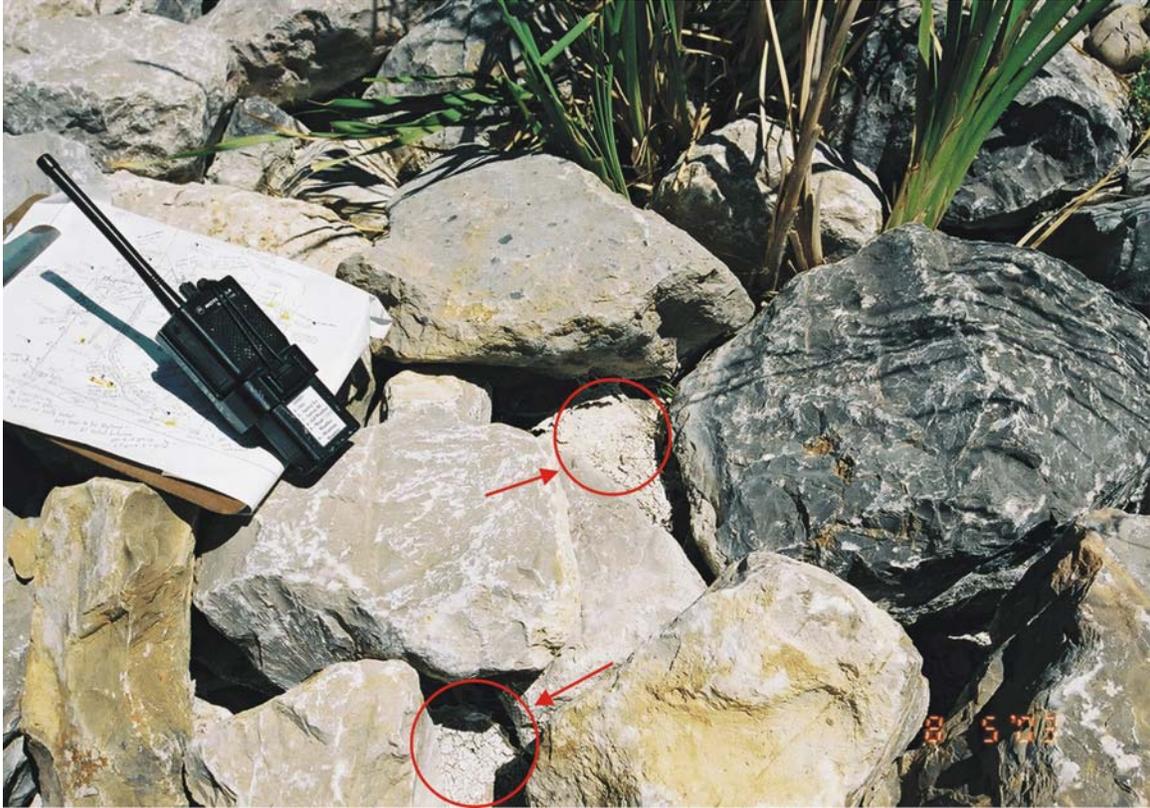
MAY 8/2003. PL-3. Evaporite deposits on apron riprap at the east corner of the cell.

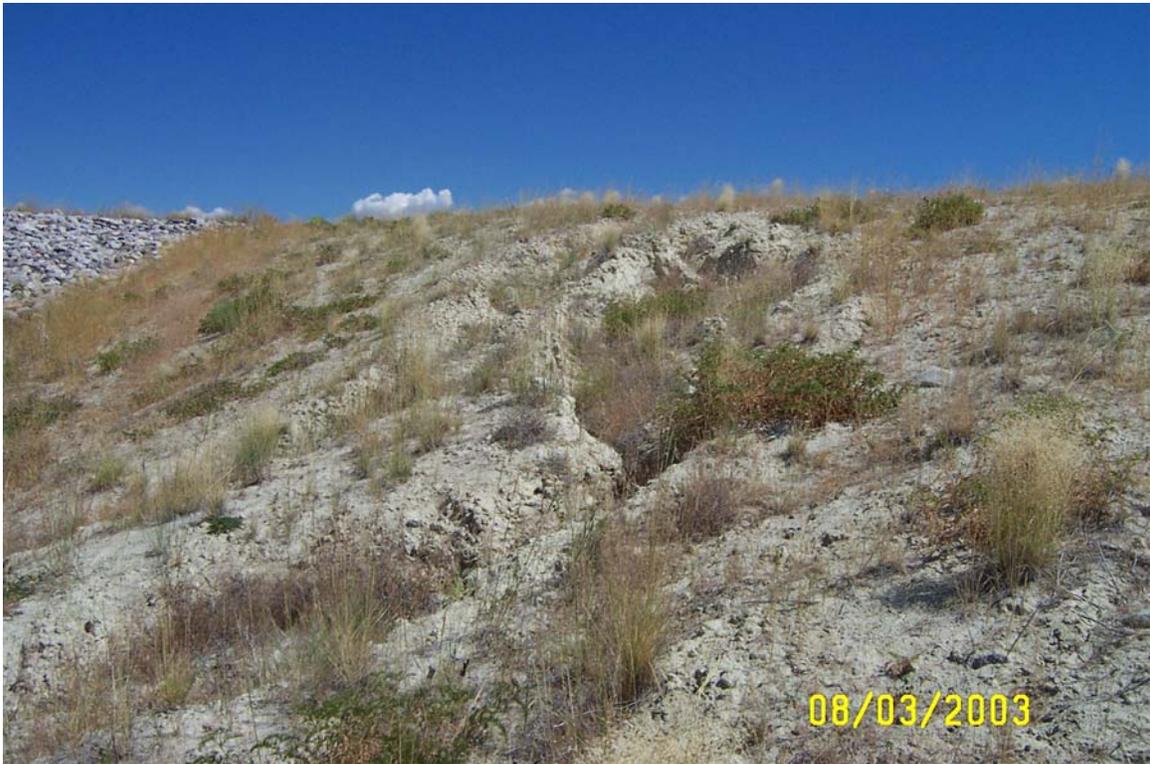
Other Areas On Site—The rock-armored ditches, swales, and gullies were in good condition. There was no evidence of sediment moving offsite into Johnson Wash, and formerly active rills and gullies appear to be stabilizing due to self-armoring and increased vegetation (PL-4).

MAY 8/2003. PL-4. Stabilizing rills and gullies on the east slope of Gully No. 1.
