3.0 Sherwood

Sherwood Site Long-Term Custody Compliance Requirements

Sherwood Site Inspection Results

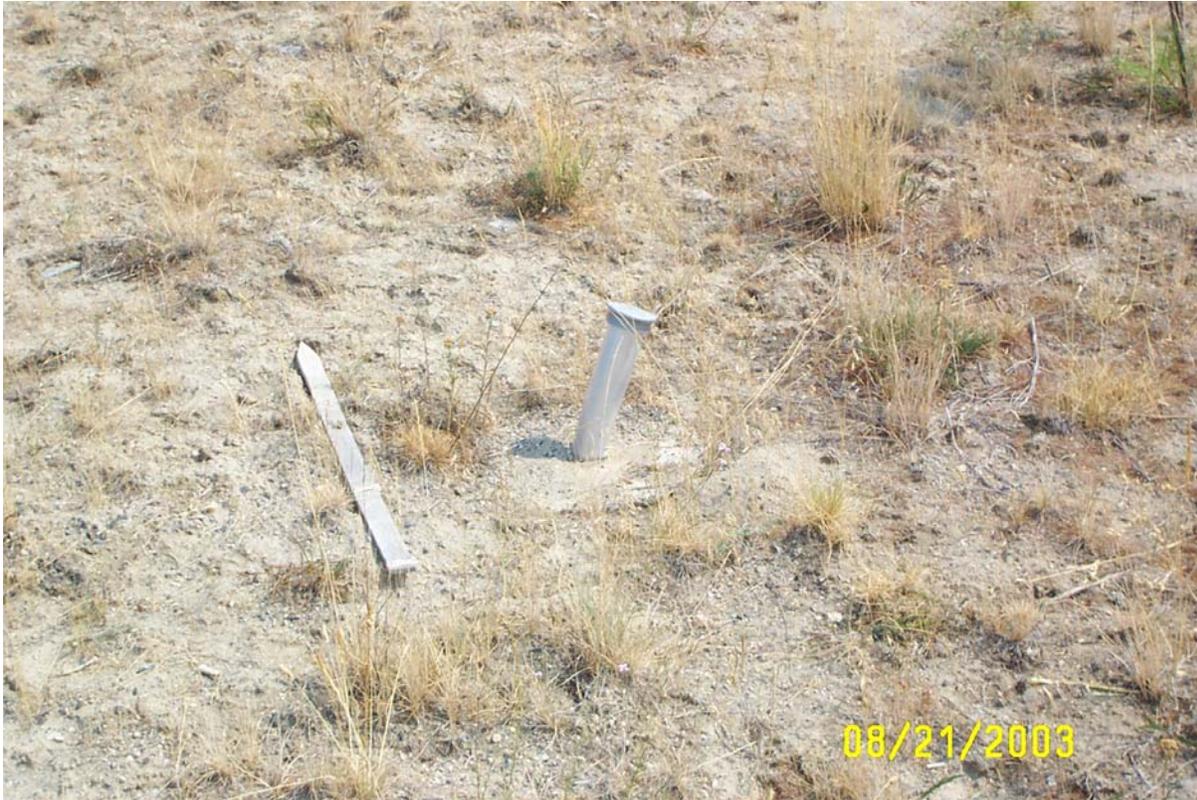
Six boundary monuments designated BM-1, BM-2, BM-3, BM-3A, BM-4, and BM-5 define the site boundary. Inspectors noted that BM-3A had been bent (PL-1); all other monuments were in excellent condition.

| Photograph Location Number | Description |
|---|--|
| SHE PL–1 | Boundary monument 3A, bent. |

SHE 8/2003. PL-1. Boundary monument 3A, bent.

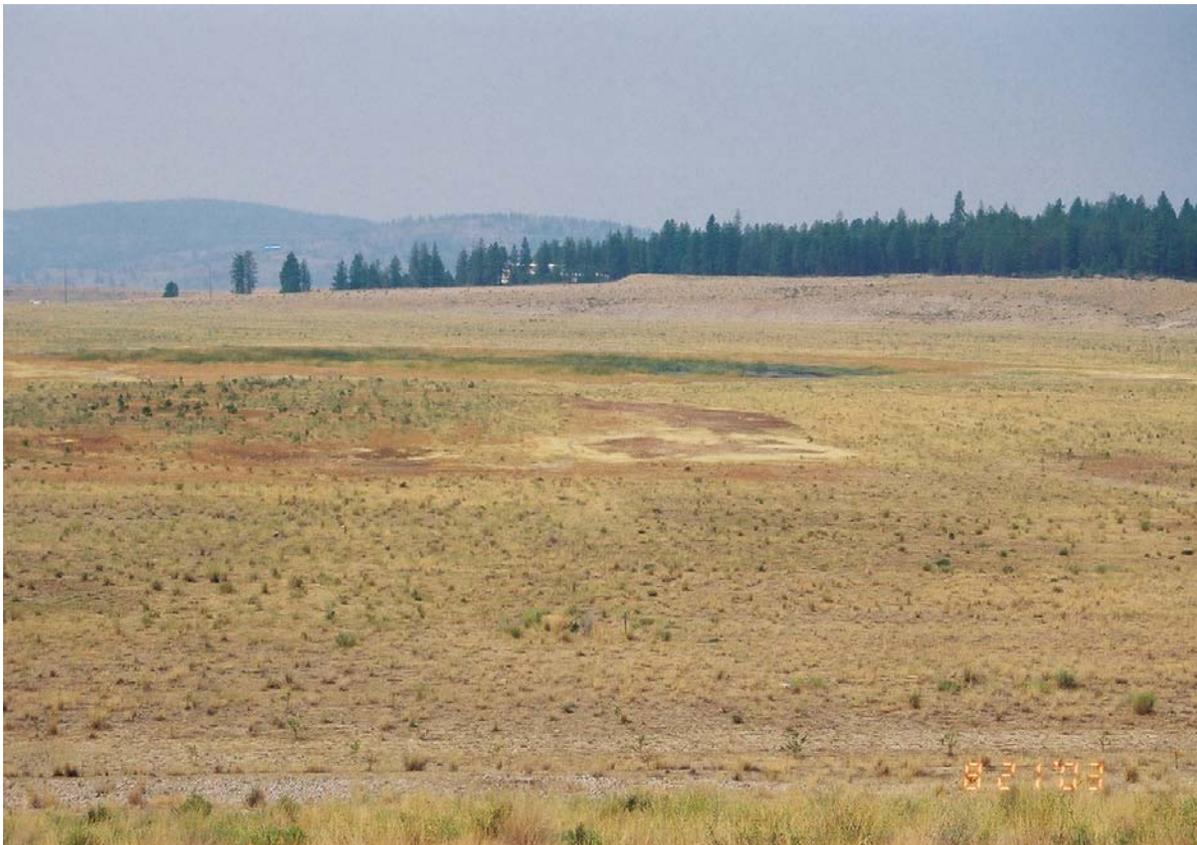
Inspectors noted an additional settlement area east of the existing pond area (PL-2). This low-lying area, 3 to 5 acres in size, contains riparian vegetation and shows indications of having saturated soils during certain times of the year. There was no water in this settled area at the time of the inspection.

| Photograph Location Number | Description |
|---|--|
| SHE PL–2 | Additional settlement area (foreground) on top of tailings impoundment; pond area (dark green) is in background. |

SHE 8/2003. PL-2. Additional settlement area on top of tailings impoundment; pond area (dark green) is in background.

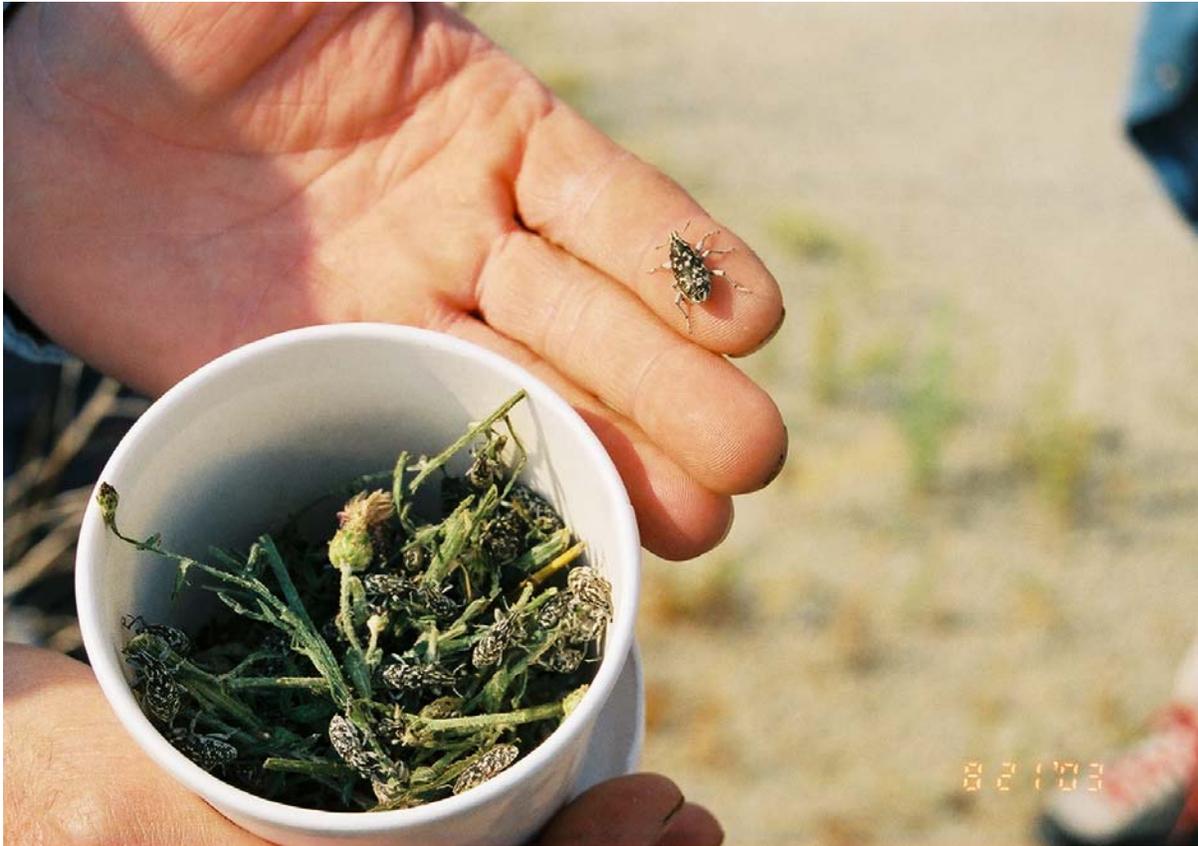
Significant populations of two noxious weed species—diffuse knapweed (*Centaurea diffusa*) and dalmation toadflax (*Linaria genistifolia*)—occur throughout and around the Sherwood site. A biological weed control program was initiated in the spring and summer of 2003 with the release of six species of insects. During the site inspection, the knapweed root weevil (*Cyphocleonus achates*) (PL-3) was being released.

SHE 8/2003. PL-3. Knapweed root weevil (Cyphocleonus achates).

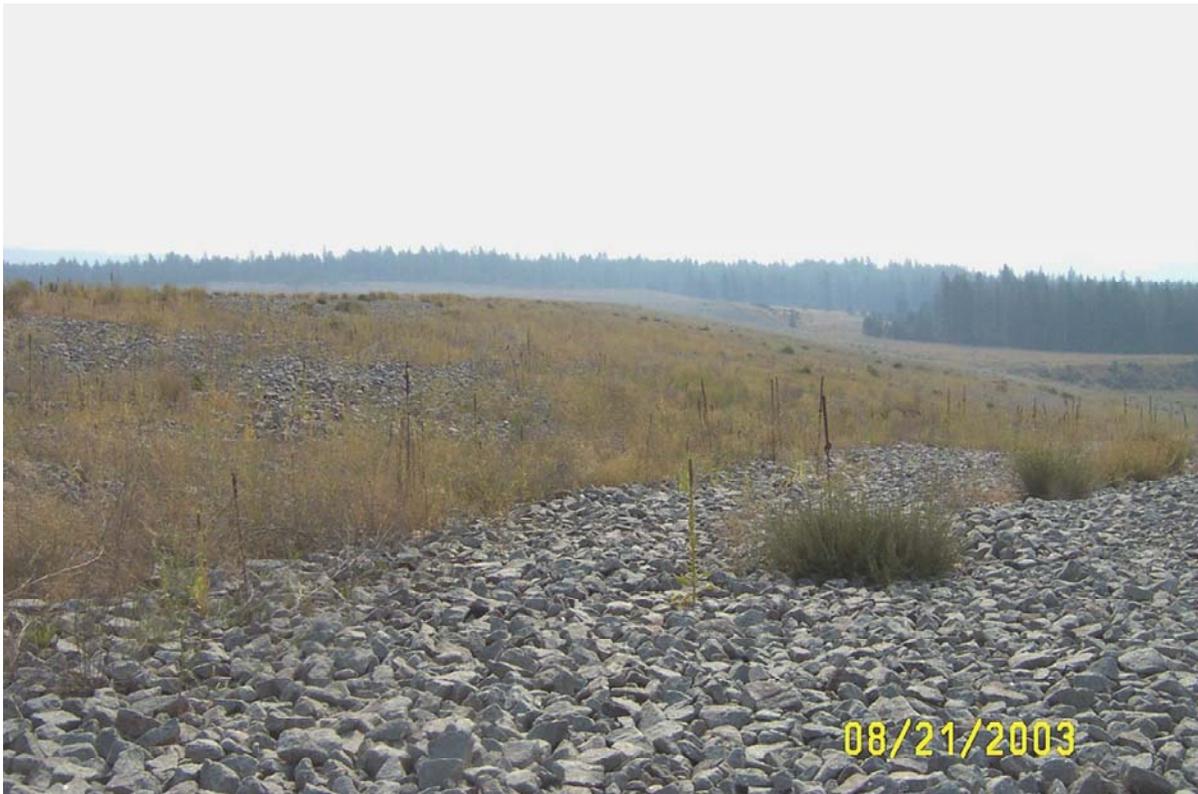
The tailings embankment on this site, classified as a dam, necessitates a dam safety inspection to assure continued compliance with the Federal Dam Safety Act. The impoundment dam face was inspected in accordance with the attached Dam Inspection Checklist and photographed (PL-4 and PL-5). No evidence of seepage, slumping, erosion, or instability was observed. Ponderosa pines, some as tall as 24 inches, were observed on the face.

SHE 8/2003. PL-4. Embankment face showing vegetation encroachment.

| Was vegetative growth that could compromise dam stability observed? If yes discuss in report. | <u>no, but Ponderosa pine seedlings are establishing on the dam face</u> |

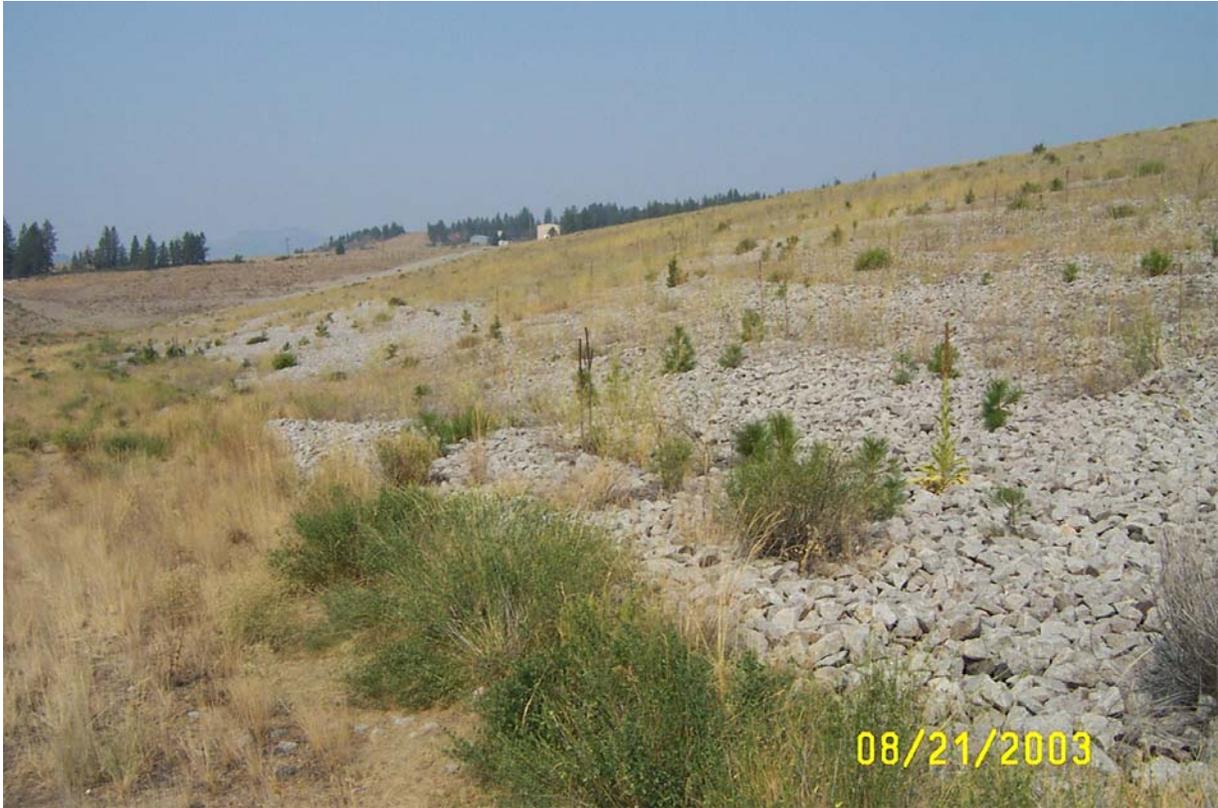
SHE 8/2003. PL-5. Embankment face showing vegetation encroachment.

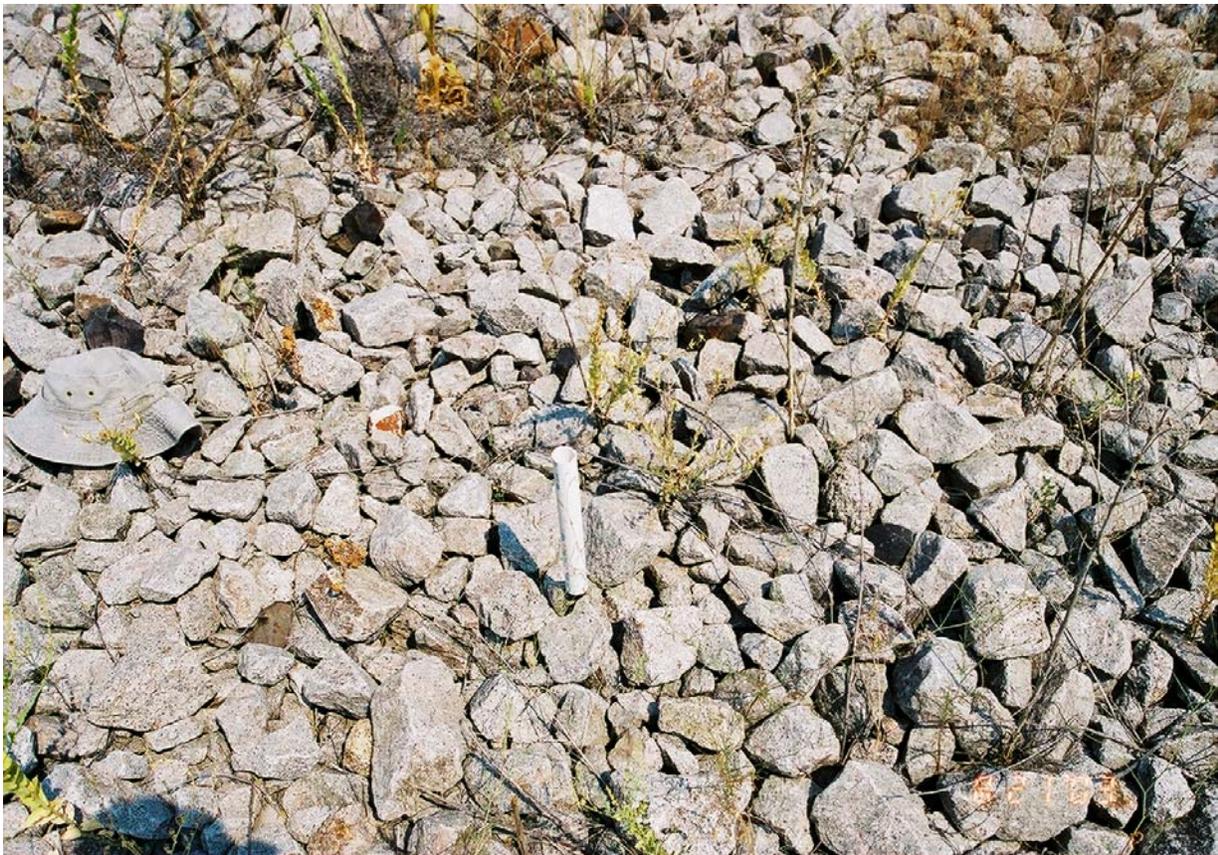
SHE 8/2003. PL-6. Rock Plot 1.

A small percentage of riprap has crumbled. In response to NRC concerns about rock quality, four "rock plots" were established on the embankment face to monitor the quality of riprap. The plots are intended to be approximately 1-meter square. Inspectors placed either a metal pin covered

with a sleeve of PVC pipe or a section of PVC pipe at the center of each plot and obtained location information using global positioning system equipment. Baseline photographs were taken of each plot (facing a northerly direction) (PL-6 through PL-9). Photography should be repeated during future inspections for comparison to baseline rock quality. Future inspectors may recommend changes to the plot inspection frequency or cessation of monitoring.

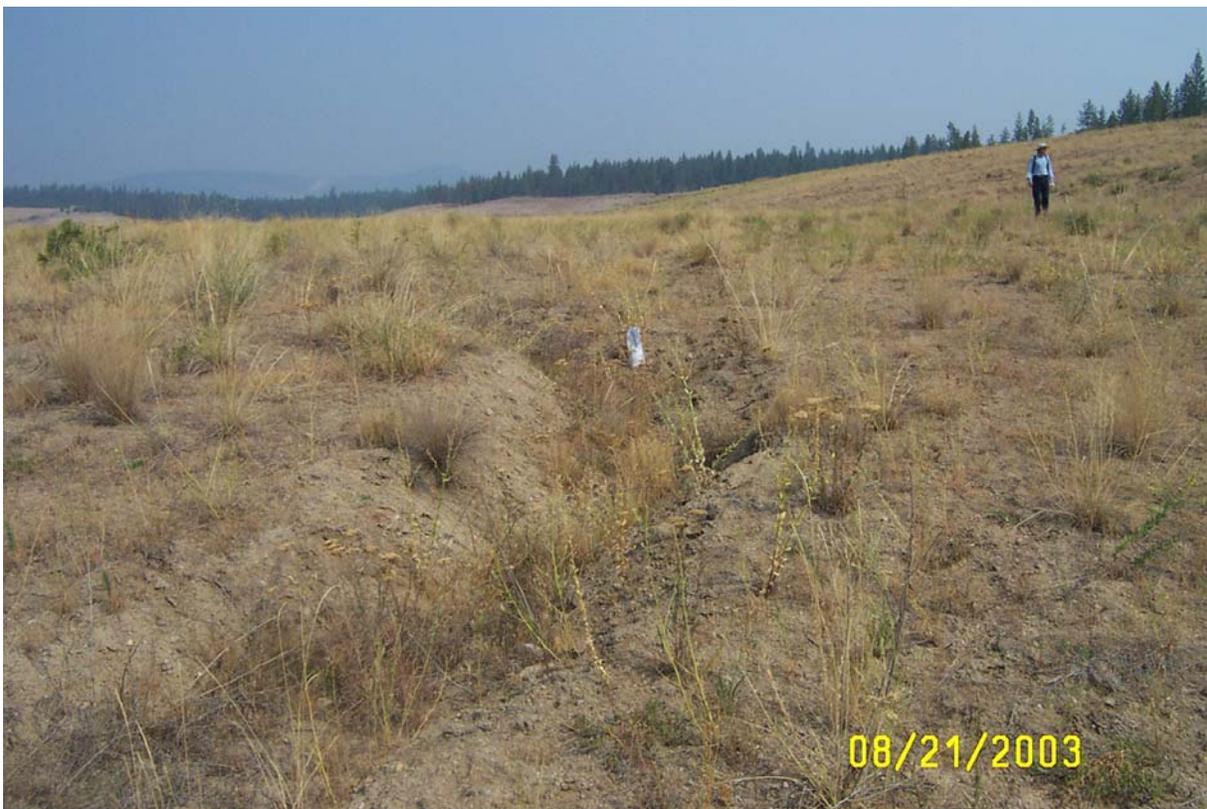
Adjacent to the eastern end of the dam face is a steep slope that is underlain by rock and covered with soil. Numerous rills and gullies noted during previous annual inspections were inspected on this slope (PL-10 through PL-13). No new rills were identified, and the size of existing rills had not increased since the 2001 and 2002 inspections. Although these erosional features do not threaten site integrity, they should be inspected annually to ensure the slope remains stable and sediment is not transported offsite.

SHE 8/2003. PL-10. Gully north of east end of embankment face.

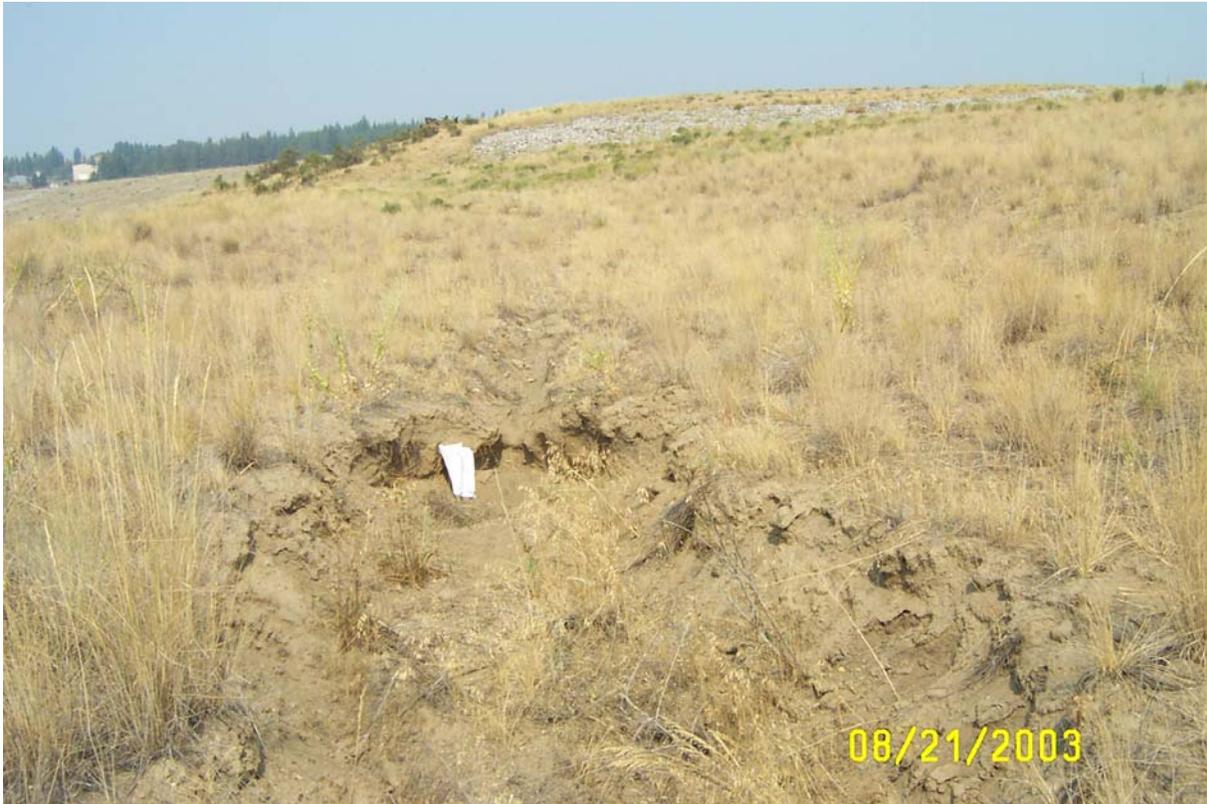
SHE 8/2003. PL-11. Gully and headcut below riprap-armored portion of swale east of embankment face.

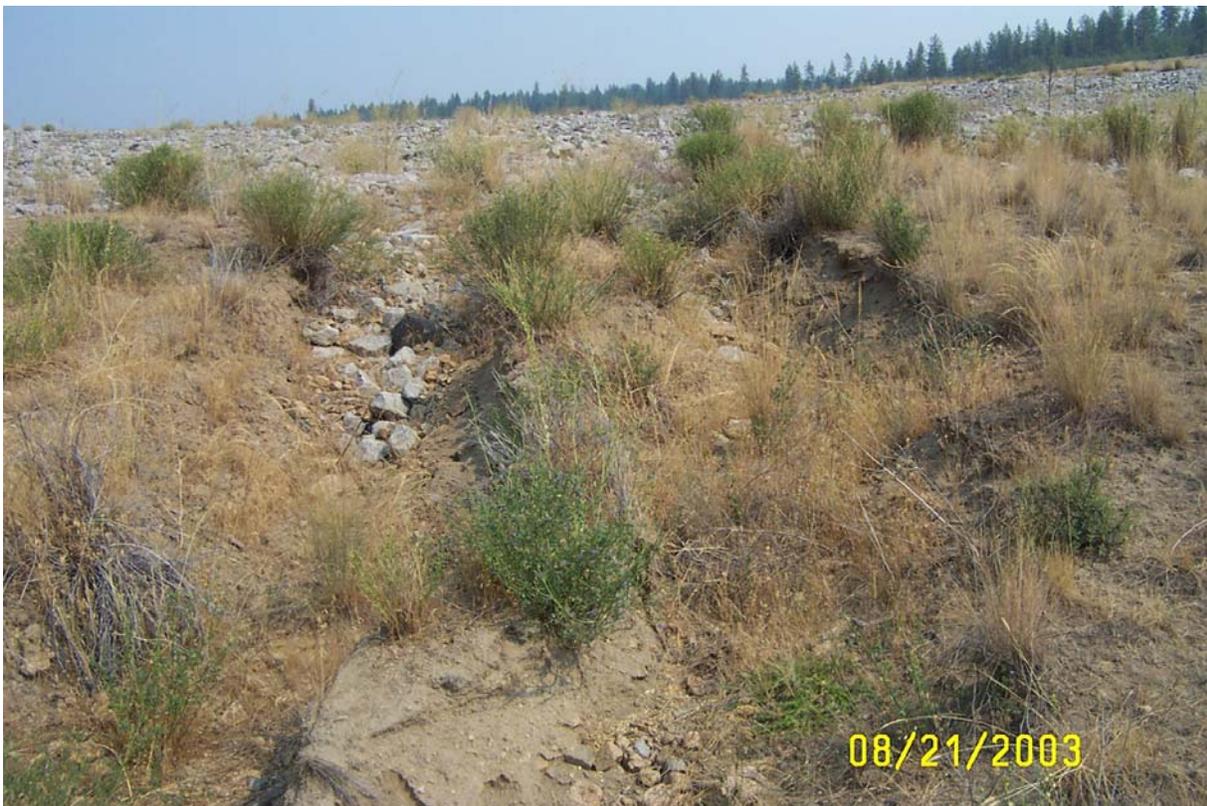
SHE 8/2003. PL-12. Gully below riprap-armored portion of swale east of embankment face.

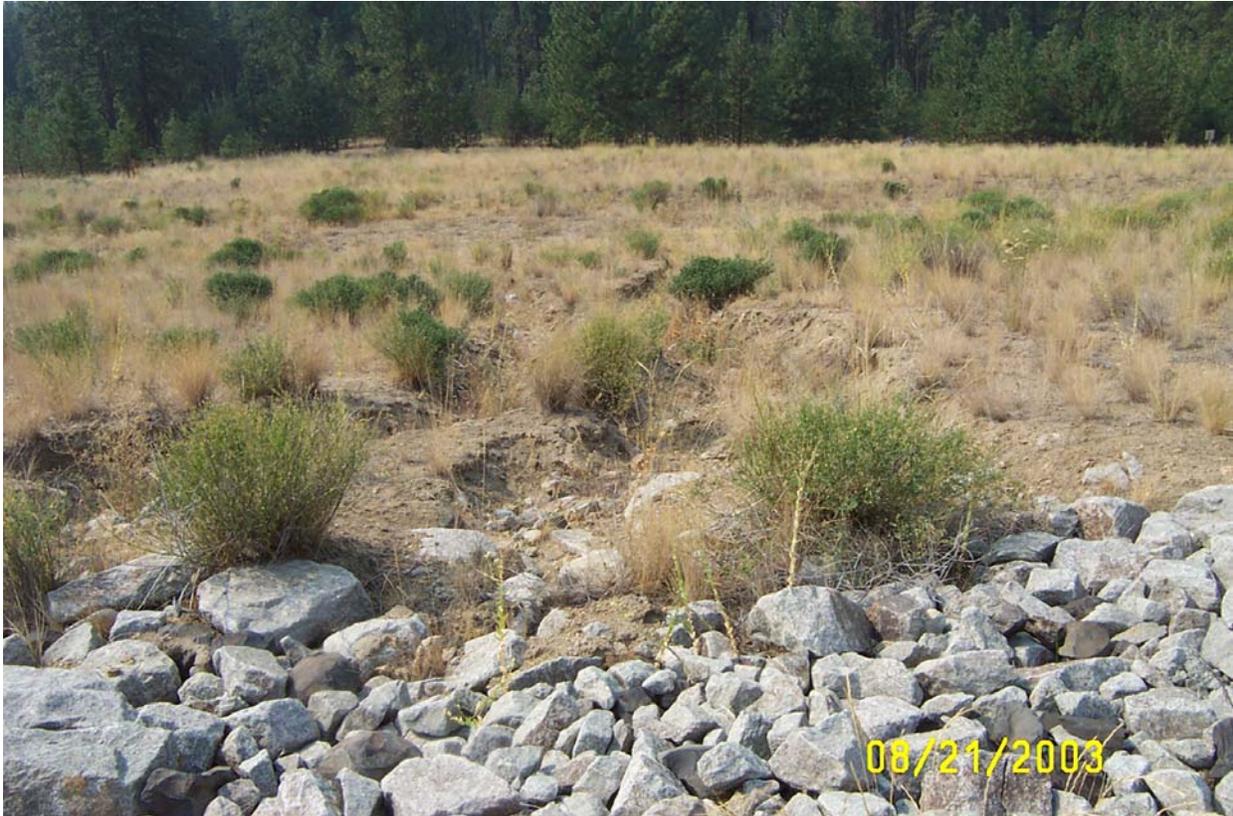
SHE 8/2003. PL-13. Gully below riprap-armored portion of swale east of embankment face.

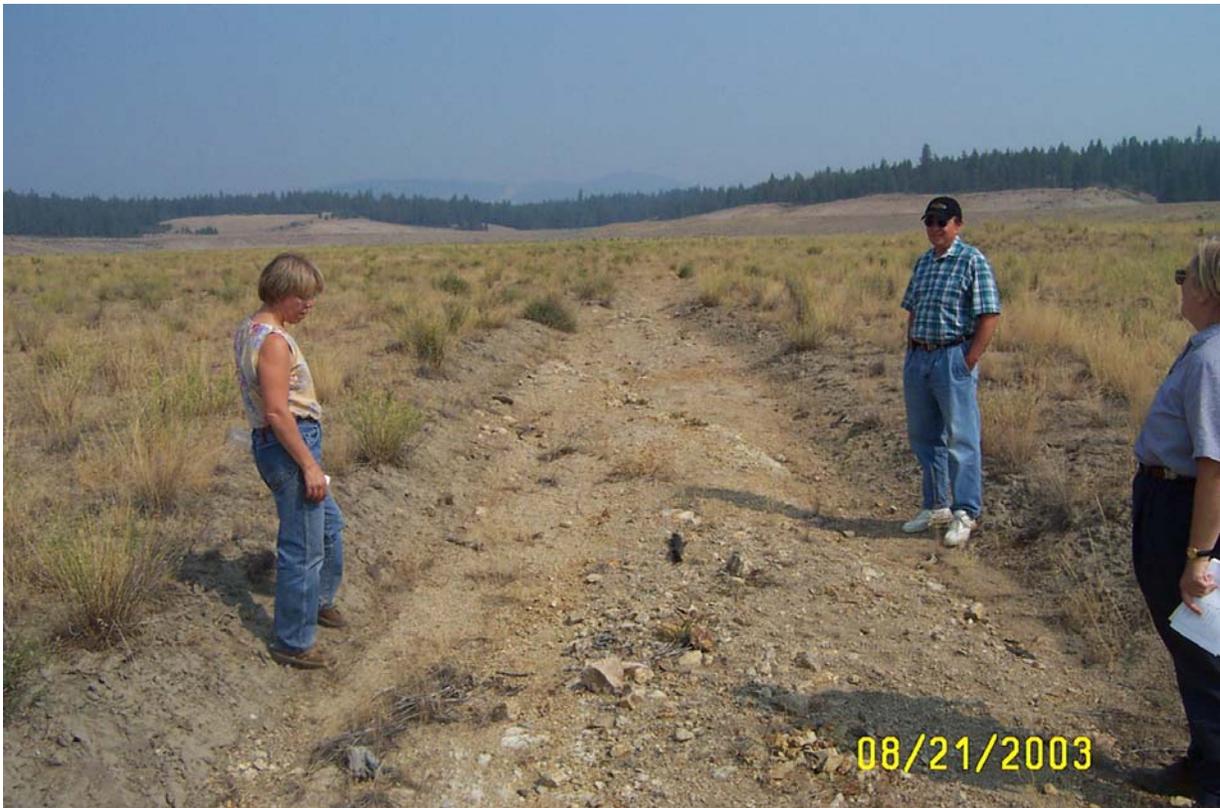
A swale across the south end of the top slope is armored with riprap at the east end of the embankment, where the gradient increases. Erosion noted previously north of the riprap has cut to bedrock but considering the resistant material exposed at the invert and the low gradient of the unarmored portion of the swale, the swale appears stable (PL-14). Although additional erosion is unlikely, inspectors should monitor this area for changes.

SHE 08/2003. PL-14. Swale at top of east end of embankment showing erosion to bedrock.
