2003 ANNUAL INSPECTION REPORT FOR THE WELDON SPRING SITE ST. CHARLES, MISSOURI

WELDON SPRING SITE REMEDIAL ACTION PROJECT
WELDON SPRING, MISSOURI

FEBRUARY 2004

2003 Annual Inspection of the Weldon Spring Site St. Charles, Missouri

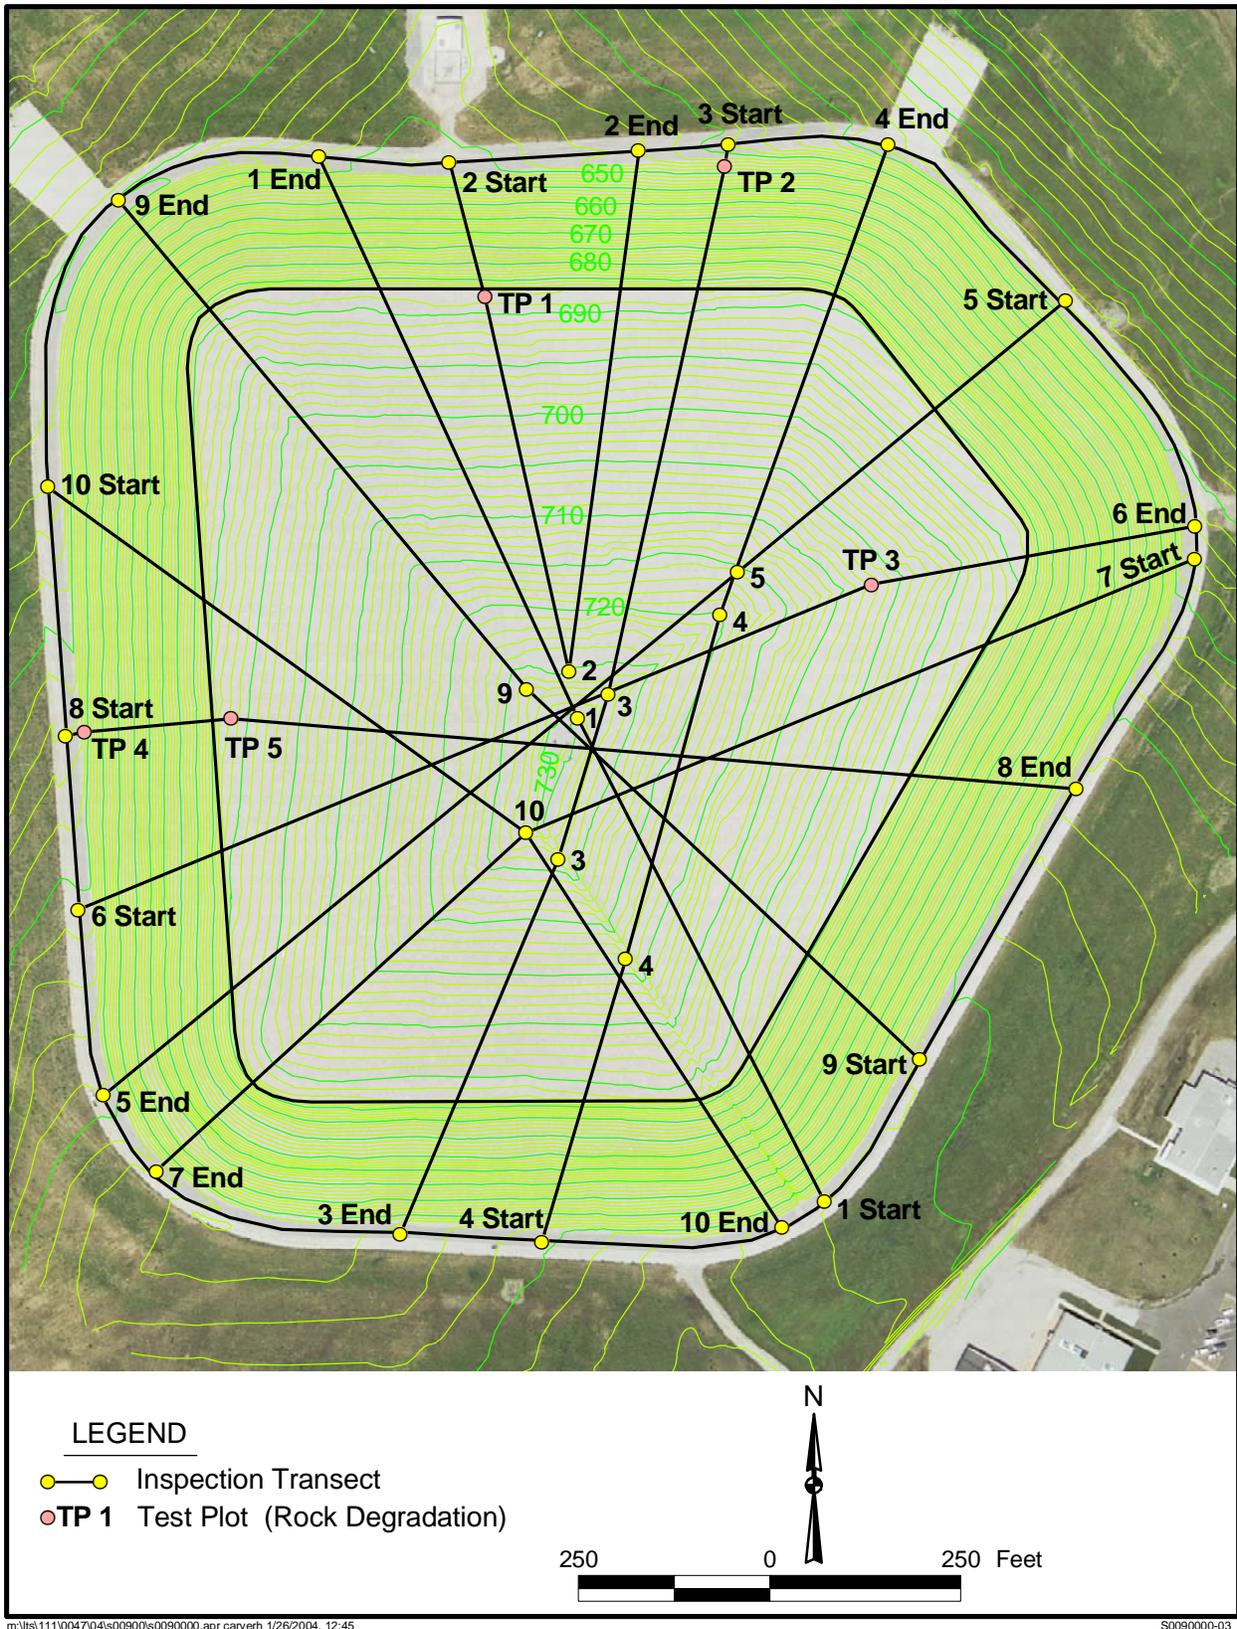
Figure 6. Disposal Cell Inspection Transects and Rock Test Plot Locations at the Weldon, Spring, Missouri, Site

The disposal cell was inspected by walking ten transects over the cell and around the cell perimeter at the grade break and the base. No unusual settlement or other unusual observations were noted. Five areas of the cell were marked for annual observations of rock degradation. The LCRS also was inspected and found to be in good condition. Sixty-five of 120 groundwater monitoring wells were inspected and found to be in generally good condition. A few of the wells needed to be labeled with the proper identification numbers and/or repainted. Other site features including the prairie, site markers and roads also were inspected.

Remarks Inspectors walked 10 transects and marked 5 areas
to document annually for rock degradation (see figure in report).
Rock was in good condition. No evidence of post-construction
degradation.

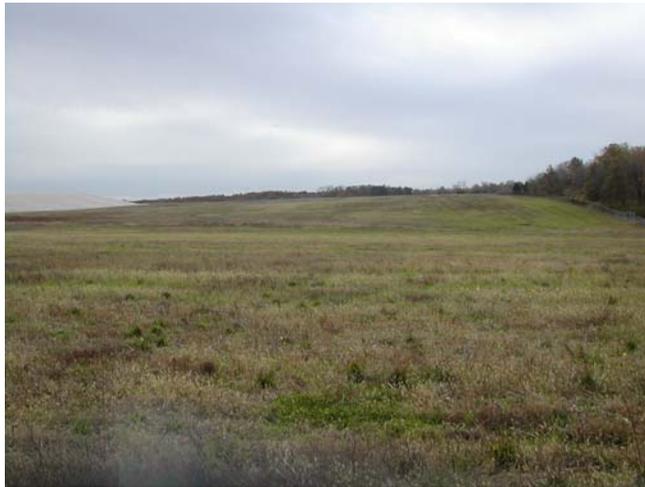
Inspection Results: This area was inspected and no indications of excavations into soil or bedrock or groundwater withdrawal or use were observed (Photo 1). MDC has been granted use and maintenance of the Hamburg Trail across DOE property. Lindenwood University has been granted use of the Administration Building. Current land use remains consistent with the planned institutional controls.

Photo 1: Photo taken from northwest corner of the site boundary facing south. Shows portion of proposed institutional control area within site boundary outside the disposal cell buffer zone.

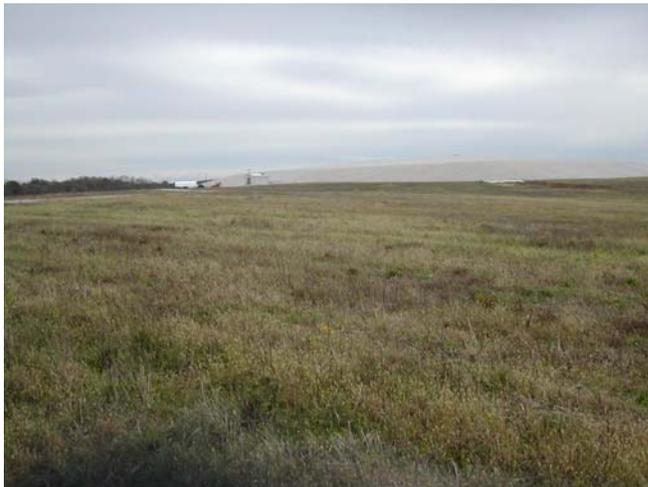
Inspection Results: This area was inspected and no indications of excavations into soils and bedrock and no residential use of the shallow groundwater within the buffer zone were observed (Photo 2). Current land use remains consistent with planned institutional controls.

Photo 2: Shows area west of the disposal area, including portion of proposed institutional control area buffer zone.

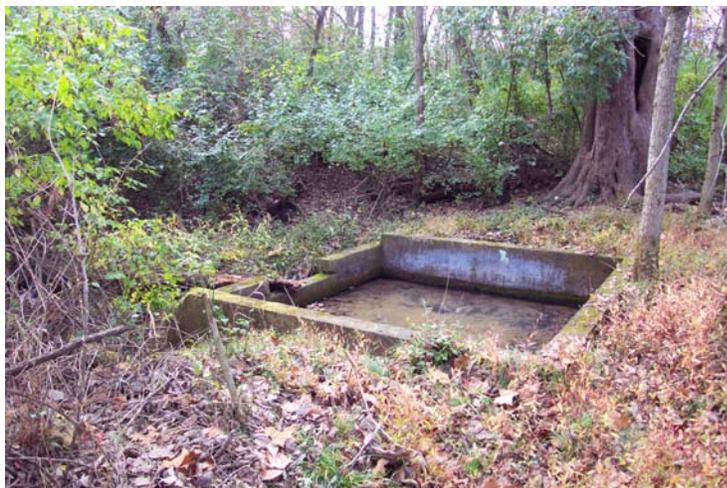
Inspection Results: The surrounding area where groundwater use will be restricted was inspected. No evidence of groundwater use was observed. Burgermeister Spring and Spring 6303 were inspected and there were no indications of spring water use (Photos 3 and 4). Current land use remains consistent with planned institutional controls.

Photo 3: Burgermeister Spring.

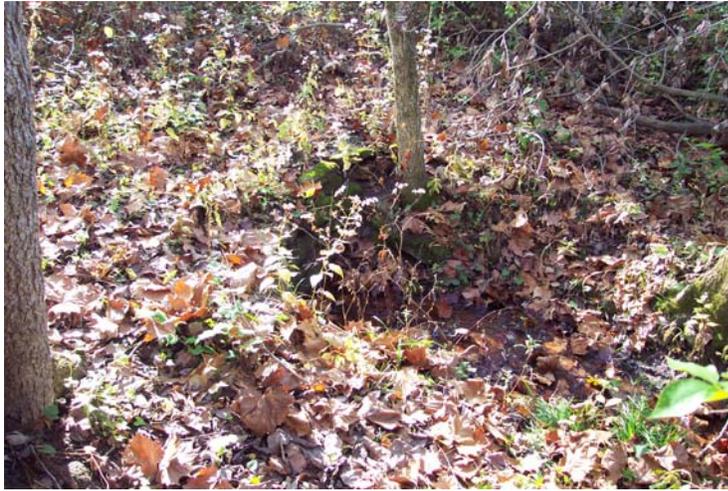
Photo 4: Spring 6303.

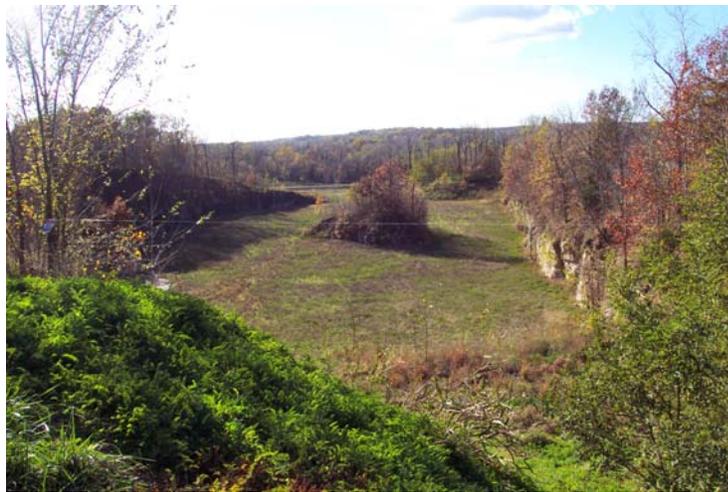
Inspection Results: The Quarry Property was inspected and no indications of excavation into soil or bedrock or groundwater withdrawal or use were observed. Also, no party has been granted use or portions of the Quarry area. Quarry backfill continues to provide positive drainage from the quarry to the Little Femme Osage Creek and vegetative cover remains well established (Photo 5). Current land use remains consistent with planned institutional controls.

Photo 5: The Quarry proper.

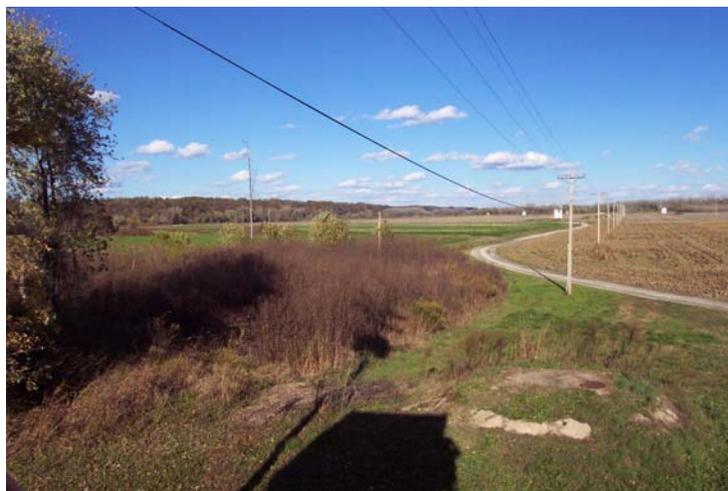
Inspection Results: The groundwater restricted area was inspected and no evidence of groundwater withdrawal or use in the area was observed (Photo 6). Several old wells owned by the county, used as test wells and which are not properly secured, were noted near and in the Quarry groundwater restriction area. Current land use remains consistent with planned institutional controls.

Photo 6: The outer edge of the quarry groundwater restriction institutional control area.

Recommendation: Transmit a copy of the inspection report to the County, pointing out the unsecured wells.

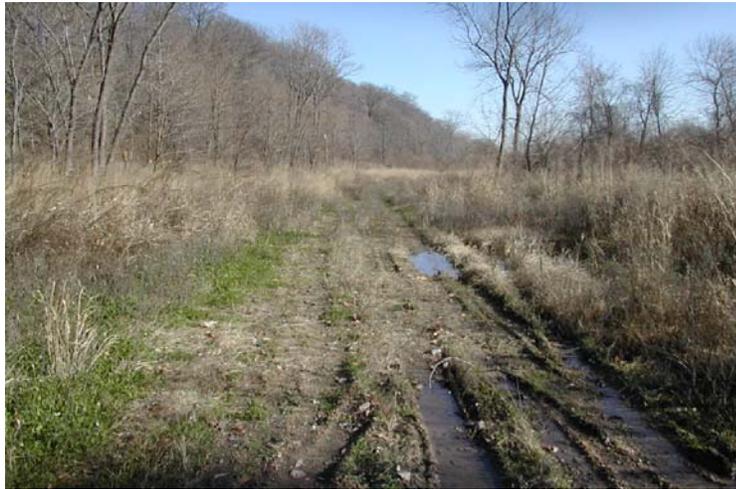
Inspection Results: The quarry reduction zone area was inspected and no indications of excavation into soils and bedrock were observed. Land use remains consistent with planned institutional controls (Photo 7).

Photo 7: Quarry Area Reduction Zone facing east just south of Katy Trail.

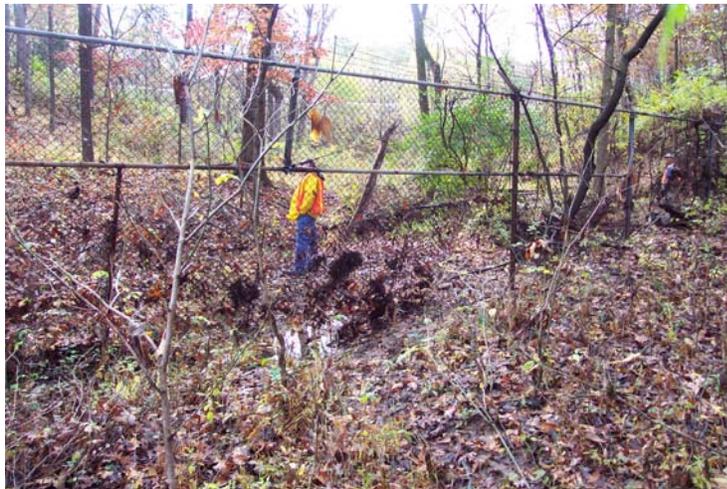
Inspection Results: The inspectors walked down the entire Southeast Drainage and no indications of residential use or construction or any other activity that would indicate non-recreational use of the area was observed. The springs also were inspected and no indication of residential, commercial, or agricultural use of the springs was observed (Photos 8, 9, and 10). Current land use remains consistent with planned institutional controls.

Photo 8: Fence across the Southeast Drainage upstream of Highway 94.

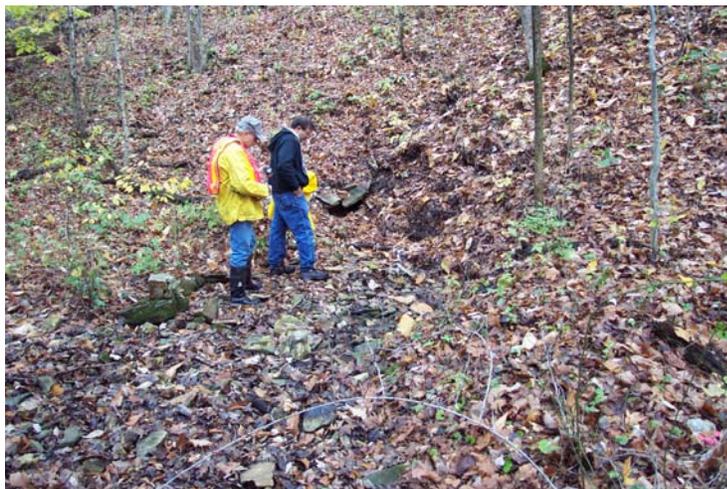
Photo 9: Spring 5303 in the Southeast Drainage.

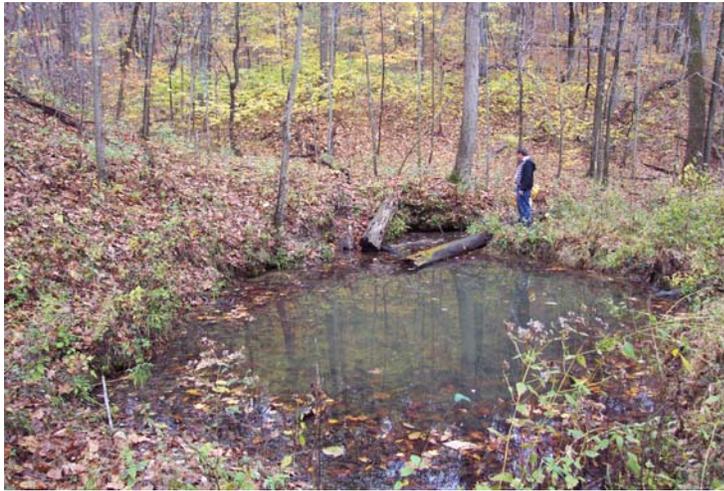
Photo 10: Spring 5304 in the Southeast Drainage.

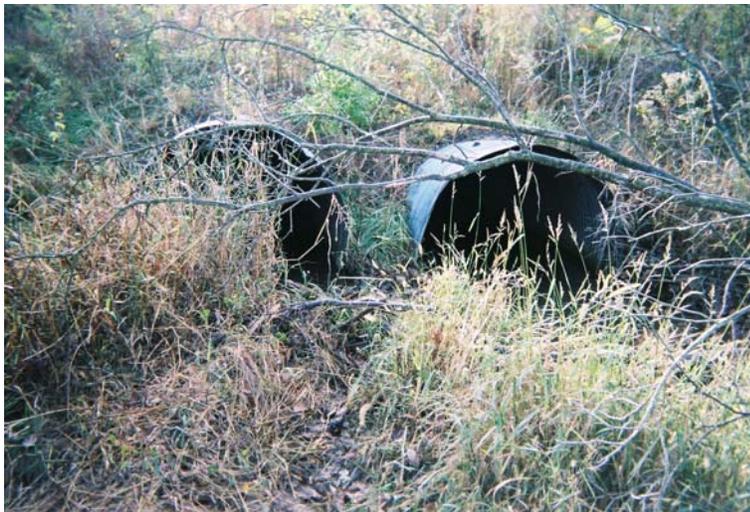
Photo 11: View of outlet side of twin culverts under Highway D.

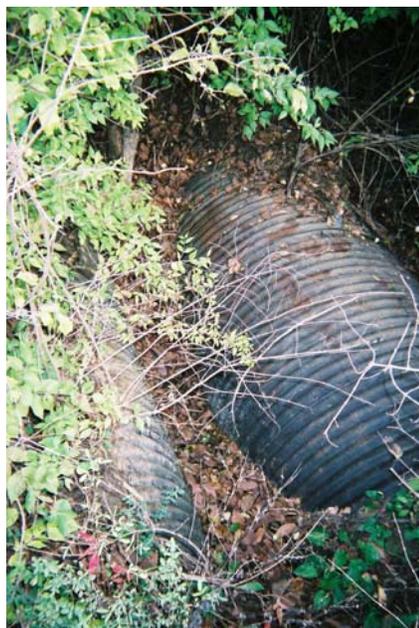
Photo 12: Eroded area where culverts are exposed in ditch between Highway D and outlet end.

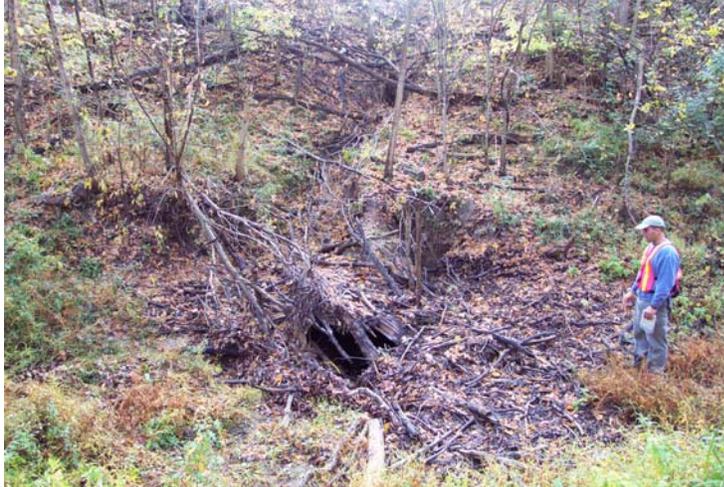
Inspection Results: The State Route 94 culvert was inspected and the upstream end was partially blocked with debris. Erosion was occurring on the embankment. The downstream end of the culvert was corroded on the bottom and the last section of pipe was partially separated from the rest of the culvert, causing runoff to leak through and erode beneath the final segment of culvert. MoDOT is adding pavement as a shoulder on State Route 94 and this construction activity could be contributing to additional erosion on the embankments (Photos 13 and 14).

Photo 13: Inlet end of State Route 94 culvert.

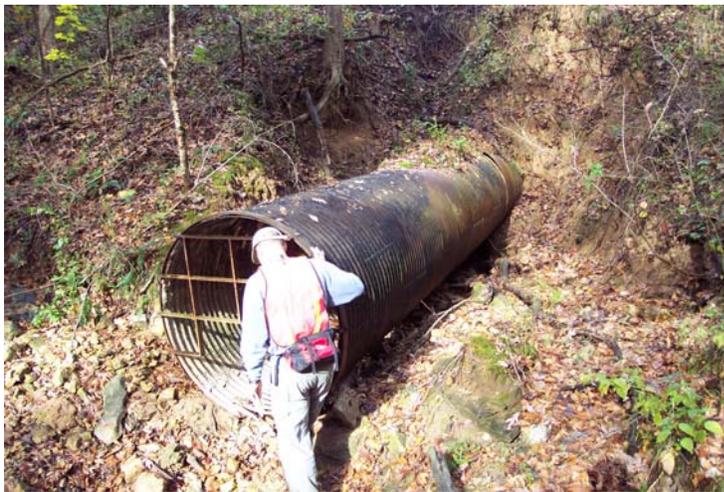
5. **Finding:** The downstream end of the State Route 94 culvert was corroded on the bottom and the last section of pipe has partially separated from the rest of the culvert causing runoff to leak through and erode beneath the final segment of culvert. MoDOT is adding pavement as a shoulder on State Route 94 and this construction activity could be contributing to additional erosion on the embankments.

Photo 14: Outlet end of State Route 94 culvert.

Recommendation: Transmit a copy of this inspection report to MoDOT for consideration.

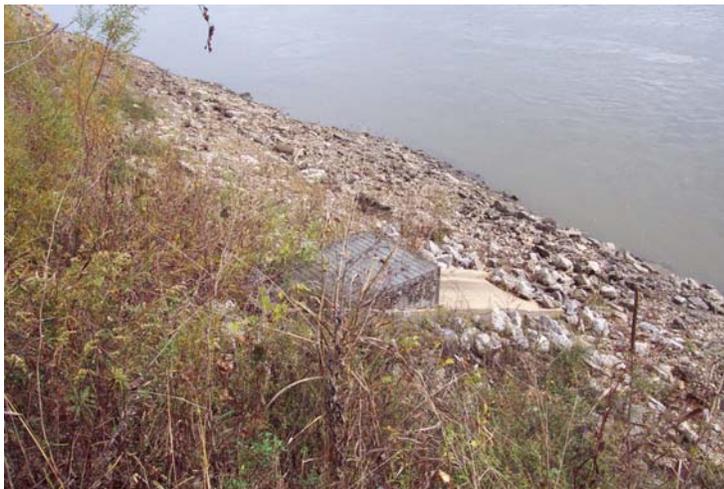
the off-site areas. During the inspection it was observed that significant vegetative growth had covered the majority of the manhole locations and they could not be located. It was recommended in the memorandum to conduct another walkover in the fall or winter of 2003/2004 when the vegetation is not as dense and to use global positioning system (GPS) surveying equipment to establish the locations of the manholes and cleanouts (Photo 15).

Photo 15: The weir that discharges from the LCRS Pipeline into the Missouri River.

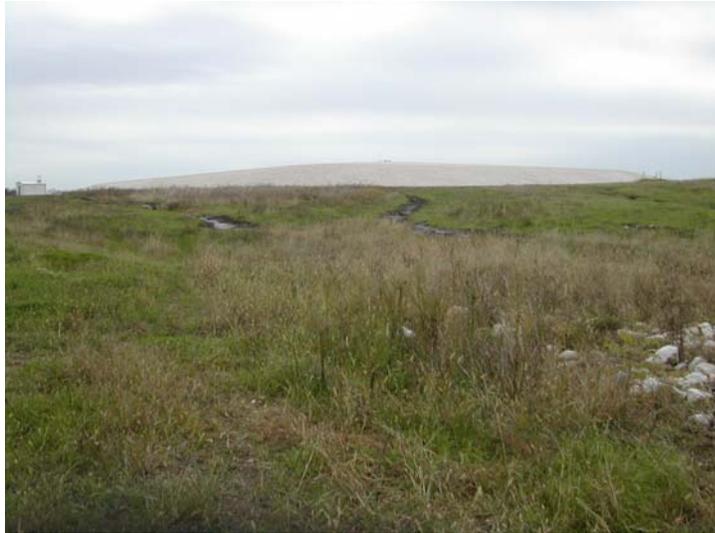
There were two areas of erosion identified at the chemical plant area. The first areas were north and northwest of the disposal cell (Photo 25). As demonstrated by the photograph, erosion repairs have been conducted in these areas. The second area of erosion was observed during the inspection of the monitoring wells on the Army property. The erosion is next to the riprap that was installed for outfall NP-0050. The erosion comes from the chemical plant property under the fence onto the Army property and has eroded out a gravel road used to travel around the Army property. The erosion has produced a ditch about 2 feet in depth (Photo 28). Repair of this area will be coordinated with the Army in order to assure good road access to monitoring wells. The eroded area does not impact the disposal cell.

Photo 25: Erosion areas behind the disposal cell.

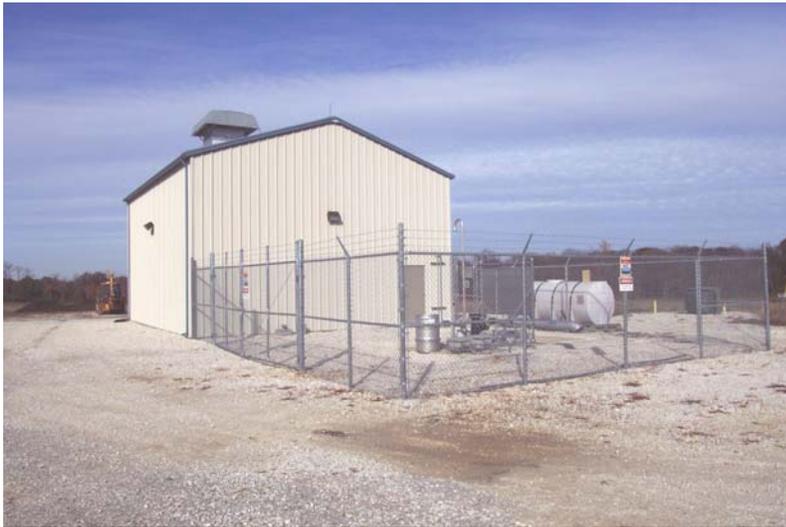
The LCRS was discussed and inspected (Photos 26 and 27). The fences and doors were locked and in good condition. The system was functioning as designed. The LCRS data and documentation were reviewed during the document review period of the inspection and the following information was checked and verified that it was available: sampling data, LCRS flow rates, action leakage rate information, "burrito" system flow rates, periodic alarm tests, and shipping records and data. As committed by the LTS&M Plan the leachate production rates, analytical results, and disposal information are provided in Appendix C.

Photo 26: Outside of LCRS building.

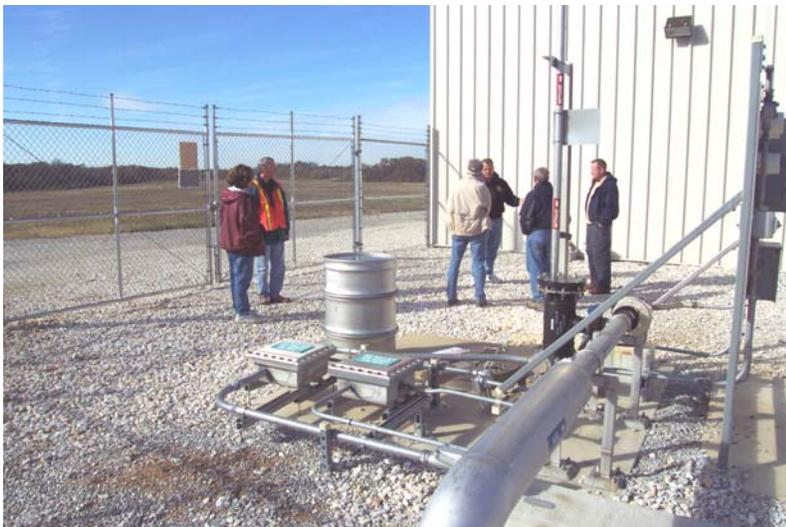
Photo 27: LCRS sump area with manhole in center of photo.

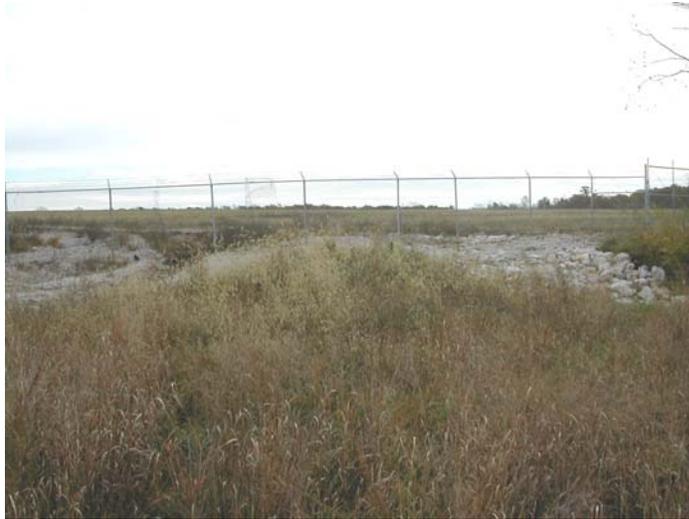
6. **Finding:** An area of erosion was observed which originates from the chemical plant and continues onto the Army property. The erosion is next to the riprap that was installed for Outfall NP-0050. The erosion has produced a ditch about 2 feet in depth and has eroded out a gravel road used to travel around the Army property. The eroded area does not impact the disposal cell.

Photo 28: Area of erosion onto the Army property. The eroded ditch is to the left and outfall NP-0050 is to the right.

Recommendation: Transmit a copy of this report to the local representative of the Army Reserves for consideration. Repair of this area will be coordinated with the Army.

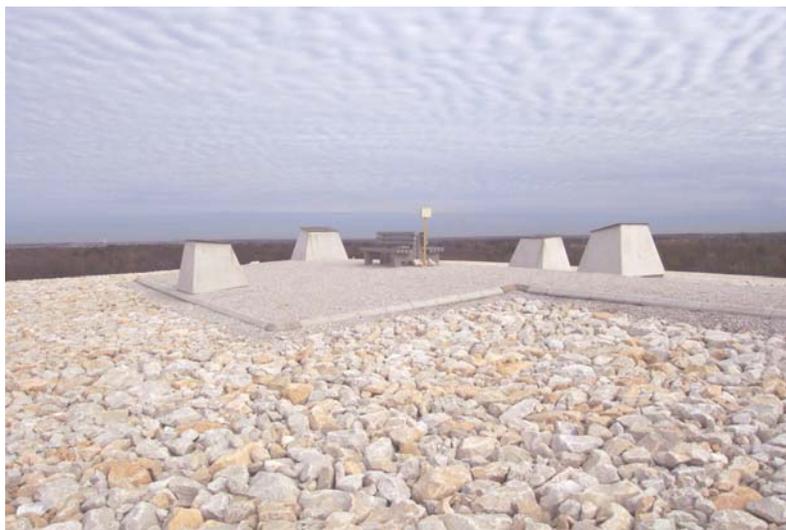
The four information plaques on top of the cell were in good condition (Photo 29). The historical markers planned for the site have not been installed yet.

Photo 29: Information plaques on top of the disposal cell.

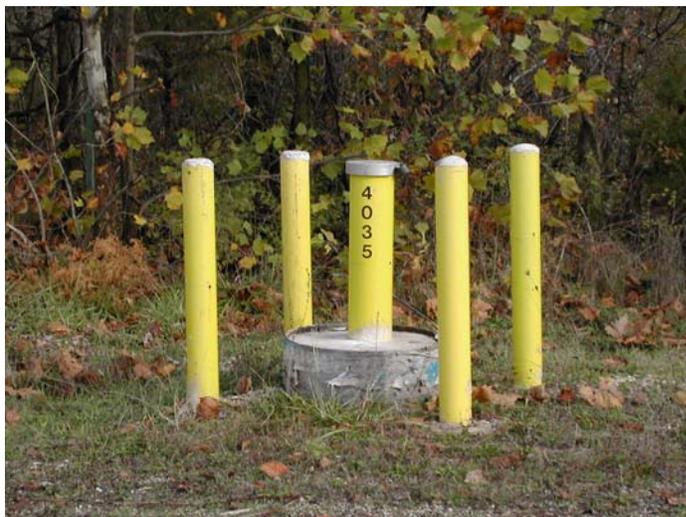
The monitoring wells in the Disposal Cell Monitoring Well Network, Chemical Plant Monitoring Well Network, and Quarry Monitoring Well Network were inspected (Photo 30). The inspection checklist required all the disposal cell wells to be inspected and greater than 10 percent of the chemical plant and quarry wells to be inspected. The checklist required the wells to be inspected to ensure they are properly secured and locked, in good condition, and to check if they need maintenance and have the proper ID number on the well.

Photo 30: An example of a site groundwater monitoring well. This well is secured (locked), maintained, and properly identified.
