# 2003 Annual Site Inspection and Monitoring Report for Uranium Mill Tailings Radiation Control Act Title I Disposal Sites

January 2004

Work Performed by S.M. Stoller Corporation under DOE Contract No. DE-AC01-02GJ79491  
for the U.S. Department of Energy, Grand Junction, Colorado

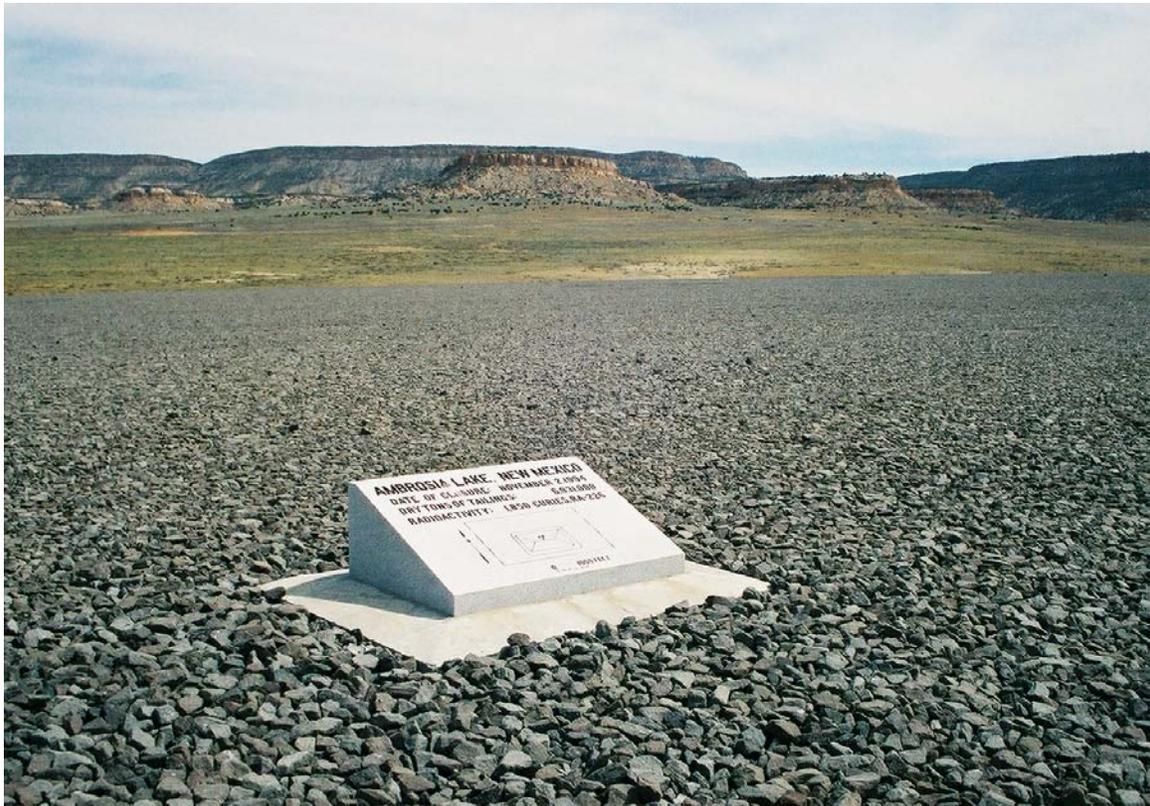
**Top of Disposal Cell**—The top of the disposal cell generally was in good condition (PL-1). With the exception of one location there was no evidence of cracking, settling, slumping, or erosion. A small shallow depression around settlement plate SP-4 was first noted during the 1997 inspection; however, there has been no evidence to suggest the depression holds water. At the time of the 2003 annual inspection, the subsidence was estimated to measure approximately 1 foot in depth (PL-2). The depression will continue to be monitored to determine if it is increasing and to ensure that the integrity and performance of the cell cover is maintained. The elevation of SP-4 and the diameter of the depression will be surveyed in 2004.

*AMB 5/2003. PL-1. Site marker SM-2 at the center of the cell cover.*

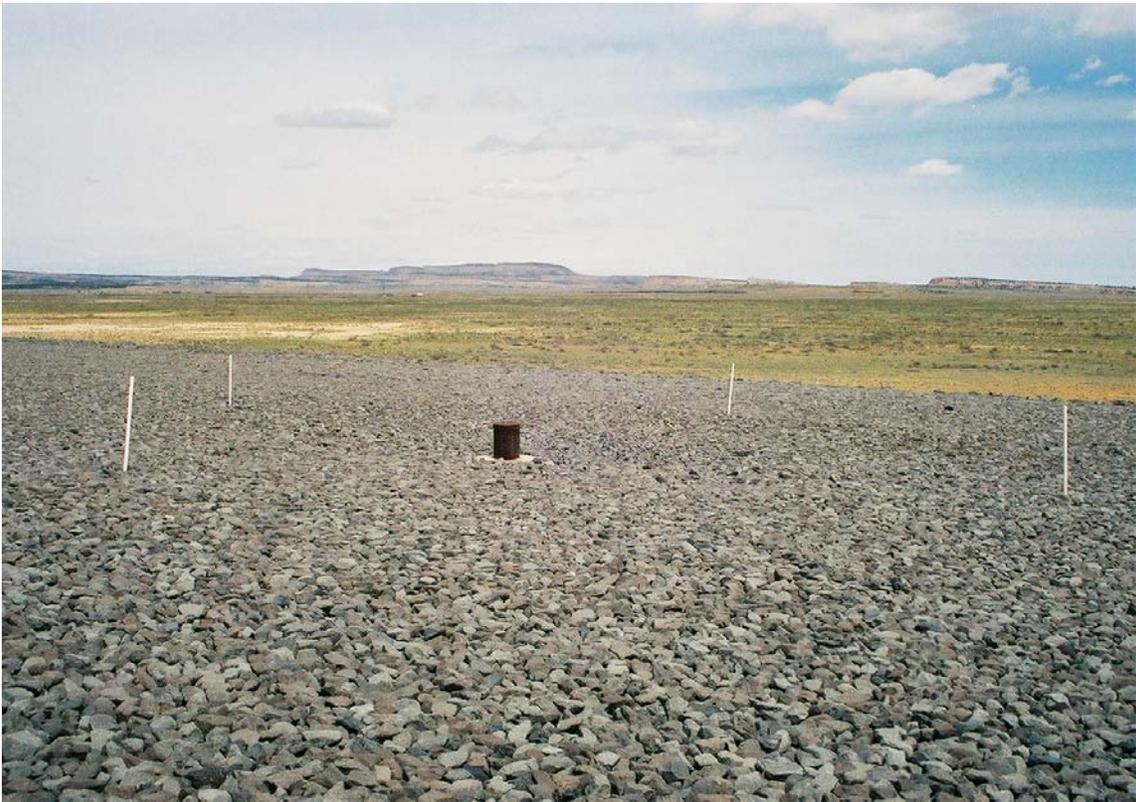
*AMB 5/2003. PL-2. Depression centered around settlement plate SP-4.*

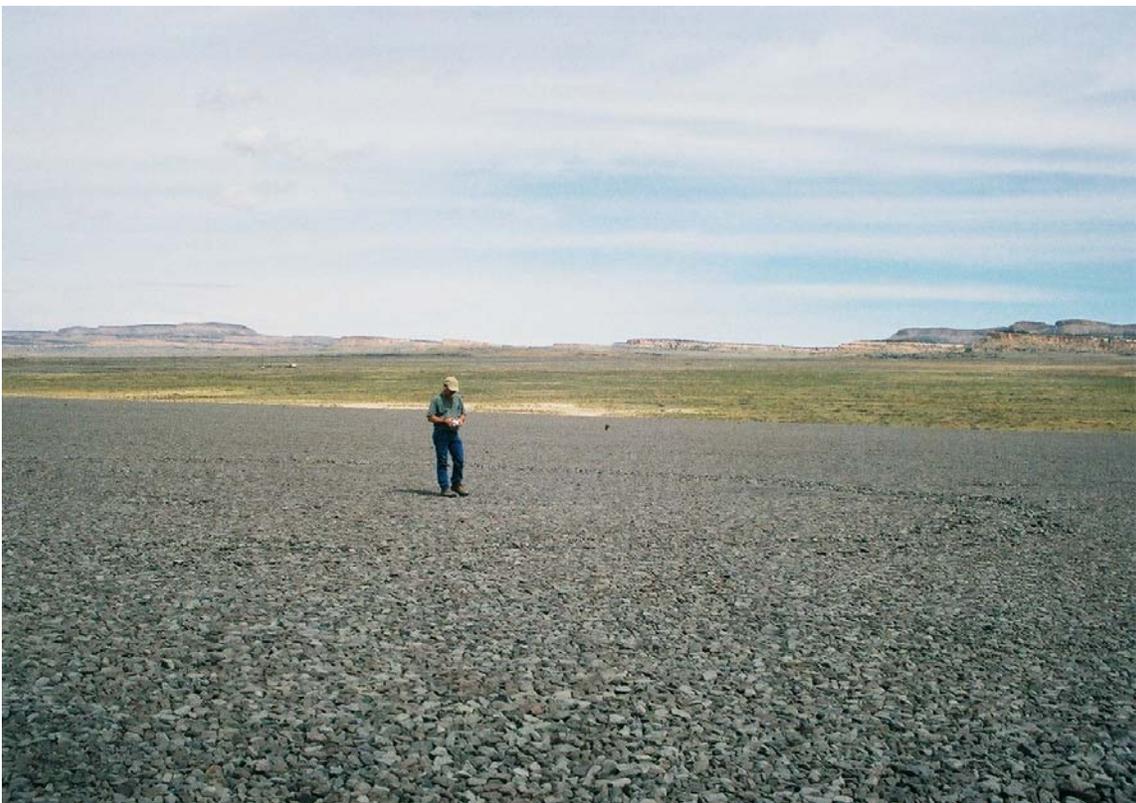
Trespassing was evident on top of the disposal cell. An all-terrain vehicle (ATV) had been driven to the top of the cell and used to mark four circles with diameters between 40 and 60 feet (PL-3). Another area of surface disturbance was noted near the southeast corner of the cell top. The tracks were very shallow and do not impair the integrity or performance of the cover.

*AMB 5/2003. PL-3. Circular-shaped vehicular disturbance on the north facet of the cell cover.*

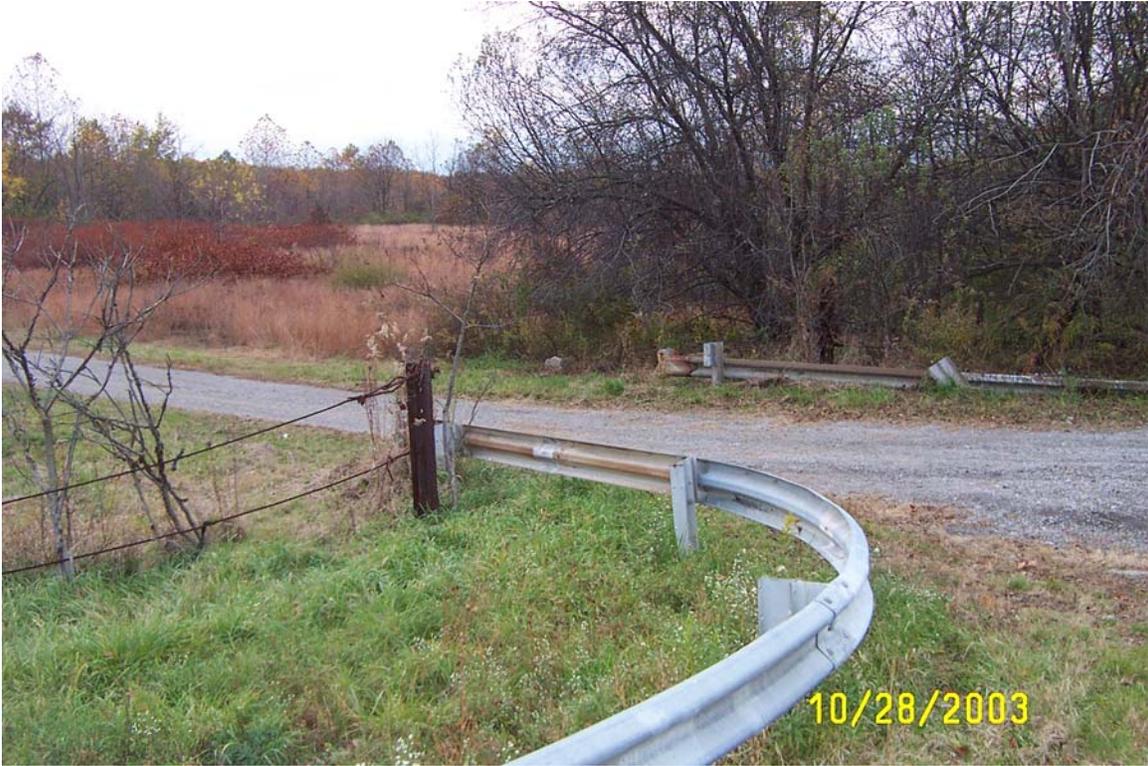
**Site Access, Fence, Gates, and Signs**—An access road leads from Strangford Road to the security fence at the site boundary. The former access gate at Strangford Road was unsuccessful in keeping people off the access road and out of the areas adjacent to the site, and was open and heavily damaged at the time of the 2002 inspection. DOE determined that limiting site access at Strangford Road did not enhance site security or protectiveness, and received concurrence from the U.S. Nuclear Regulatory Commission on April 28, 2003, to remove the gate. The gate was removed prior to the 2003 inspection (PL-1). The hard-packed graveled access road runs southwest across DOE's perpetual right-of-way (Tract 201-E) and DOE's leased crossing over Norfolk Southern Railroad right-of-way to the site. There were shallow potholes in the road but it was easily passable in a passenger car.

*BUR 10/2003. PL-1. Location of the former access gate at Strangford Road.*

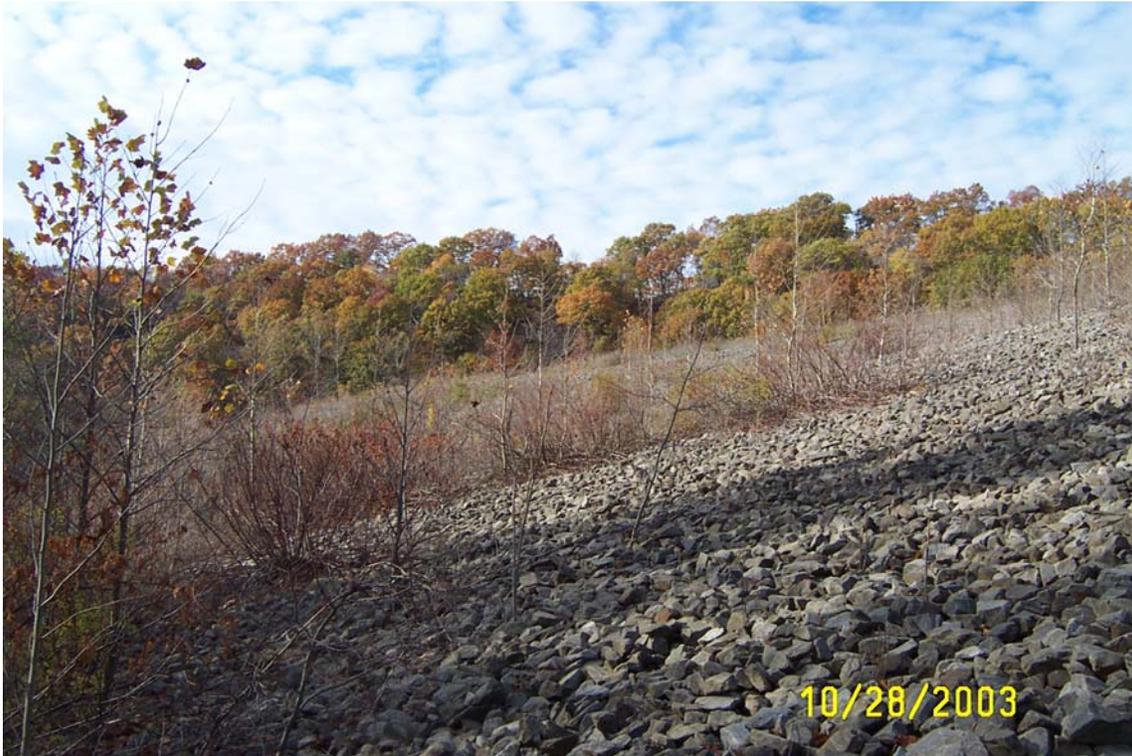
Trees and shrubs continue to establish in the riprap (PL-2). In the past, this vegetation was aggressively controlled with massive applications of herbicide. A study that evaluated risks posed by encroachment of plants on the disposal cell demonstrated that the plants will not degrade the long-term performance of the cell and may improve performance by reducing moisture in the cover through evapotranspiration.

*BUR 10/2003. PL-2. Vegetation on the south slope of the disposal cell.*

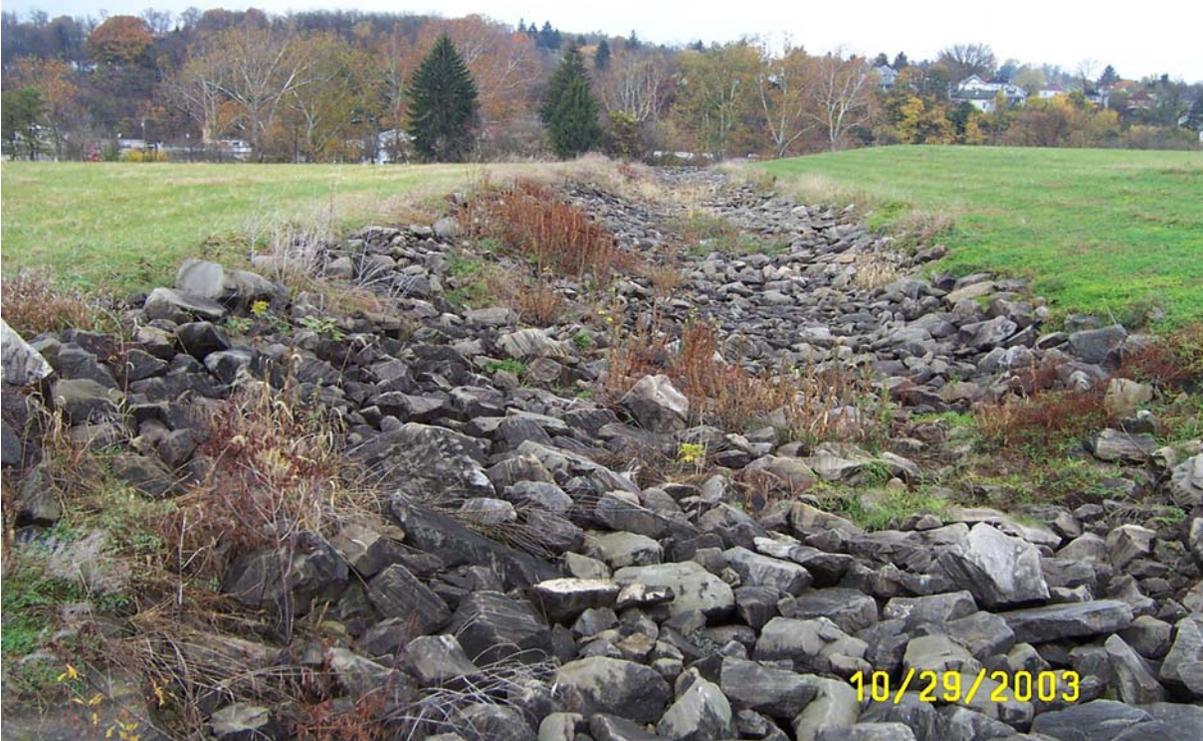
*CAN 10/2003. PL-1. Vegetation encroachment in the western diversion channel.*

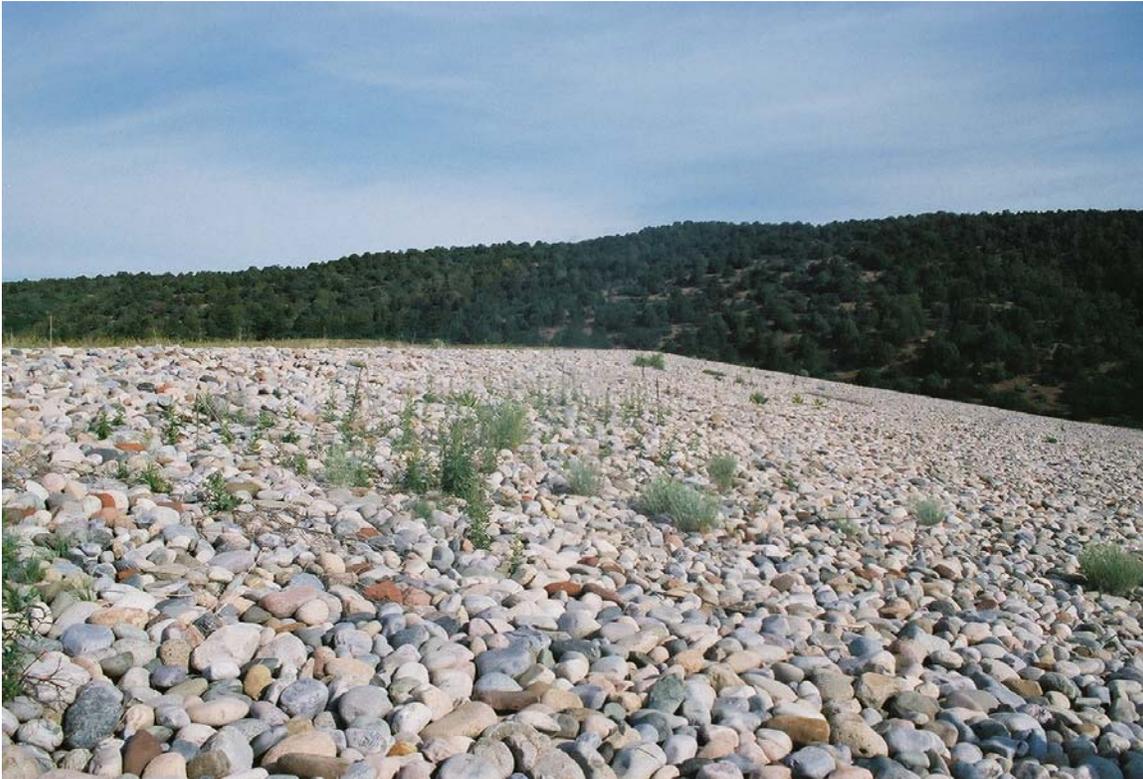
*DUR 6/2003. PL-1. Vegetation, including Canada thistle, on the east side slope of the cell.*

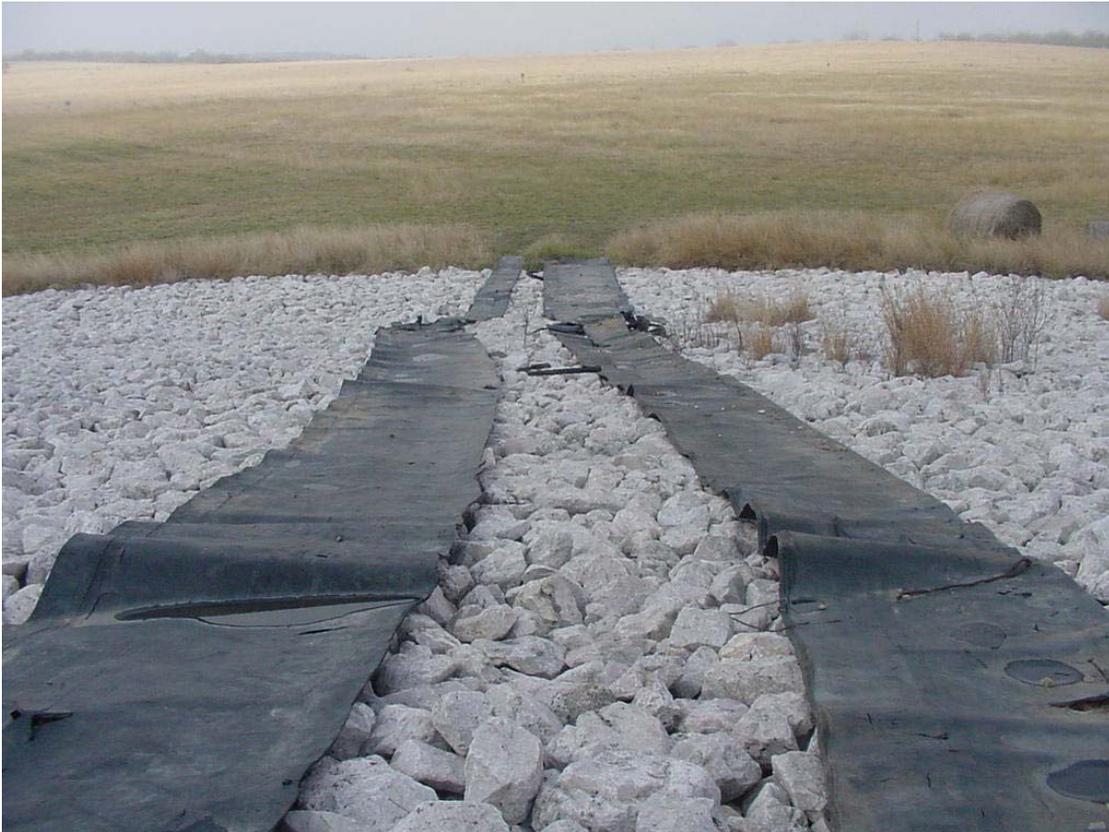
*FCT 1/2003. PL-1. Conveyor belt material placed on the side slope at the west corner of the disposal cell.*

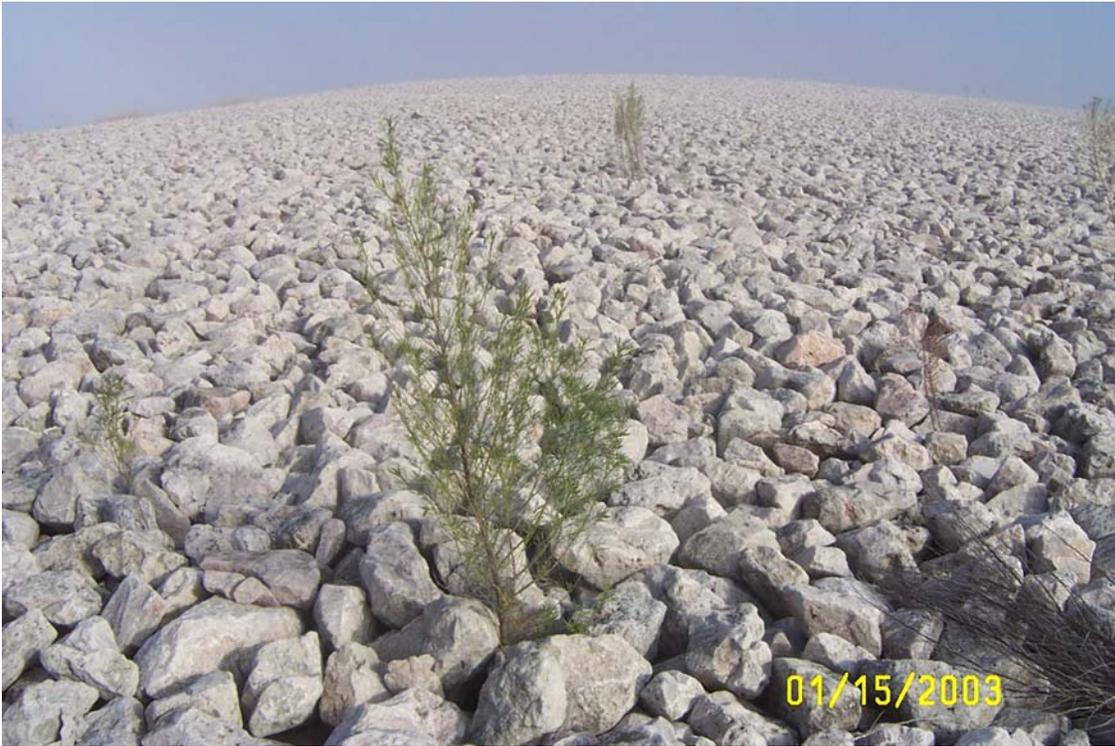
*FCT 1/2003. PL-2. Woody plants on the side slope at the south corner of the disposal cell.*

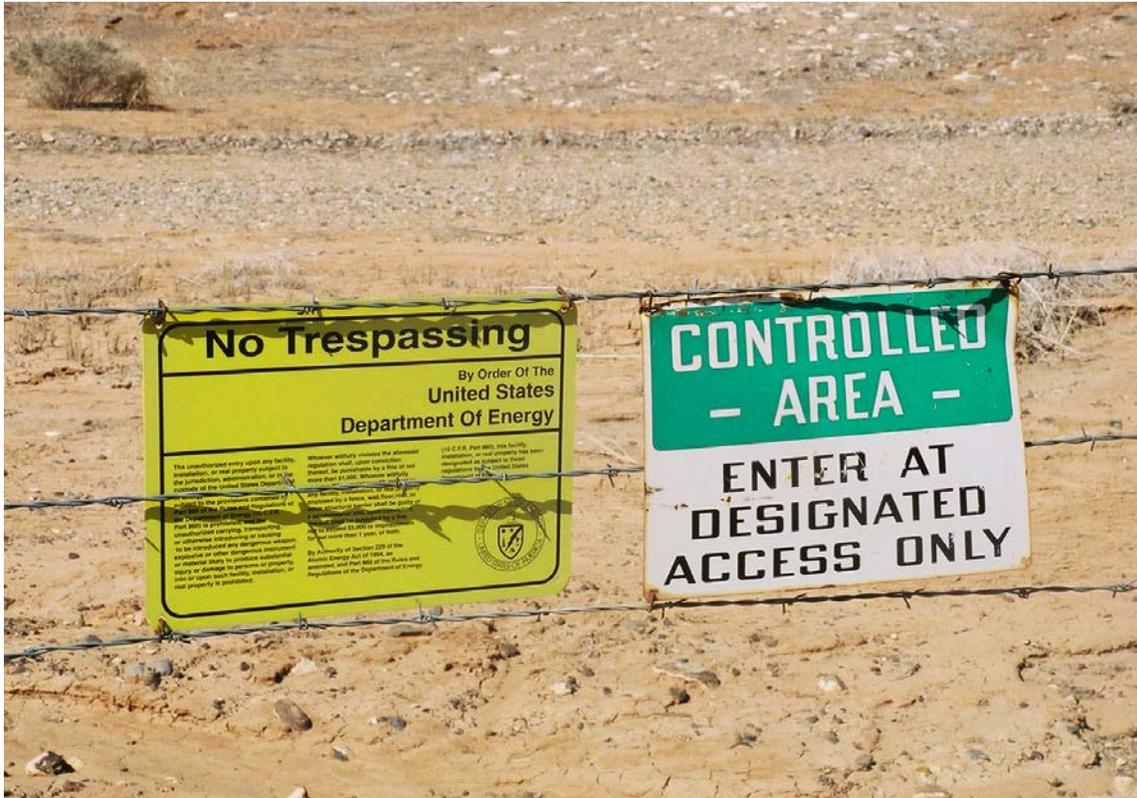
GRJ 03/2003. PL-1. Warning signs on the perimeter fence.

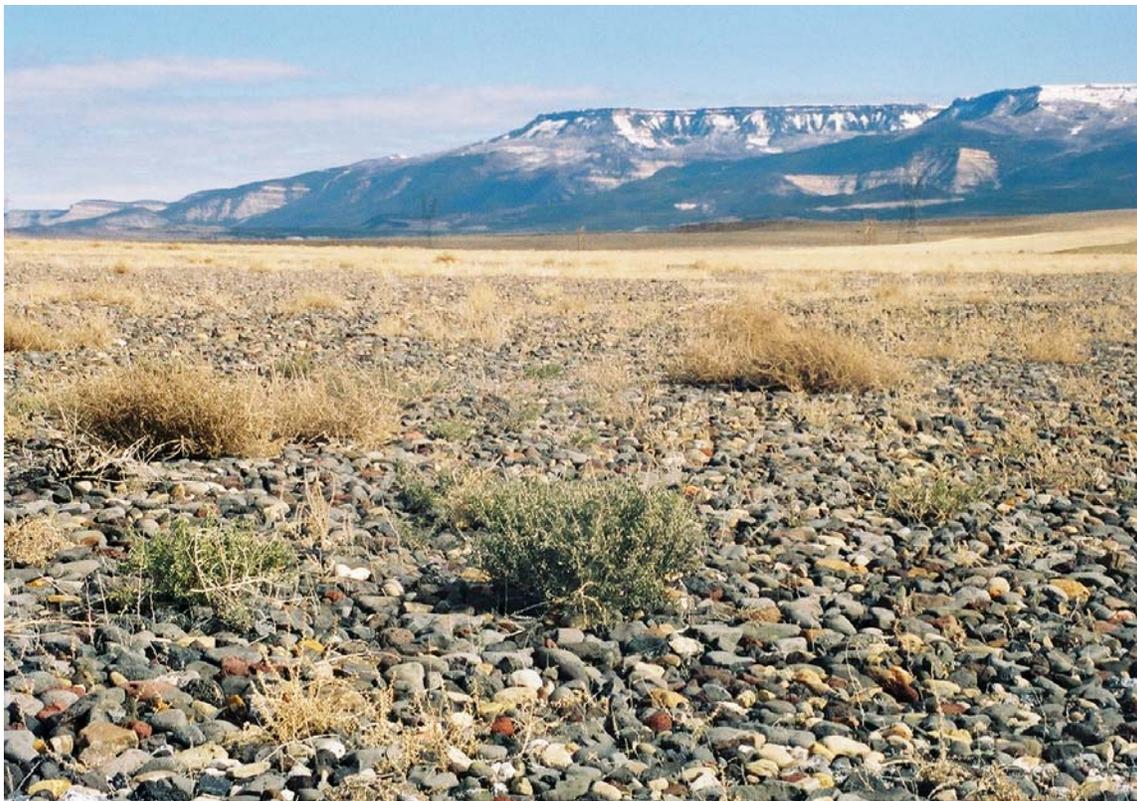
GRJ 03/2003. PL-2. Scattered vegetation on cell top near the southeast corner of disposal cell.

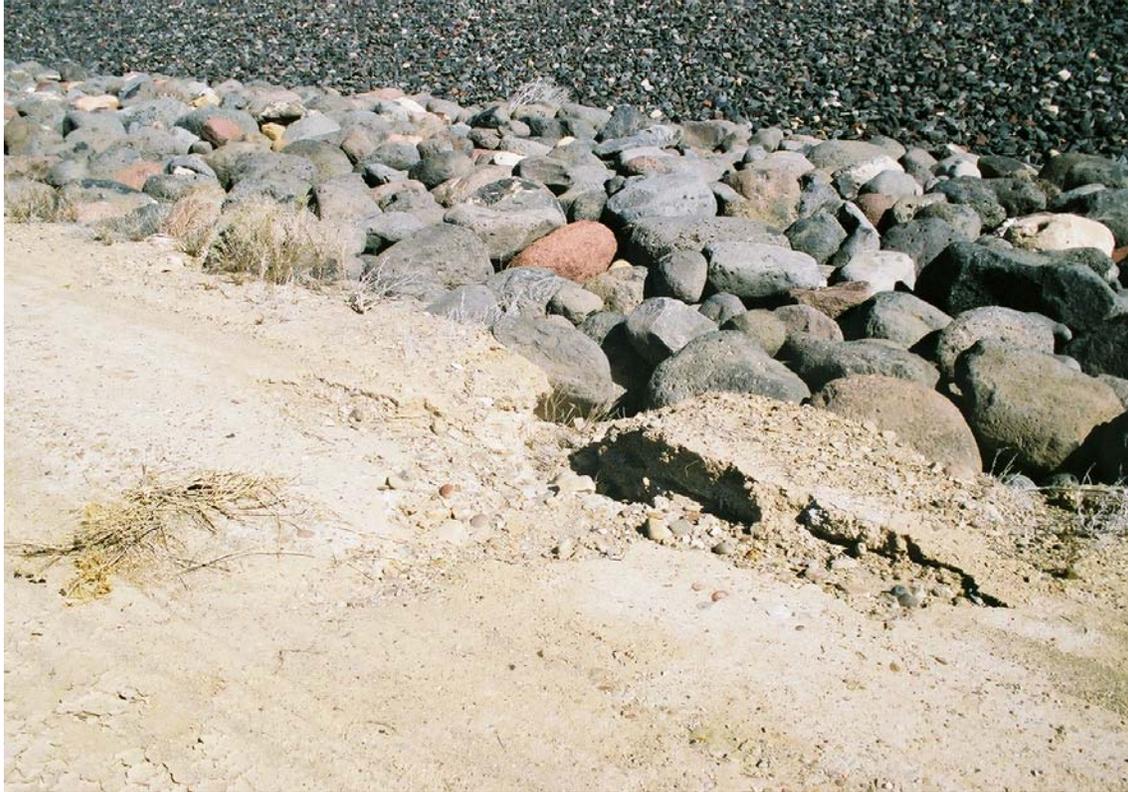
*GRN 03/2003. PL-1. Erosion in the cell perimeter road along the southwest side of the disposal cell.*

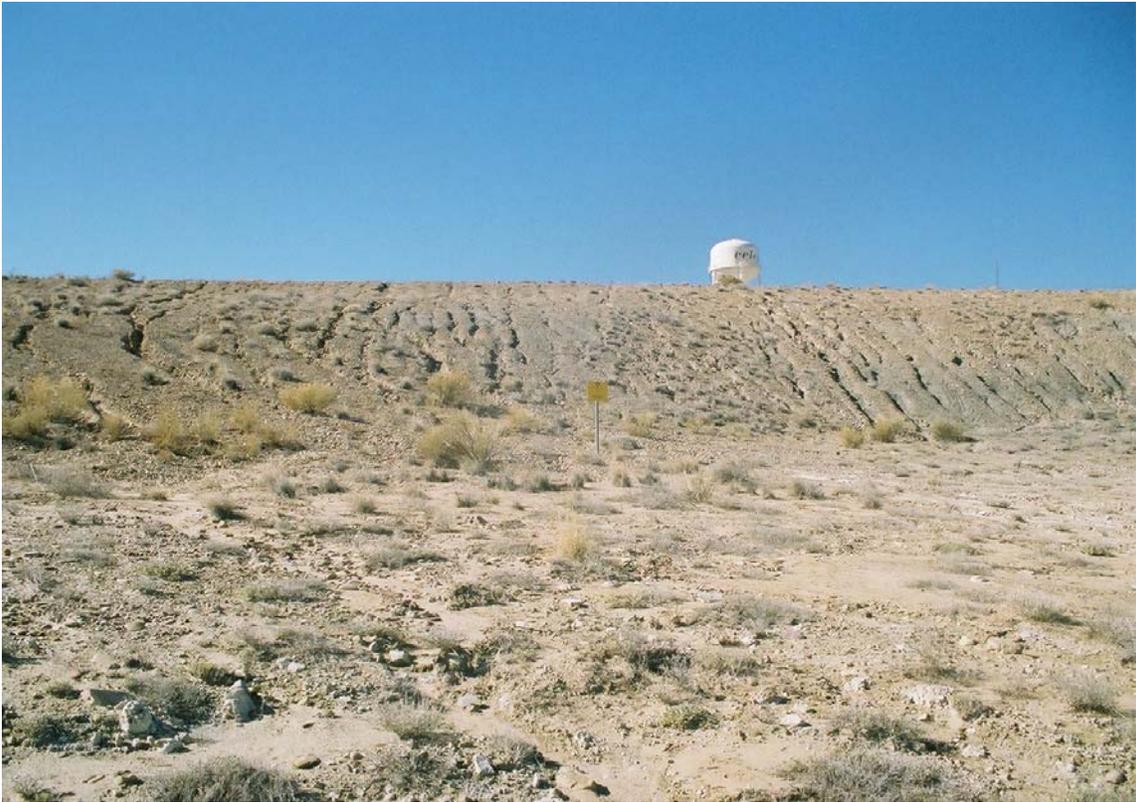
*GRN 03/2003. PL-2. Erosion along the north side of the property near perimeter sign P11.*

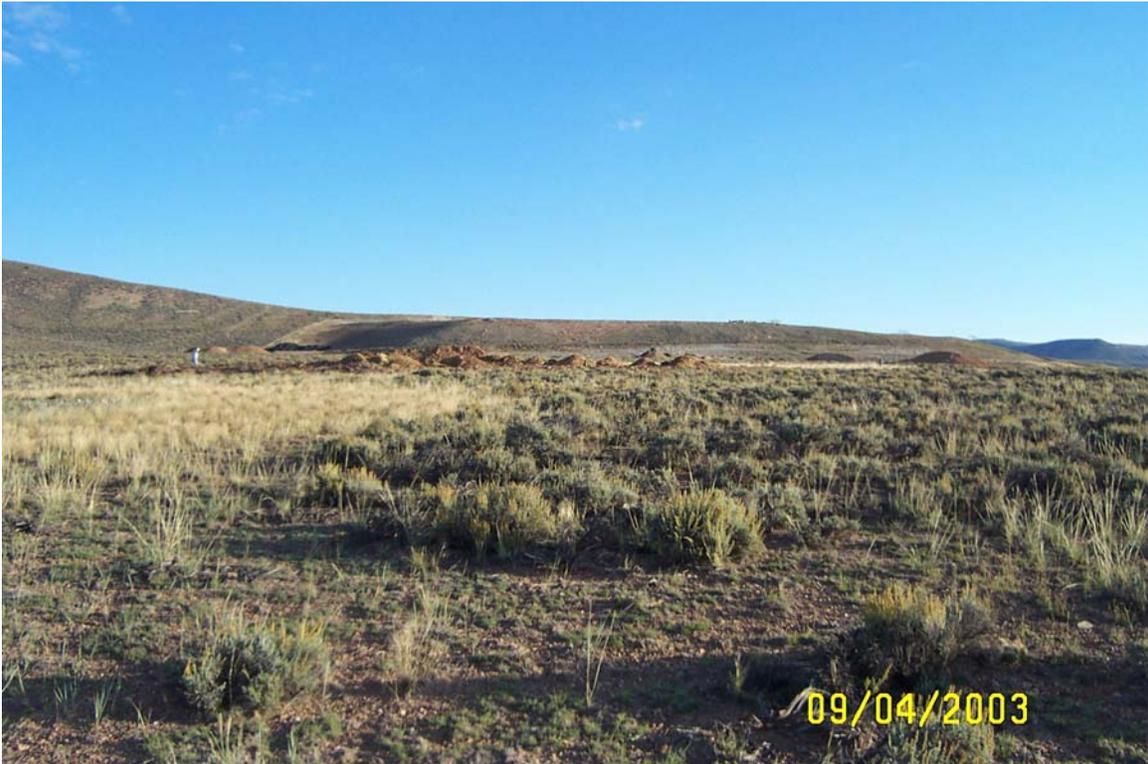
*GUN 9/2003. PL-2. County landfill dirt and woodchip piles near the northeast corner of the disposal site.*

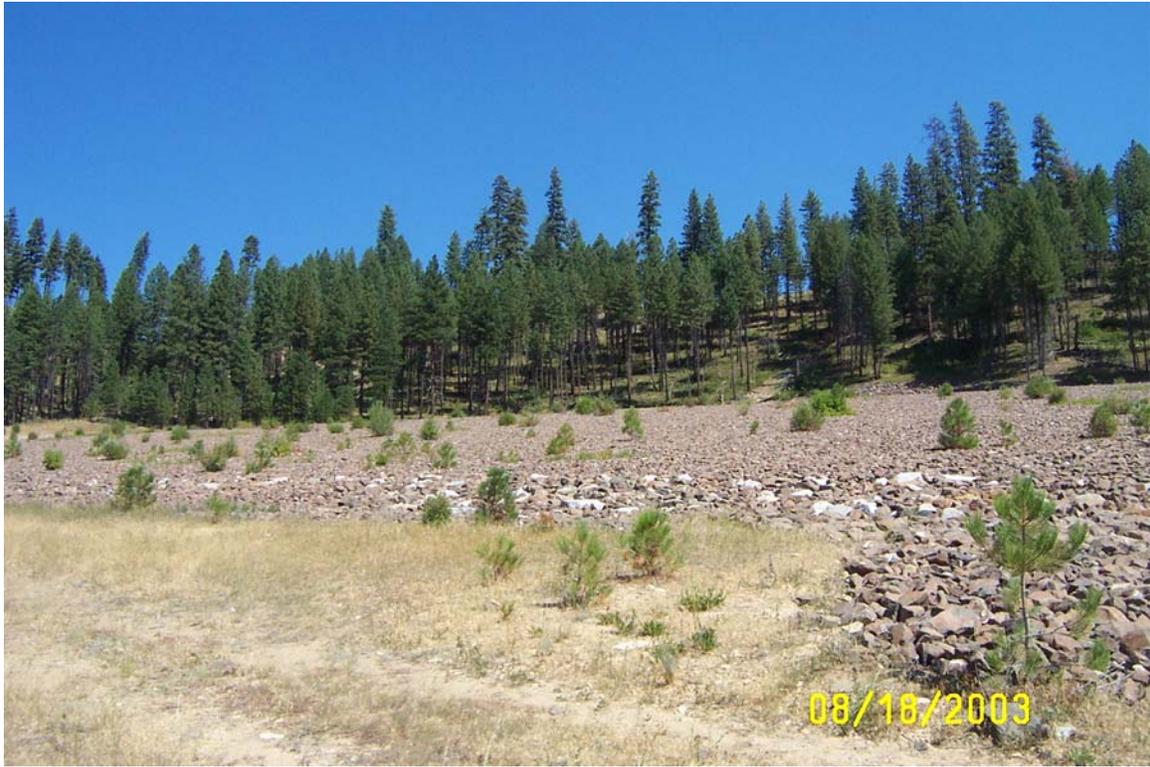
*LOW 8/2003. PL-1. Vegetation encroachment on the cell top.*

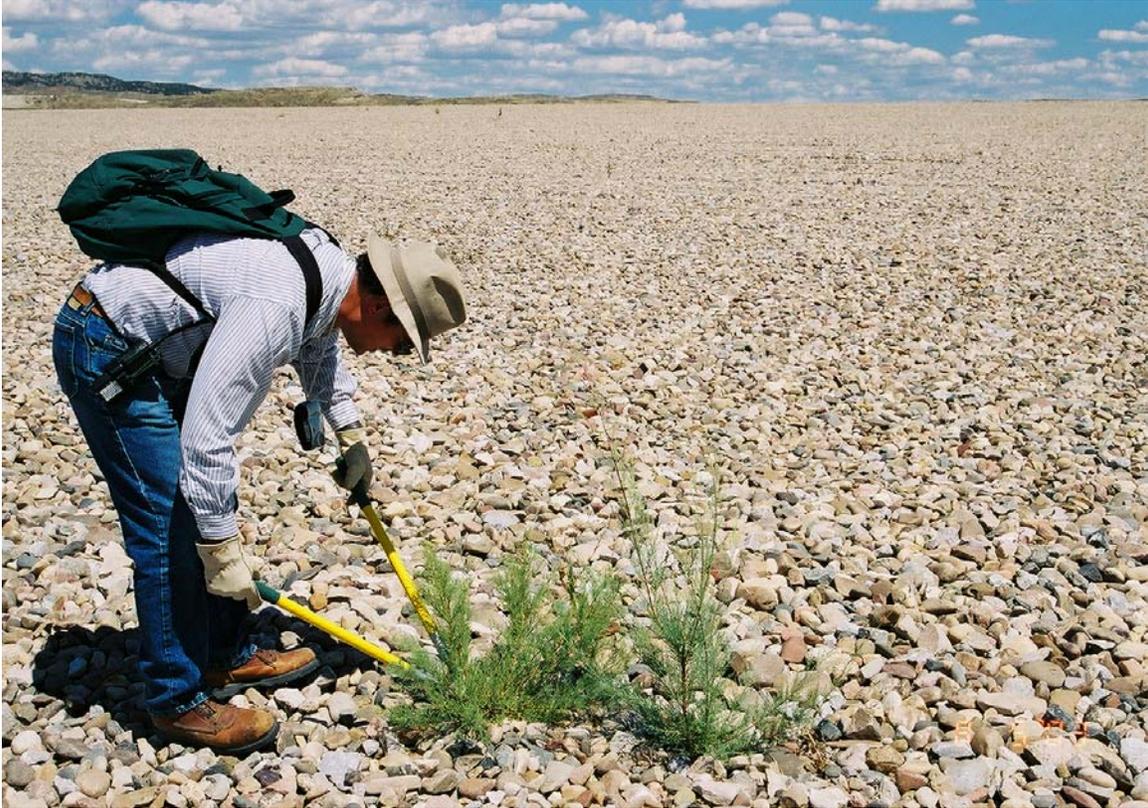
*MAY 8/2003. PL-1. Tamarisk on the cell top being cut.*

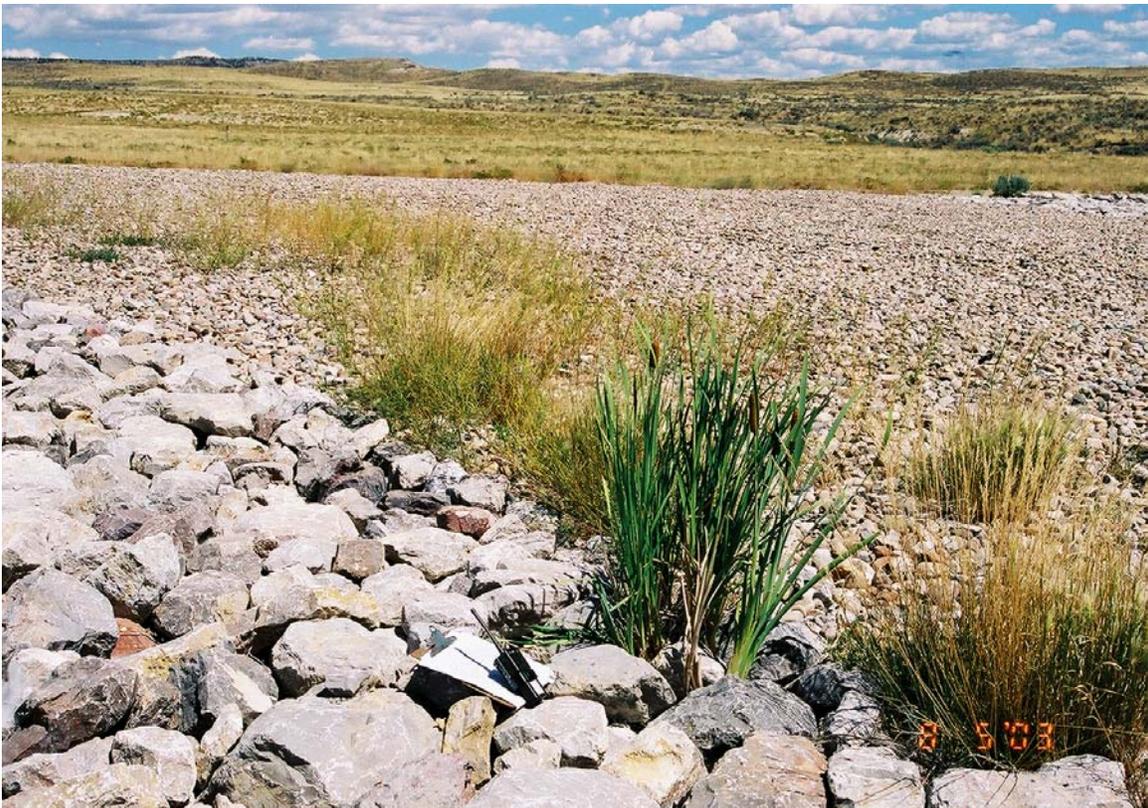
*MAY 8/2003. PL-2. Vegetation in the cobble blanket at the east corner toe of the cell.*

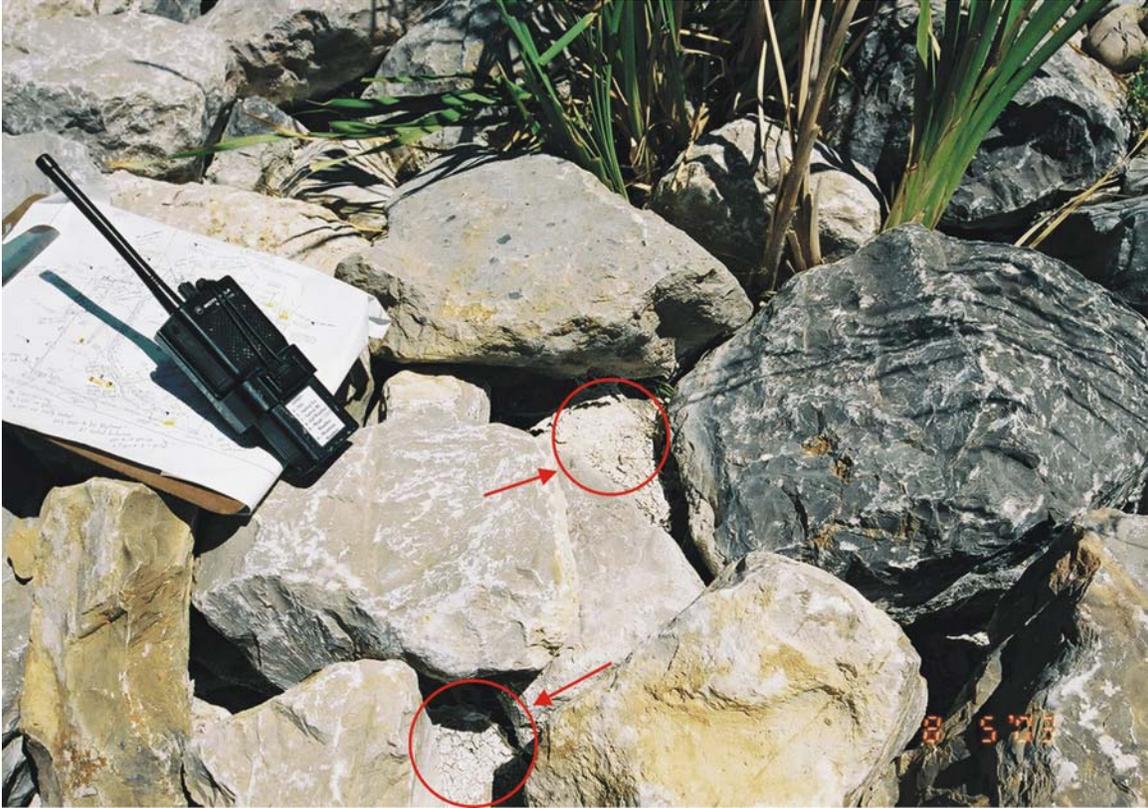
MAY 8/2003. PL-3. Evaporite deposits on apron riprap at the east corner of the cell.

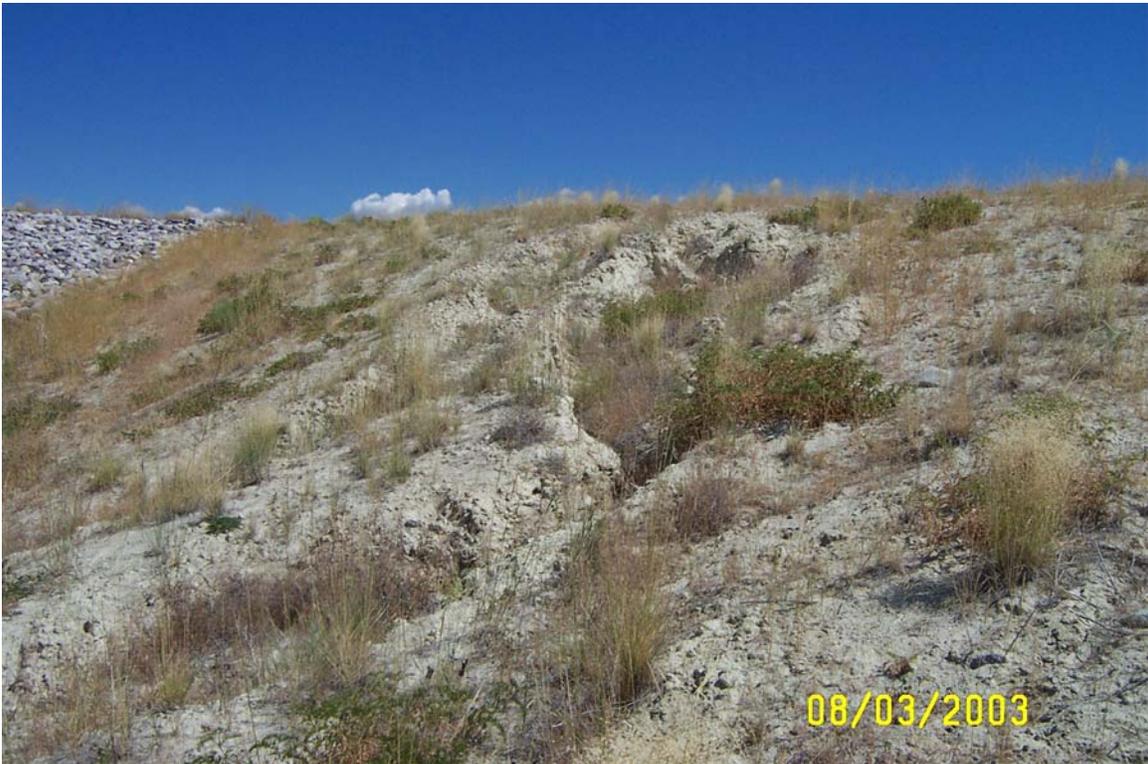
MAY 8/2003. PL-4. Stabilizing rills and gullies on the east slope of Gully No. 1.

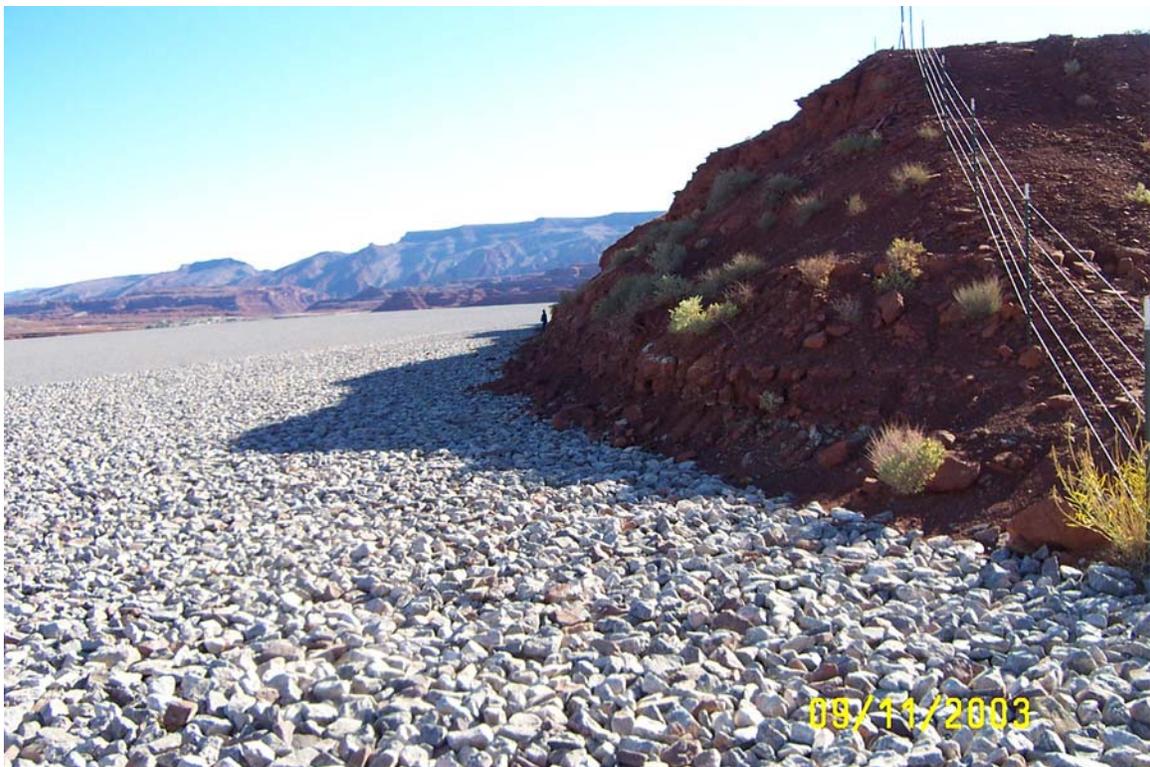
HAT 9/2003. PL-1. Baseline location photograph of sloughing hill slope materials along the south apron.

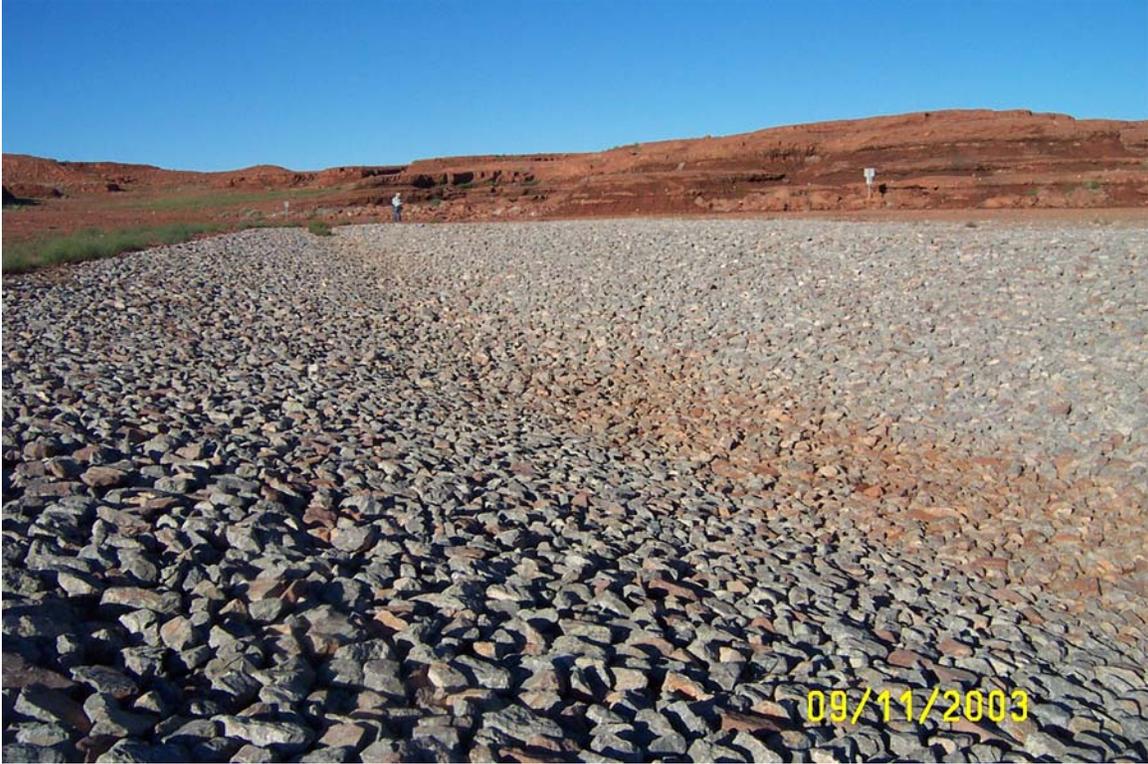
*HAT 9/2003. PL-2. Repaired washout area at the head of West Ditch.*

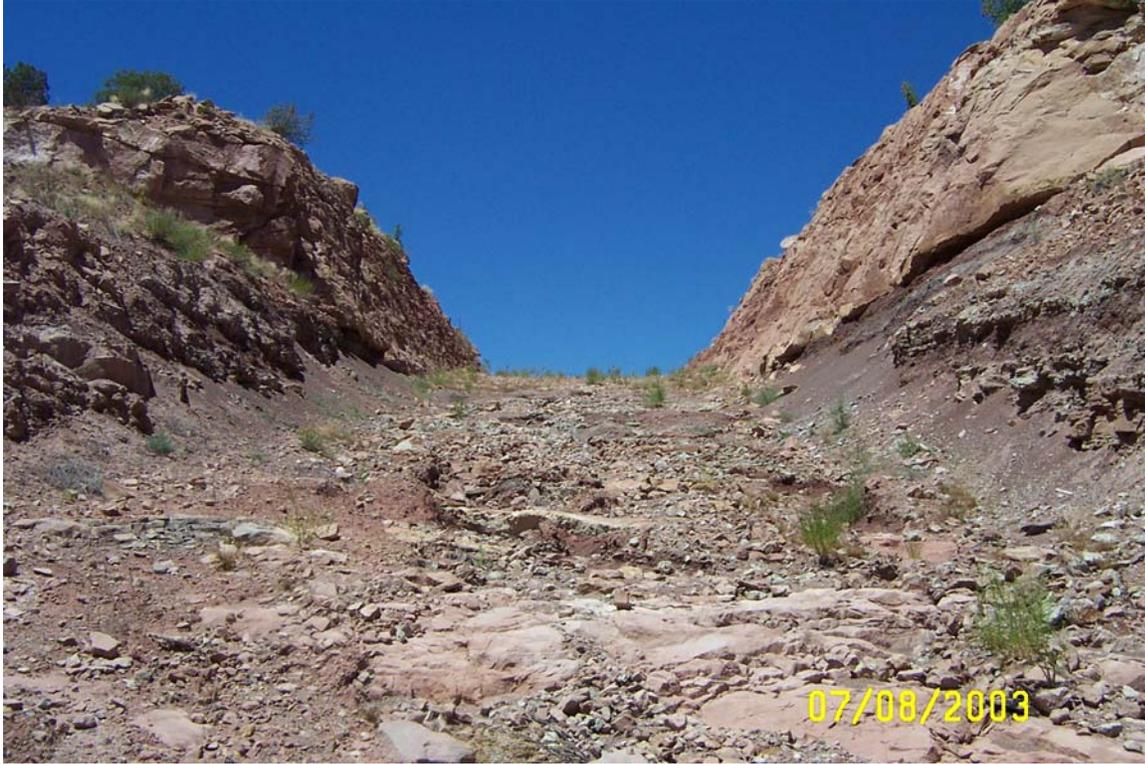
*NAT 07/2003. PL-1. Erosion in the western toe drain outlet channel.*

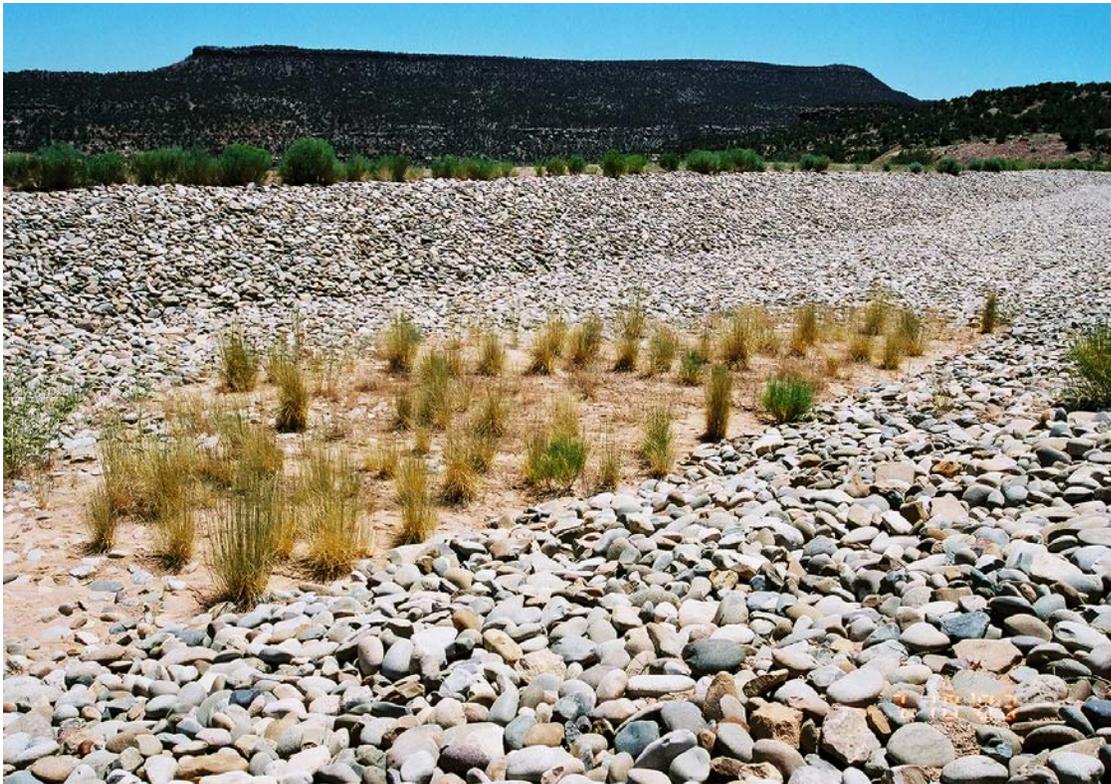
*NAT 07/2003. PL-2. Sediment accumulation in the interceptor channel.*

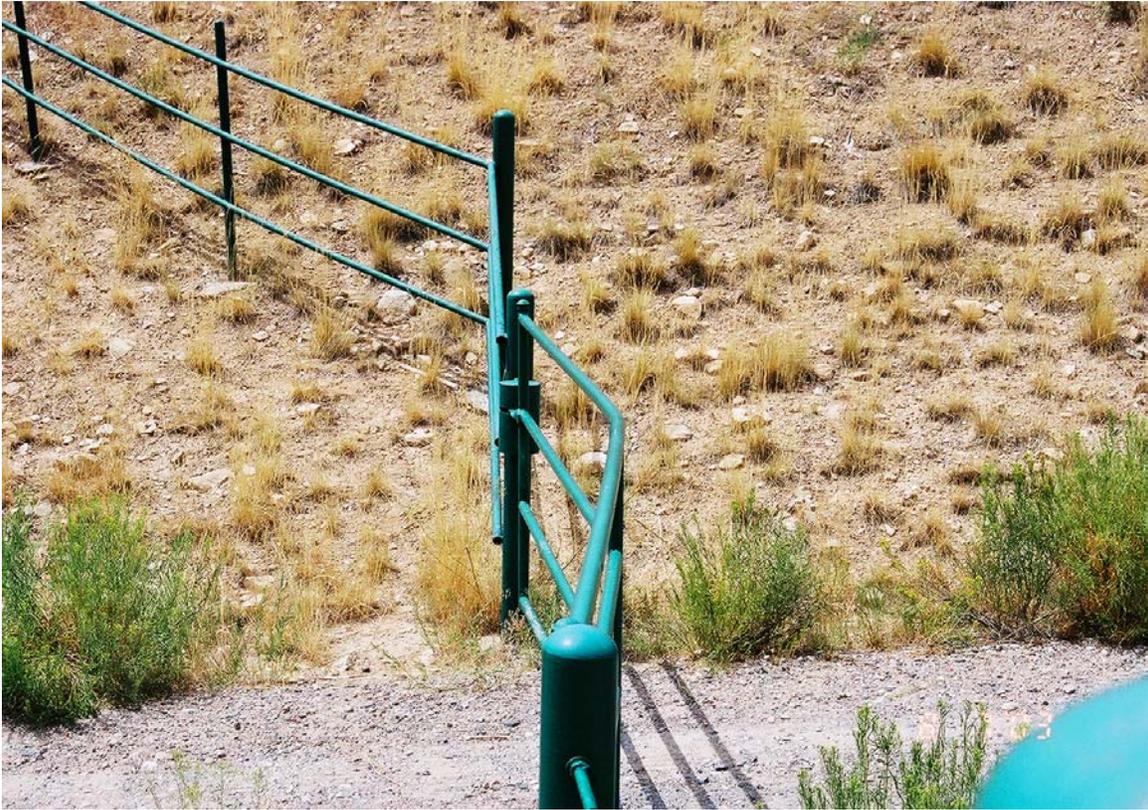
*RFL 8/2003. PL-1. Bent access road gate (subsequently repaired).*
