# 2003 Annual Site Inspection and Monitoring Report for Uranium Mill Tailings Radiation Control Act Title I Disposal Sites

January 2004

Work Performed by S.M. Stoller Corporation under DOE Contract No. DE-AC01-02GJ79491  
for the U.S. Department of Energy, Grand Junction, Colorado

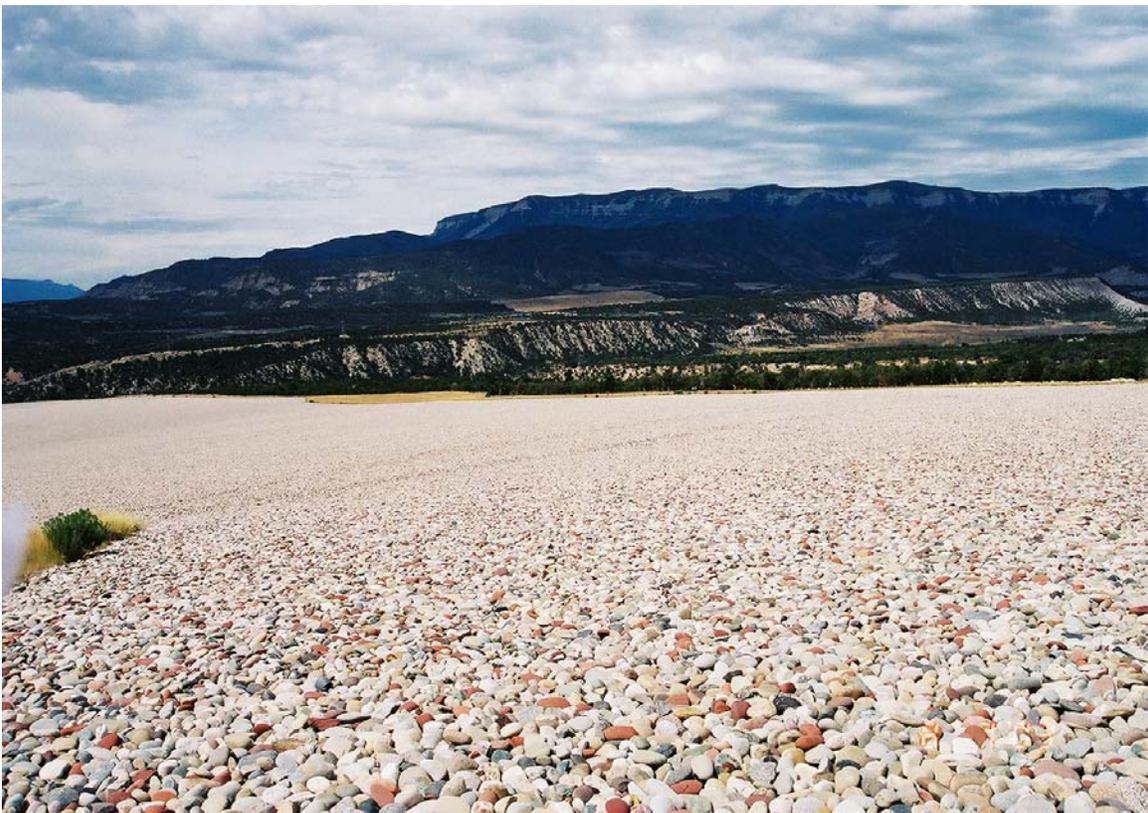
*RFL 8/2003. PL-2. Vehicle tracks across the disposal cell top.*

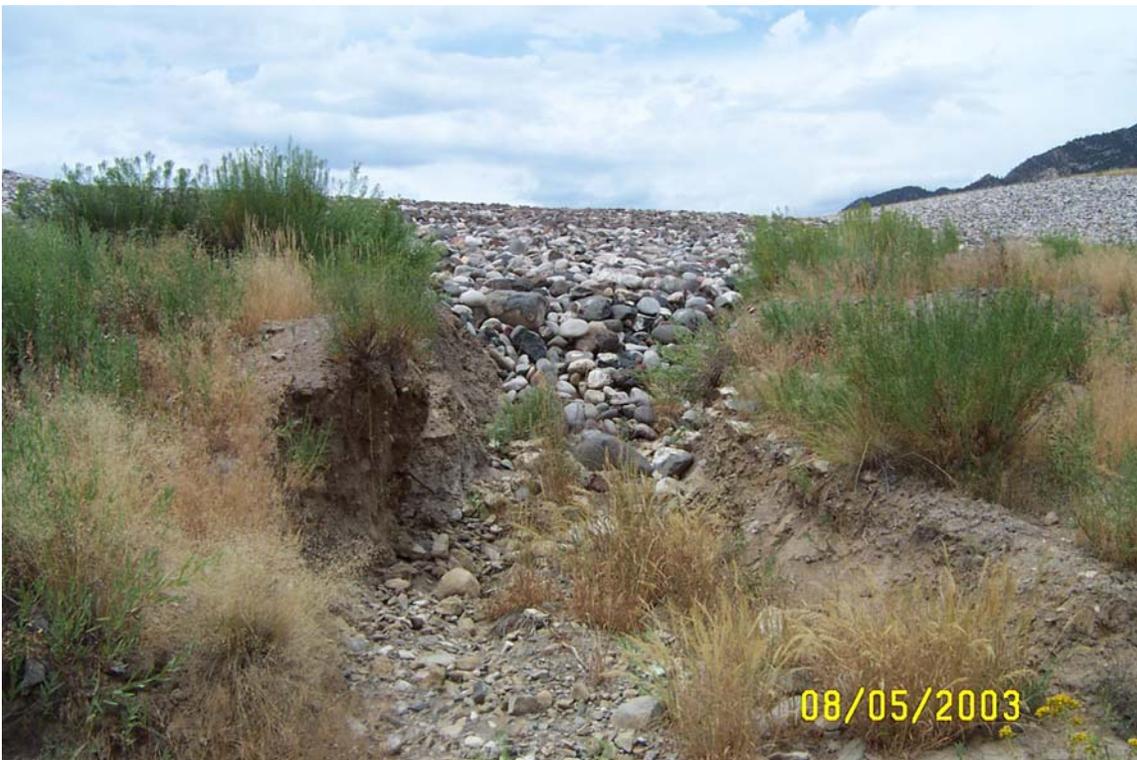
*RFL 8/2003. PL-4. Stabilized erosion at the toe ditch outlet.*

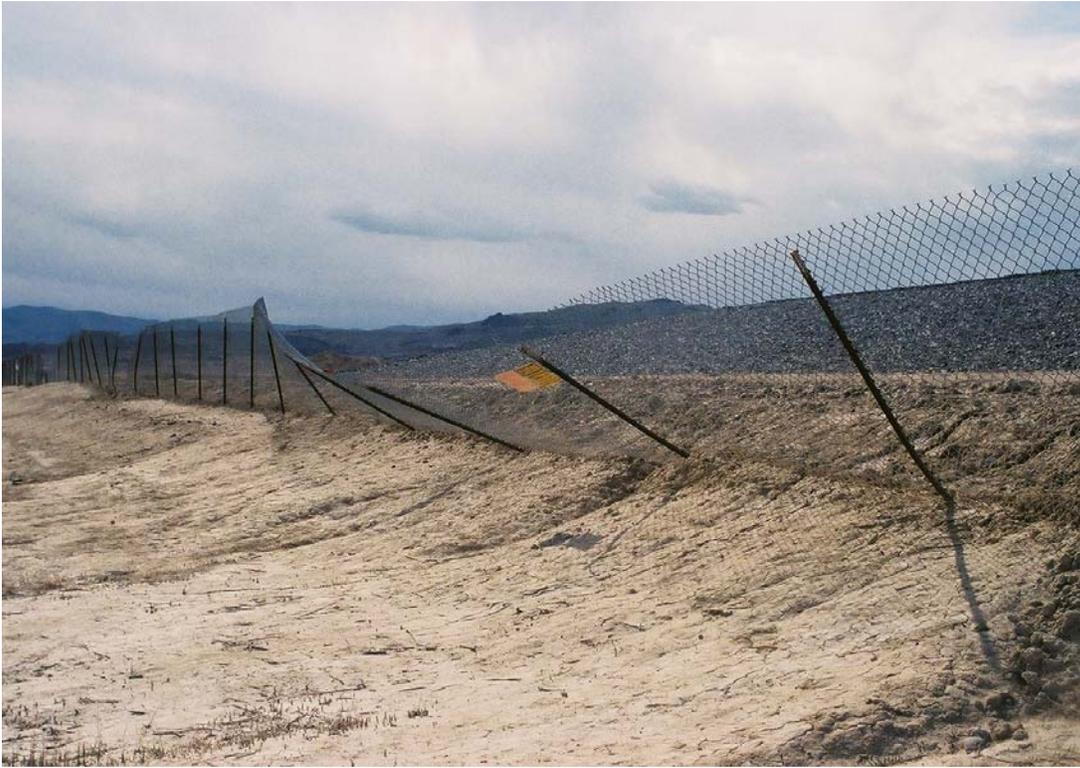
*SLC 6/2003. PL-1. Envirocare fence damage.*

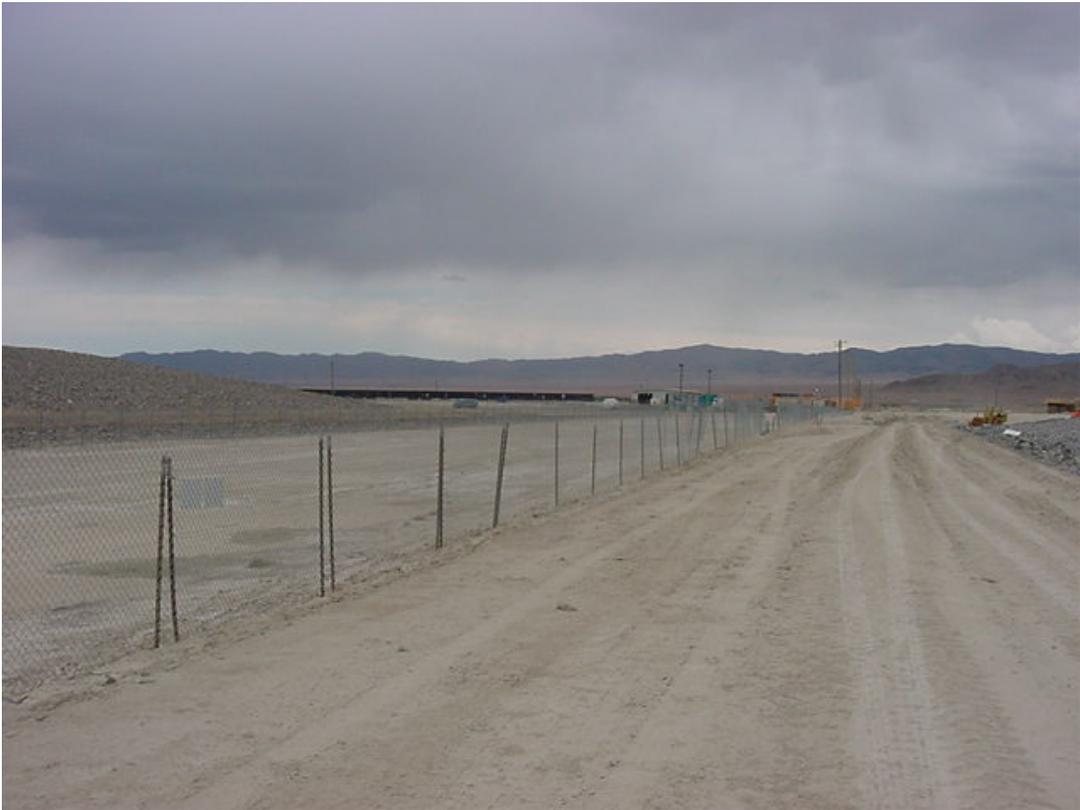
*SLC 6/2003. PL-2. Repaired Envirocare fence (photo provided by Envirocare).*

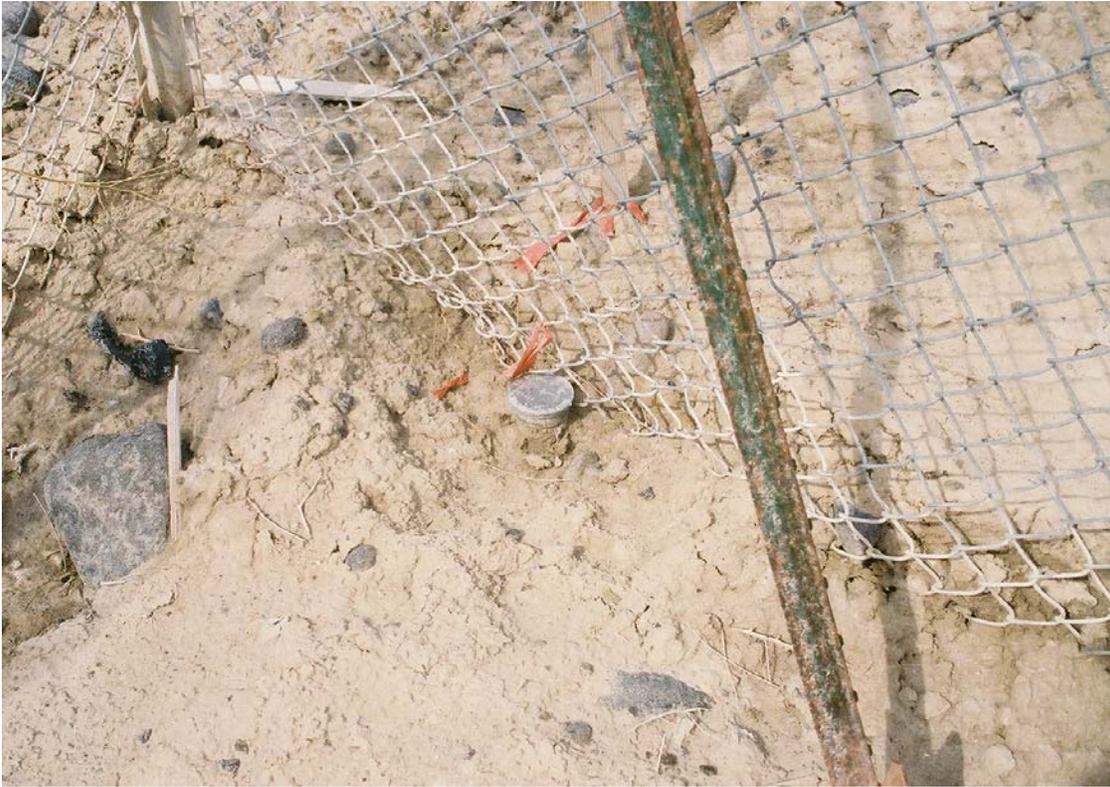
*SLC 6/2003. PL-3. Boundary monument BM-4 uncovered by Envirocare.*

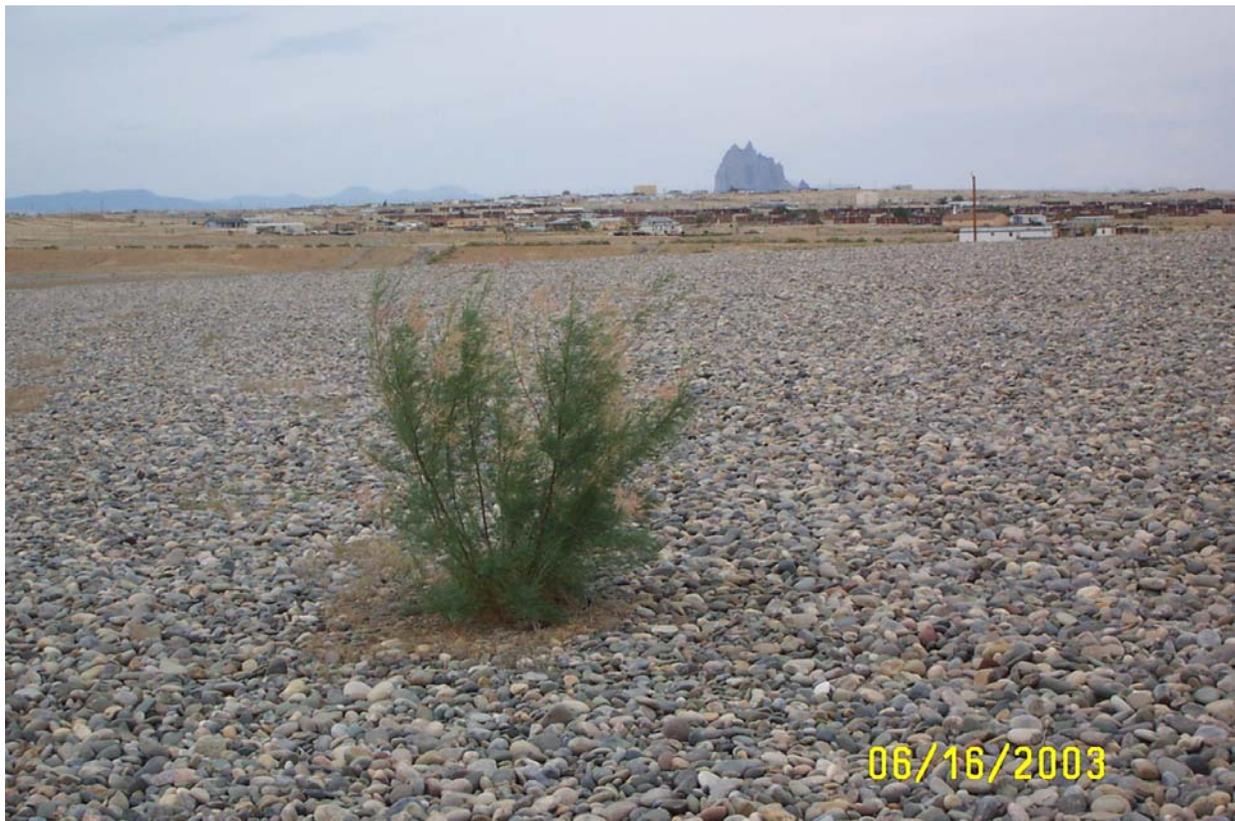
SHP 6/2003. PL-1. Tamarisk on the cell top before being cut and treated with herbicide.

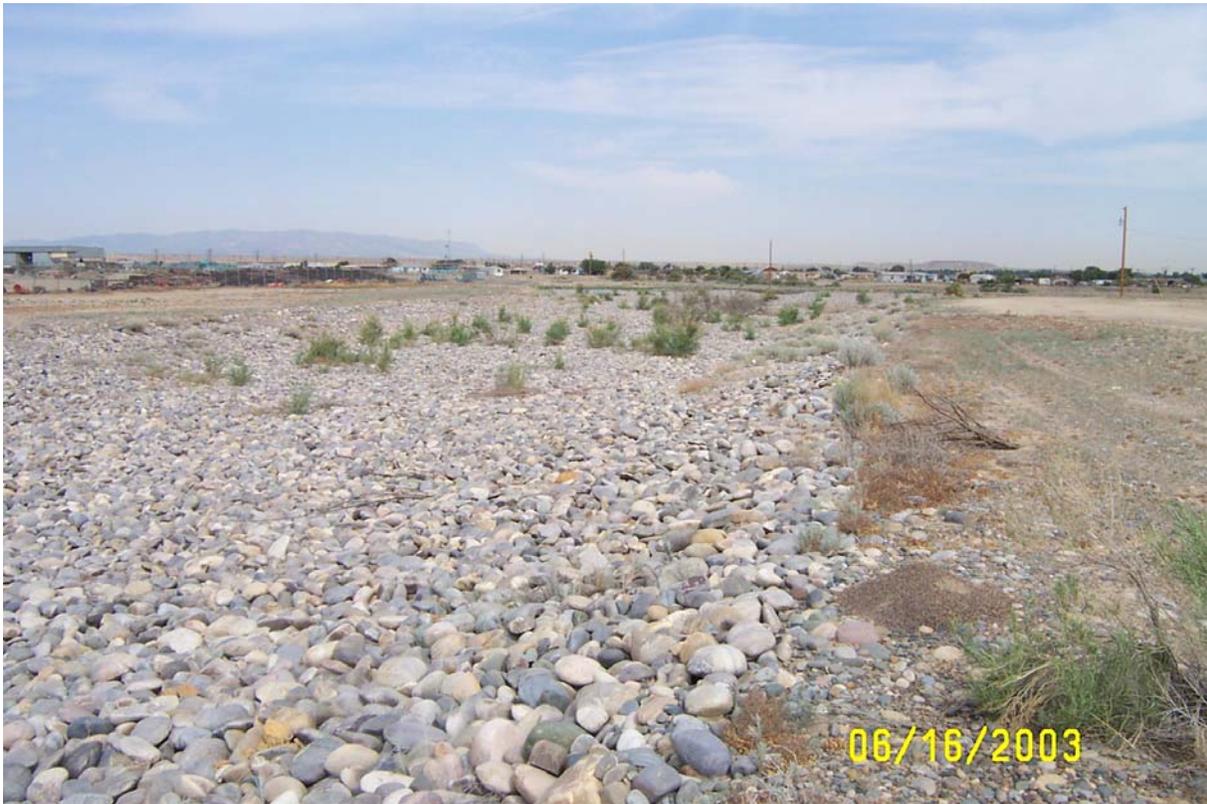
*SHP 6/2003. PL-2. Vegetation in the outflow channel.*

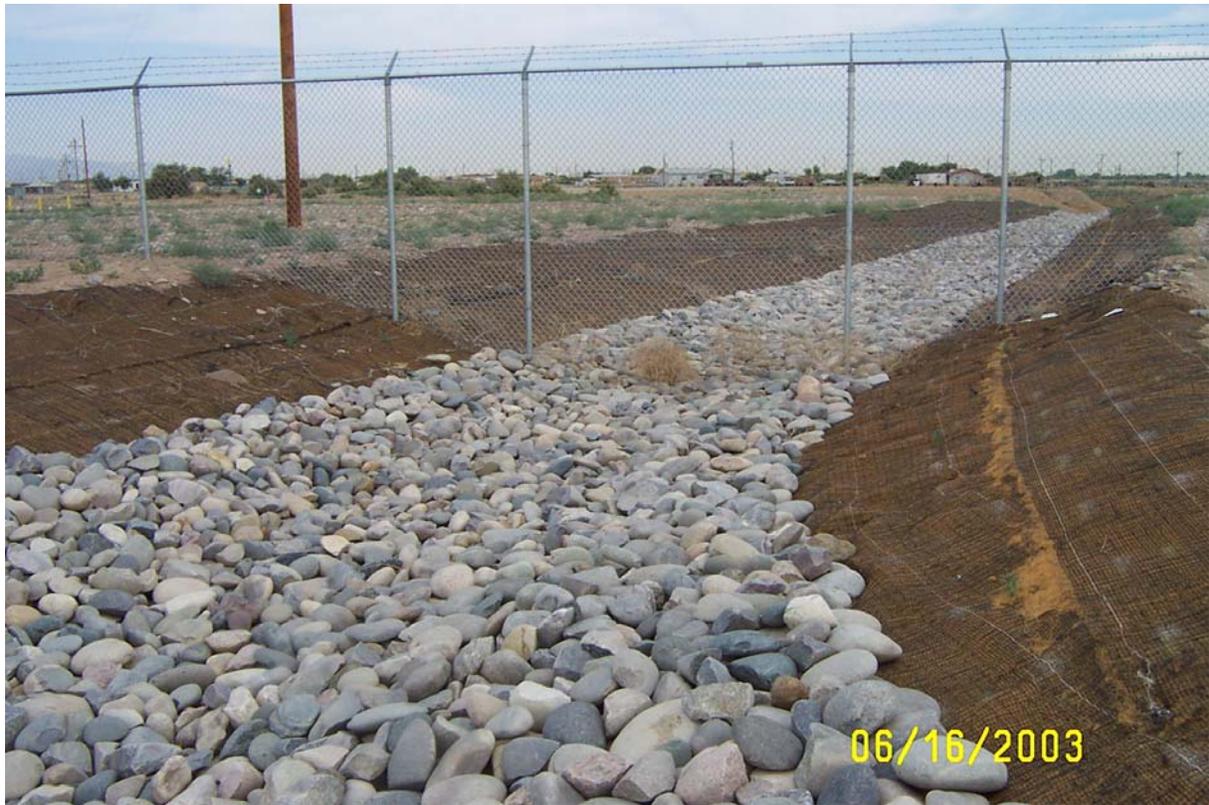
*SHP 6/2003. PL-3. Reconstructed outflow channel where it exits the property.*

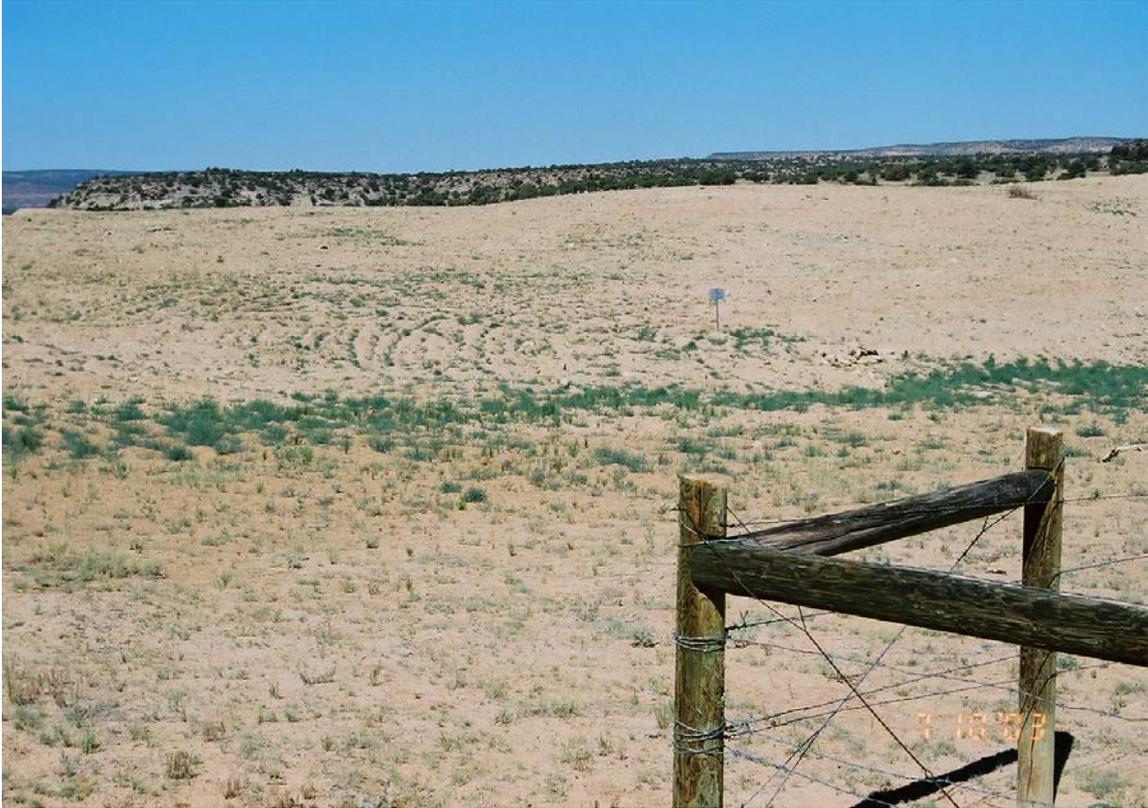
*SRK 7/2003. PL-1. Sparse vegetation on the northeast slope of the regraded spoils pile.*

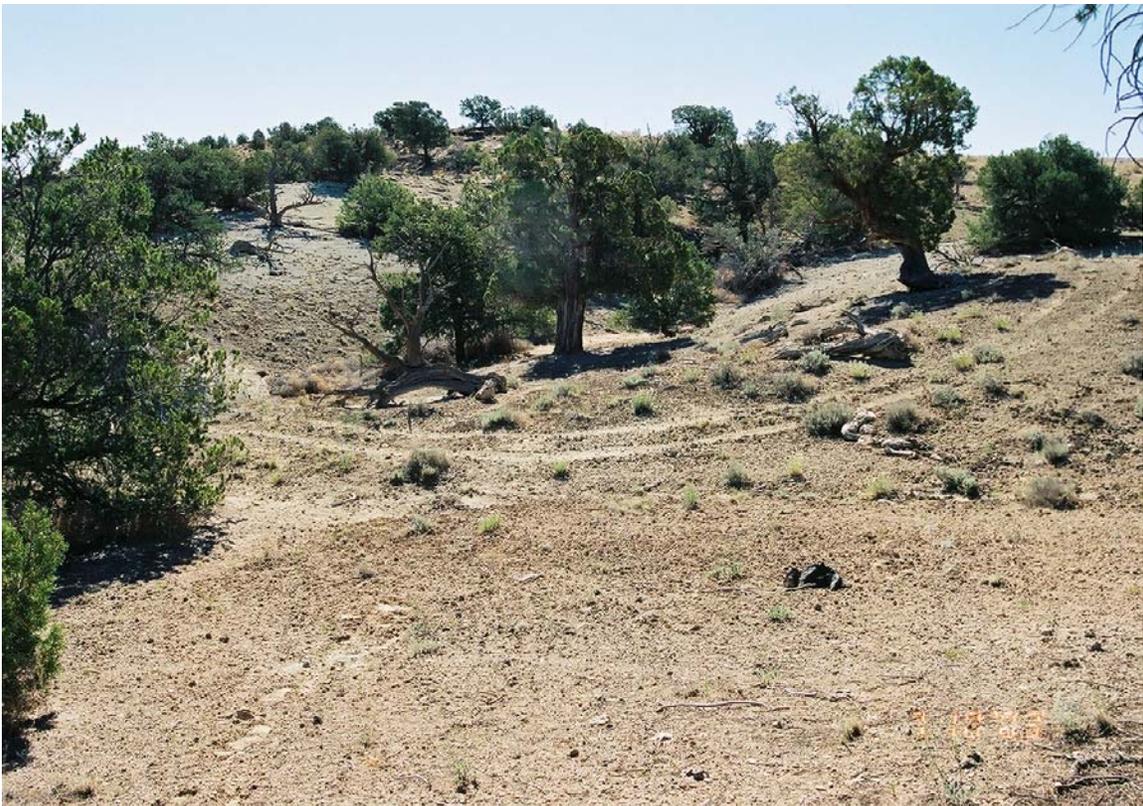
*SRK 7/2003. PL-2. All-terrain vehicle tracks in the northwest corner of the property.*

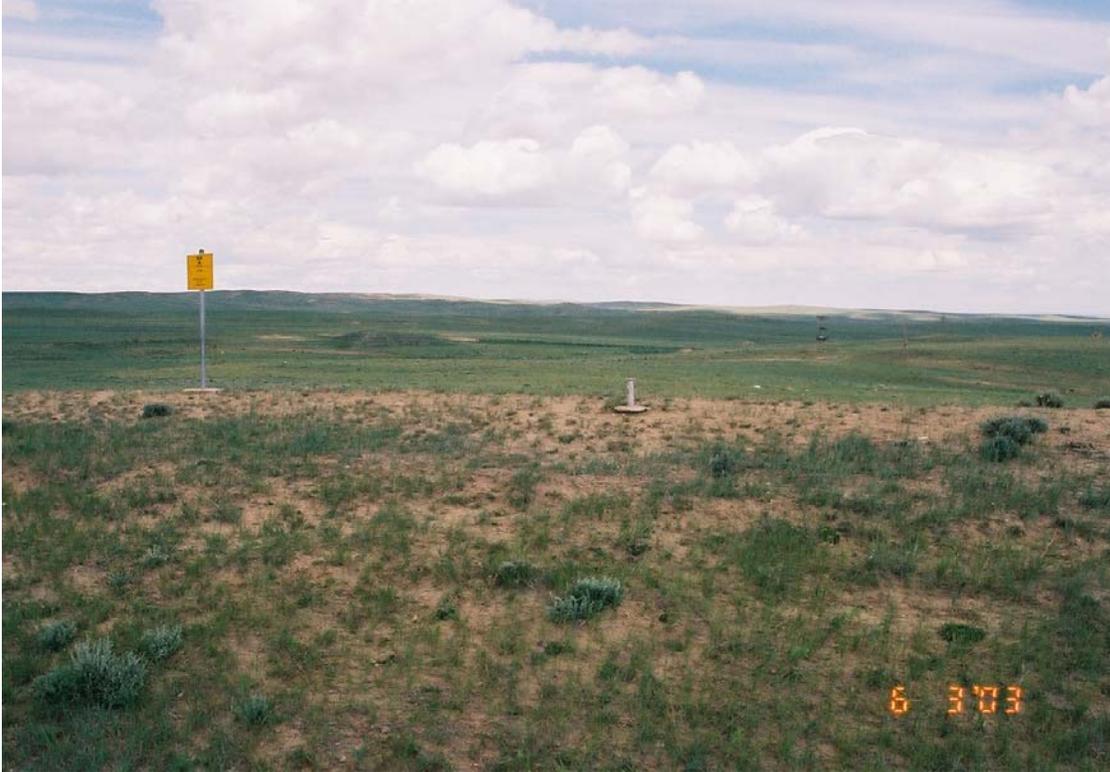
*SPK 6/2003. PL-1. Wind erosion around the concrete collar of boundary monument BM-6.*

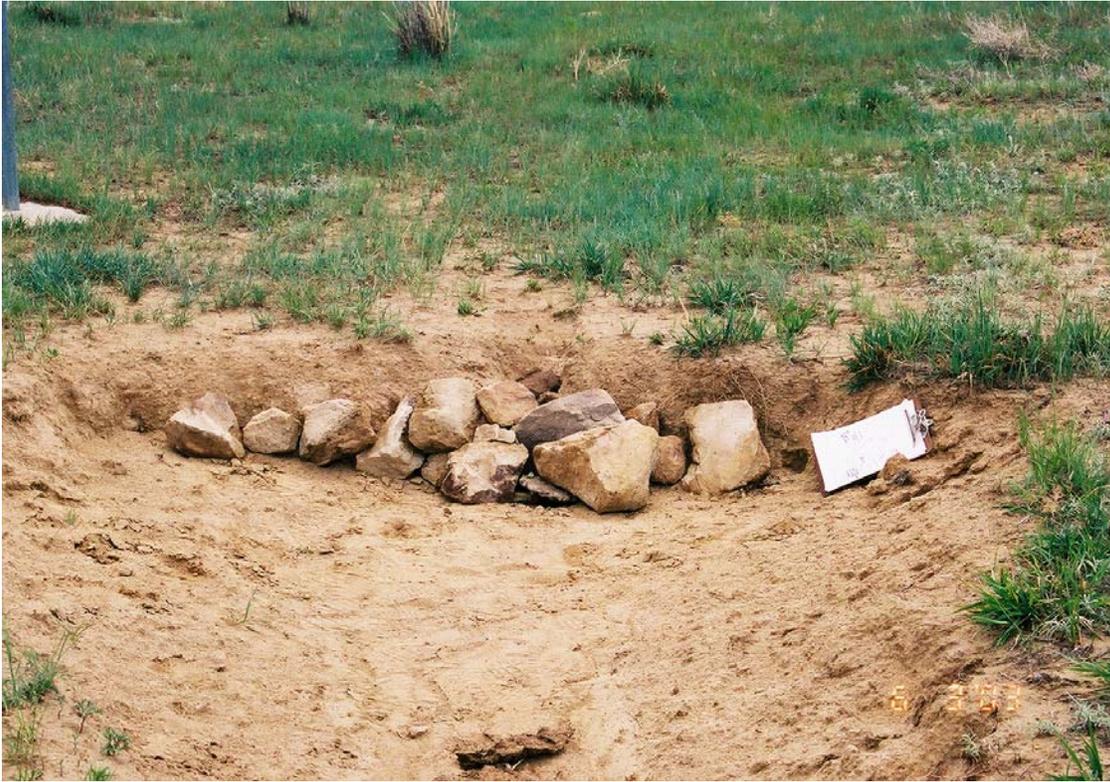
*SPK 6/2003. PL-2. Rocks placed at a gully knickpoint near perimeter sign P4.*

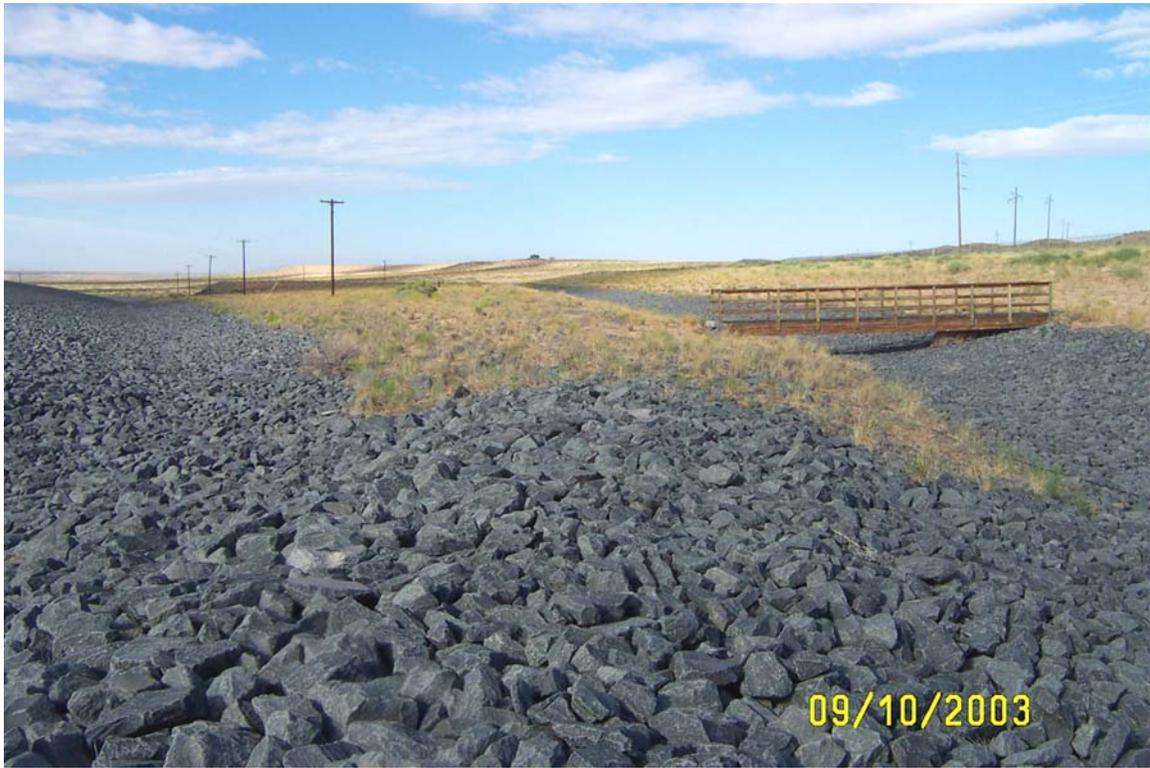
*TUB 9/2003. PL-2. Sand accumulation and vegetation between the toe drainage channel (left) and the storm water diversion channel (right).*
