## 10.0 Lowman, Idaho, Disposal Site

### 10.1 Compliance Summary

The Lowman Disposal Site, inspected on August 20, 2003, was in excellent condition. Areas to the north and west of the disposal cell, regraded and seeded in fall 1998, have successfully revegetated and are functioning as designed. In July 2003, a silt fence was removed and erosion features at two areas along the former silt fence and at the upper end of the collection ditch were stabilized by placement of rock. Herbicide was applied twice during 2003 to control noxious weeds at the site. Inspectors identified no cause for a follow-up or contingency inspection.

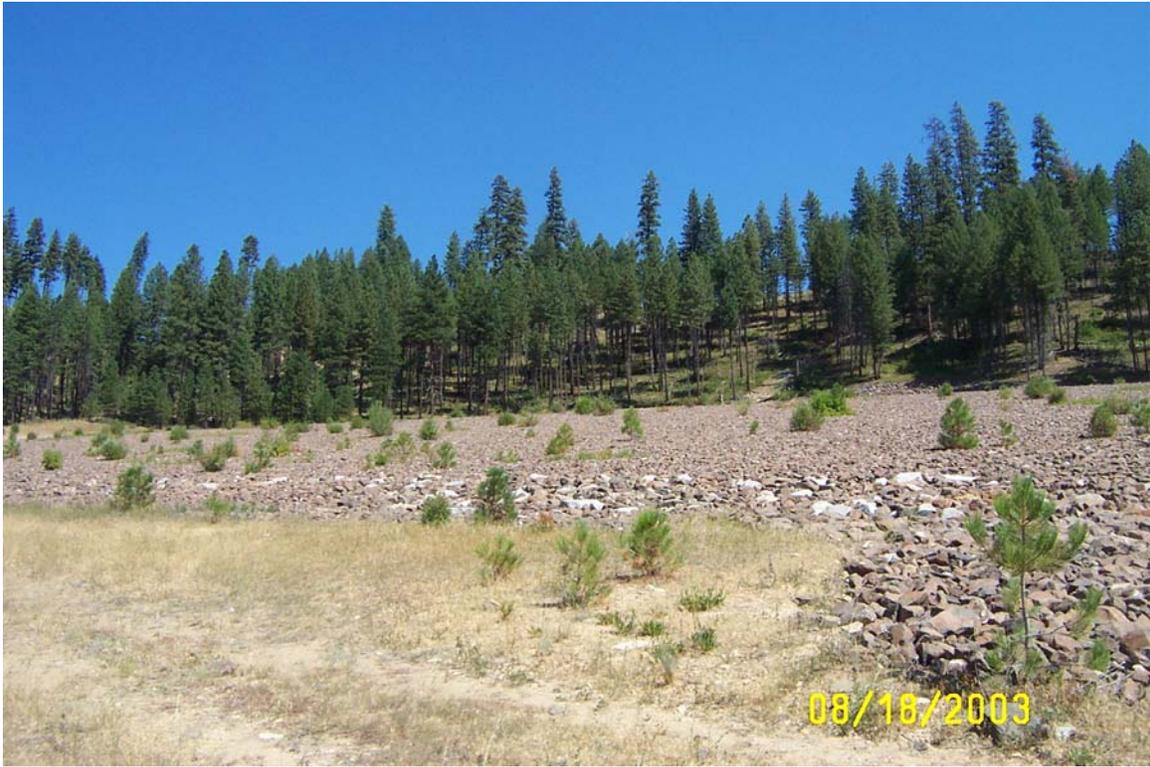
10A Encroachment of vegetation continues on the top and side slope of the disposal cell (PL-1). Based on the results of column leach studies conducted by DOE, the natural plant community succession can be allowed to proceed without increased risk to public health, safety, or the environment. However, DOE plans to remove large ponderosa pine trees periodically, before they are susceptible to blowdown and consequent uprooting which would dislodge erosion-protection riprap. These recommendations will be included in a revised Long-Term Surveillance Plan that is expected to be submitted to NRC for concurrence in 2004.

*LOW 8/2003. PL-1. Vegetation encroachment on the cell top.*

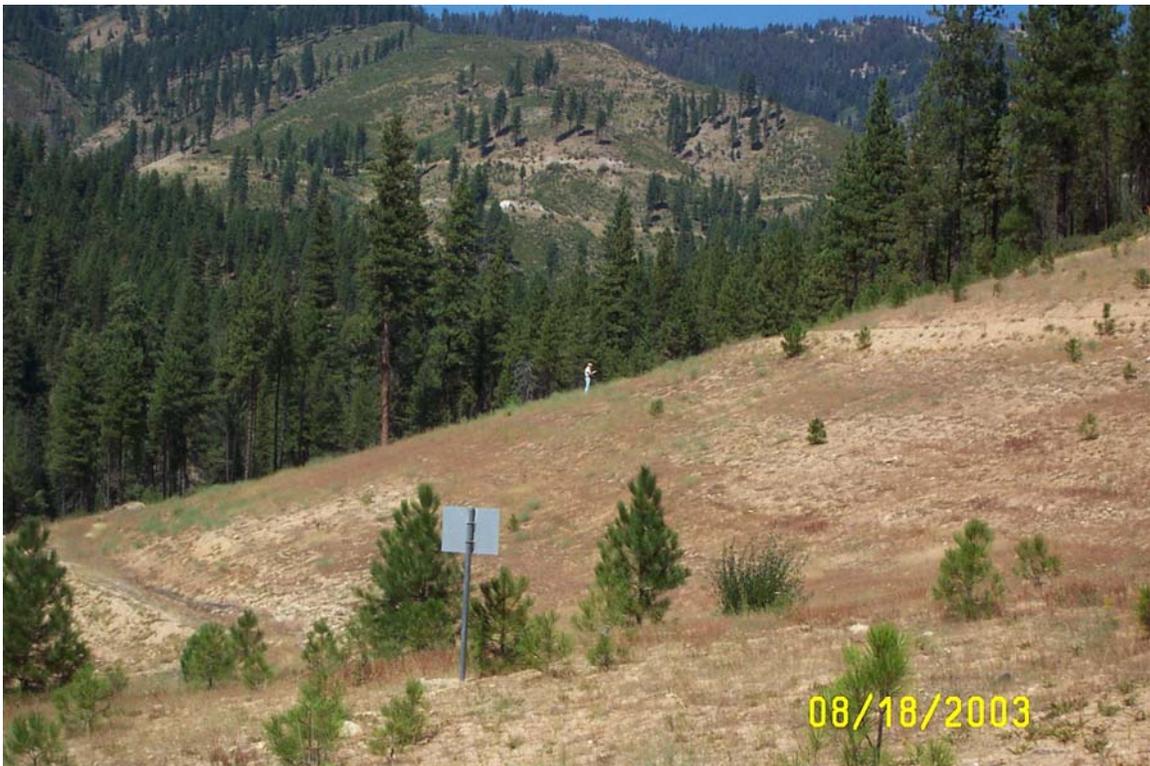
10C The interceptor benches, collection ditch, and vegetation were effectively controlling soil erosion in the revegetated area north and west of the site. Overall, the benches and collection ditch were in good condition (PL-2). Erosion has occurred near the upper end of the collection ditch. In July 2003, DOE repaired the erosion and hardened the area with rock. The revegetation effort on the slopes north and west of the disposal cell has been successful. DOE will continue to monitor the revegetated area for erosion.

*LOW 8/2003. PL-2. Restored area north of the disposal site.*
