18.0 Spook, Wyoming, Disposal Site

18.1 Compliance Summary

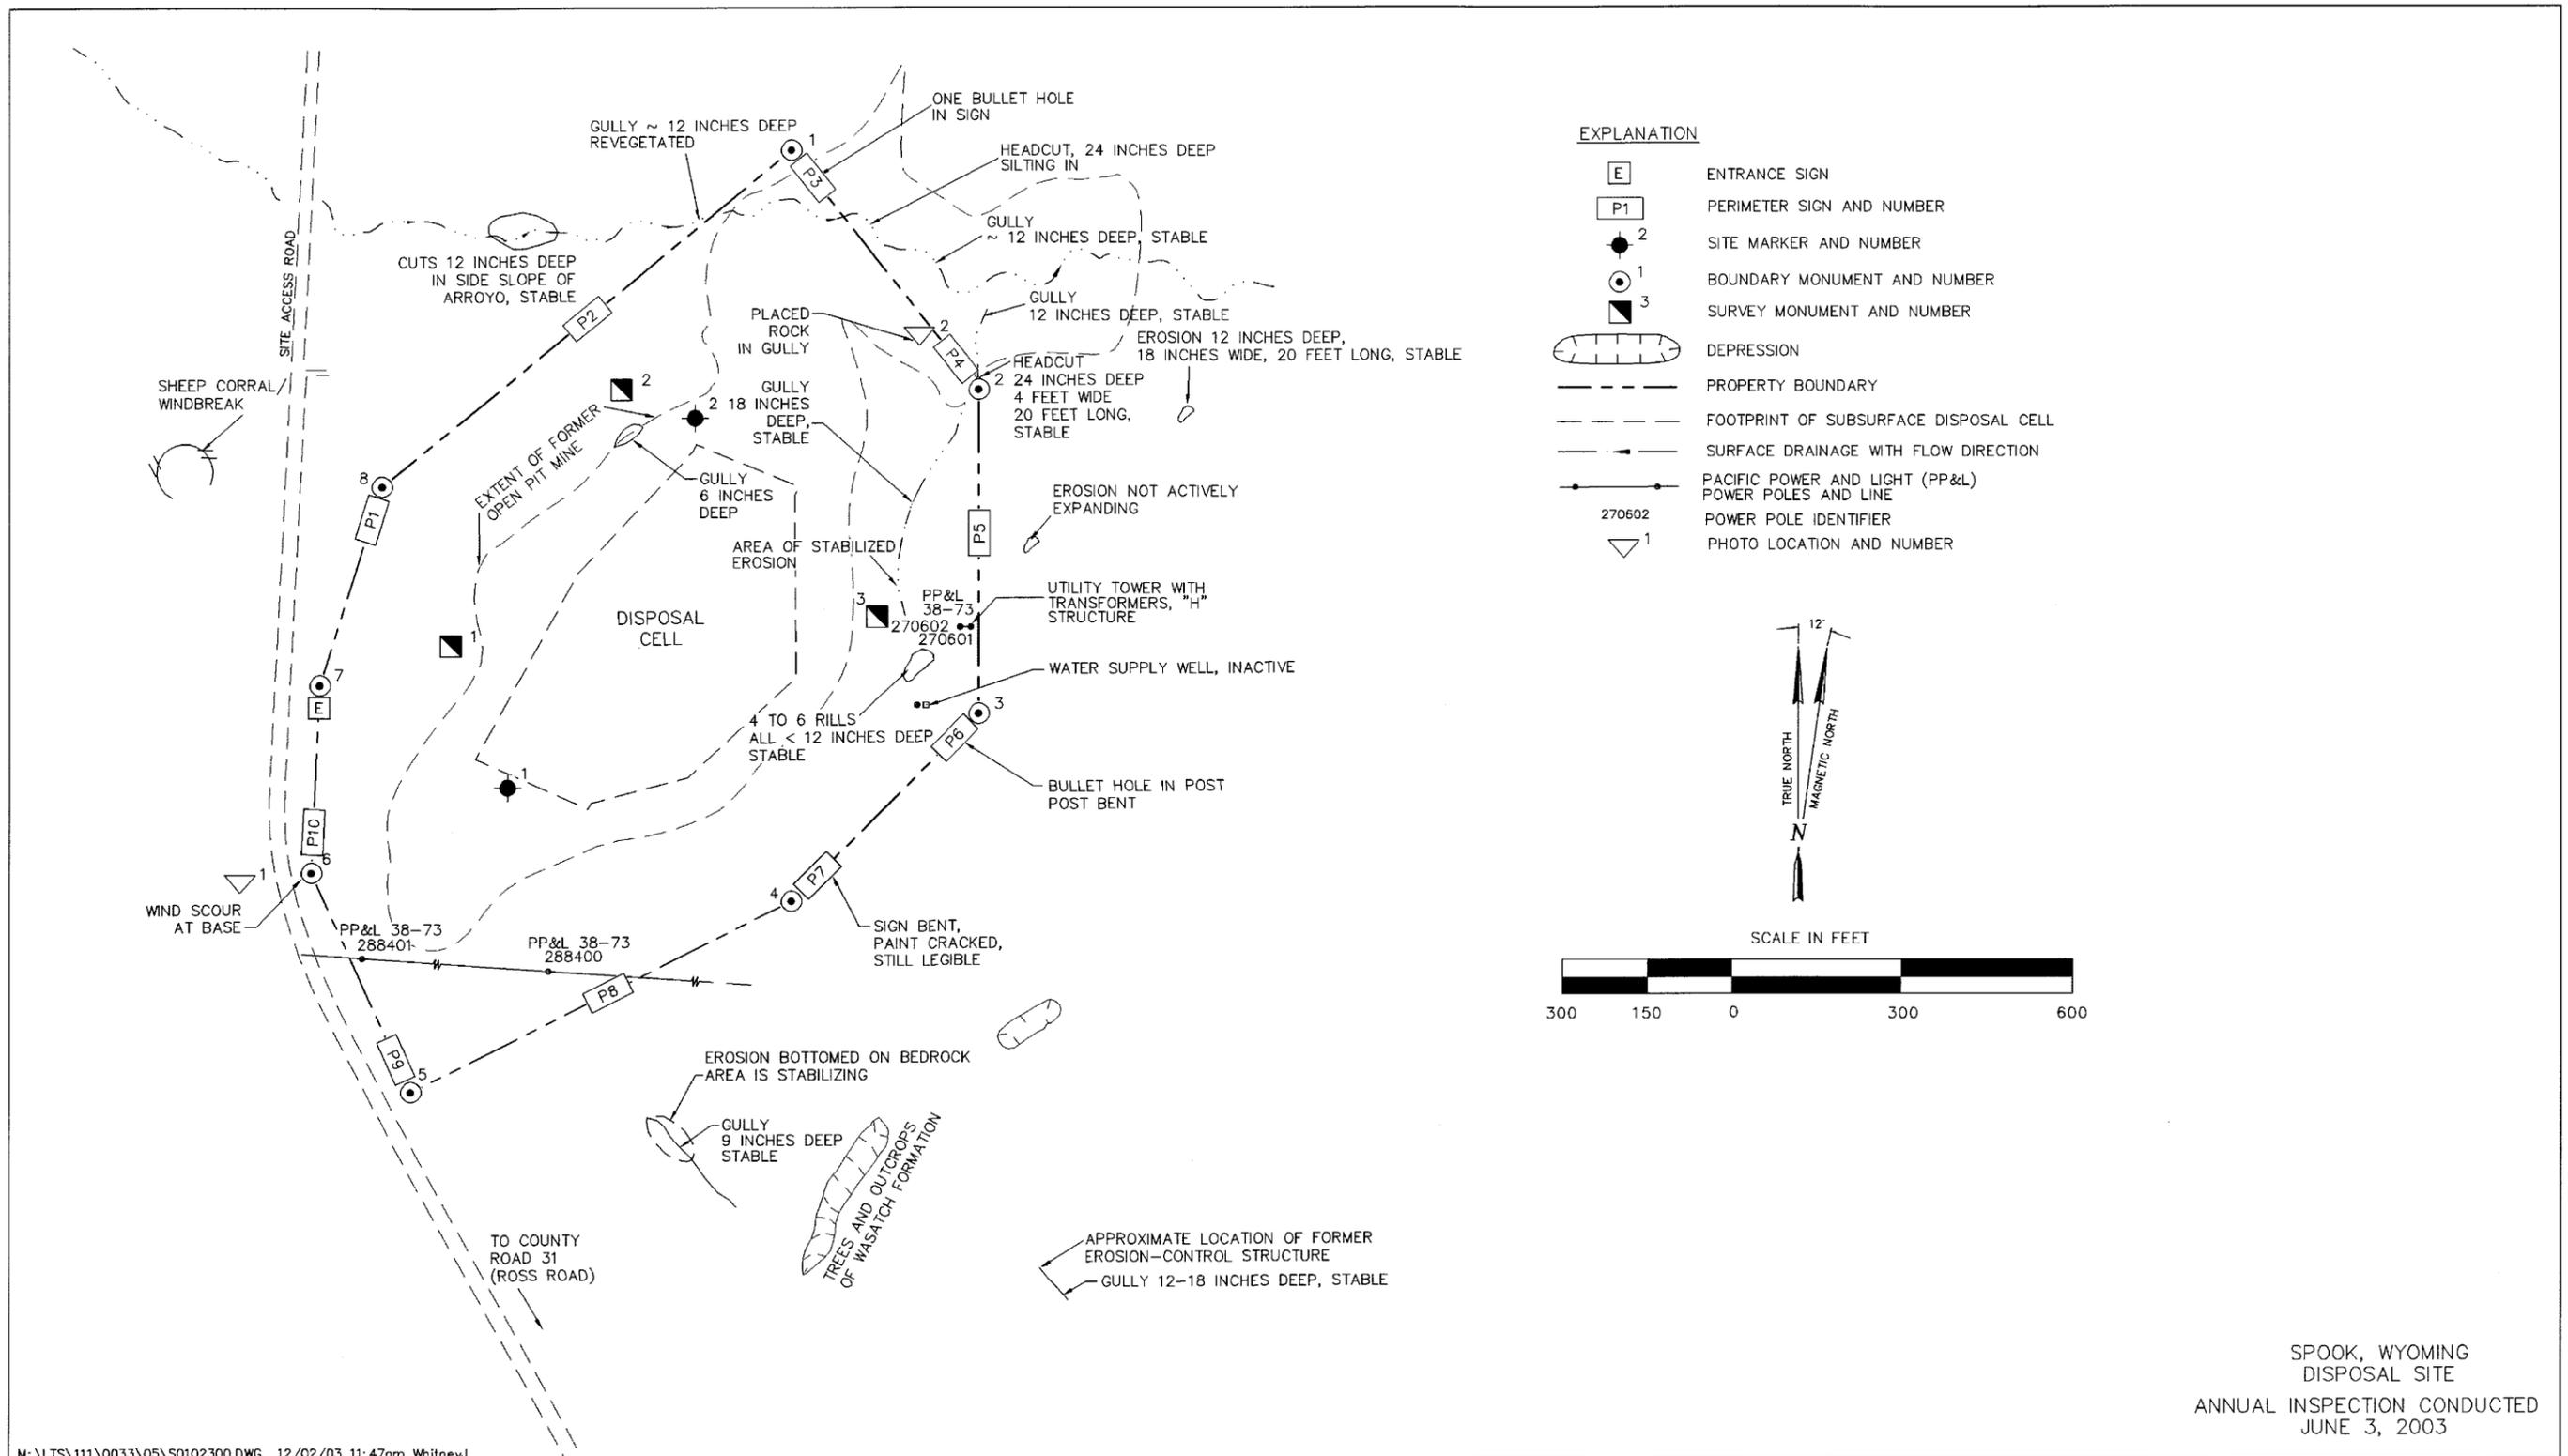
Figure 18-1. 2003 Annual Compliance Drawing for the Spook, Wyoming, Disposal Site

The site, located in north central Converse County, Wyoming, was inspected on June 3, 2003. Results of the inspection are described below. Features and the photograph locations (PLs) mentioned in this report are shown on Figure 18–1. The number in the left margin of this report refers to items summarized in the Executive Summary table.

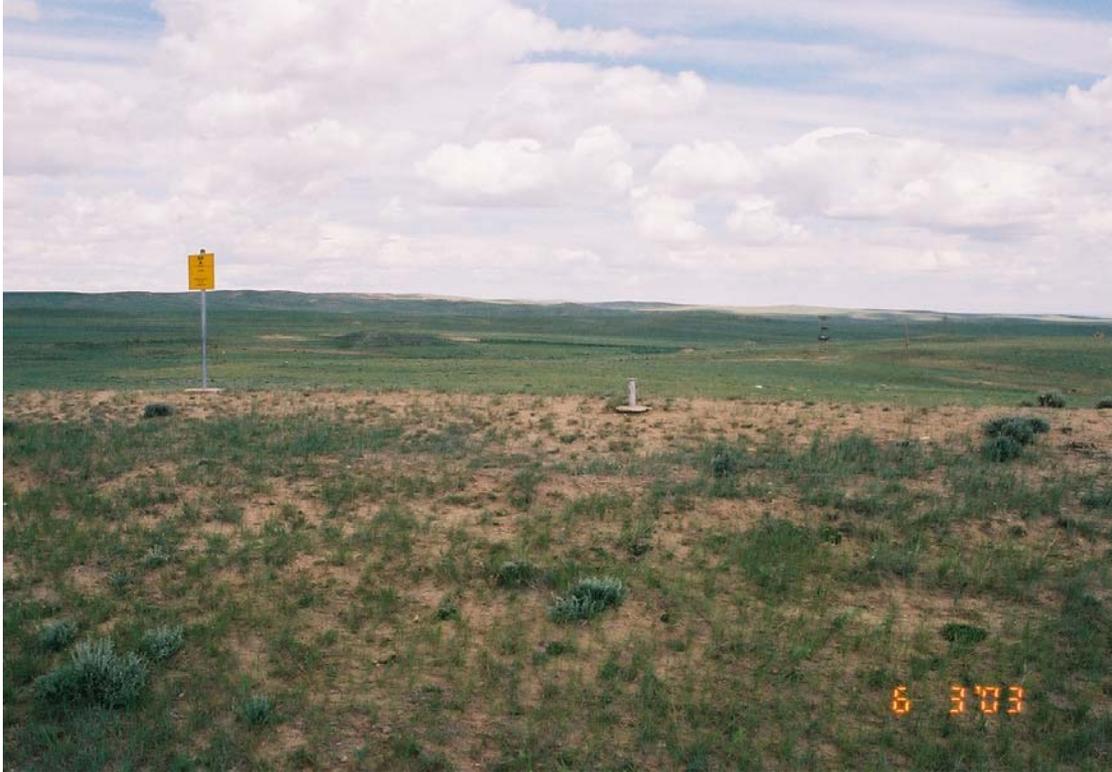
Site Markers and Monuments—The site has two site markers, eight boundary monuments, and three survey monuments. The concrete base of site marker SMK-1 is cracked and spalling but the granite marker is in excellent condition. Wind has scoured soil from beneath the surface concrete collar around boundary monument BM-6 but this will not compromise the integrity of the monument (PL-1). The other marker and monuments were undisturbed and in excellent condition.

SPK 6/2003. PL-1. Wind erosion around the concrete collar of boundary monument BM-6.

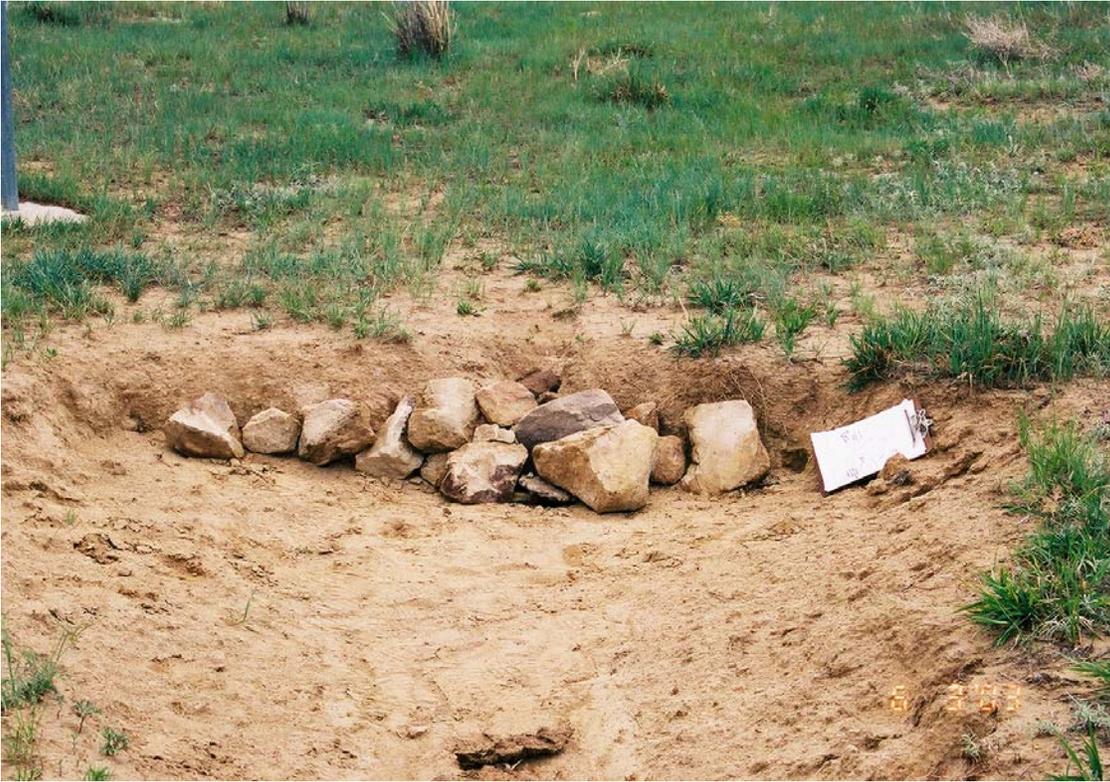
18A Most erosion features observed during previous inspections have stabilized, as indicated by vegetation growing in the rills and gullies. Only one gully, near perimeter sign P4, appeared active; the inspectors placed some rocks at the knickpoint to help control the erosion (PL-2).

SPK 6/2003. PL-2. Rocks placed at a gully knickpoint near perimeter sign P4.

Other than placing rock at the knickpoint of a gully to retard erosion, no maintenance was required in 2003.
