# **Trip Report**

## **2003 Annual Inspection of the Hallam Nuclear Power Facility, Hallam, Nebraska, D&D Site**

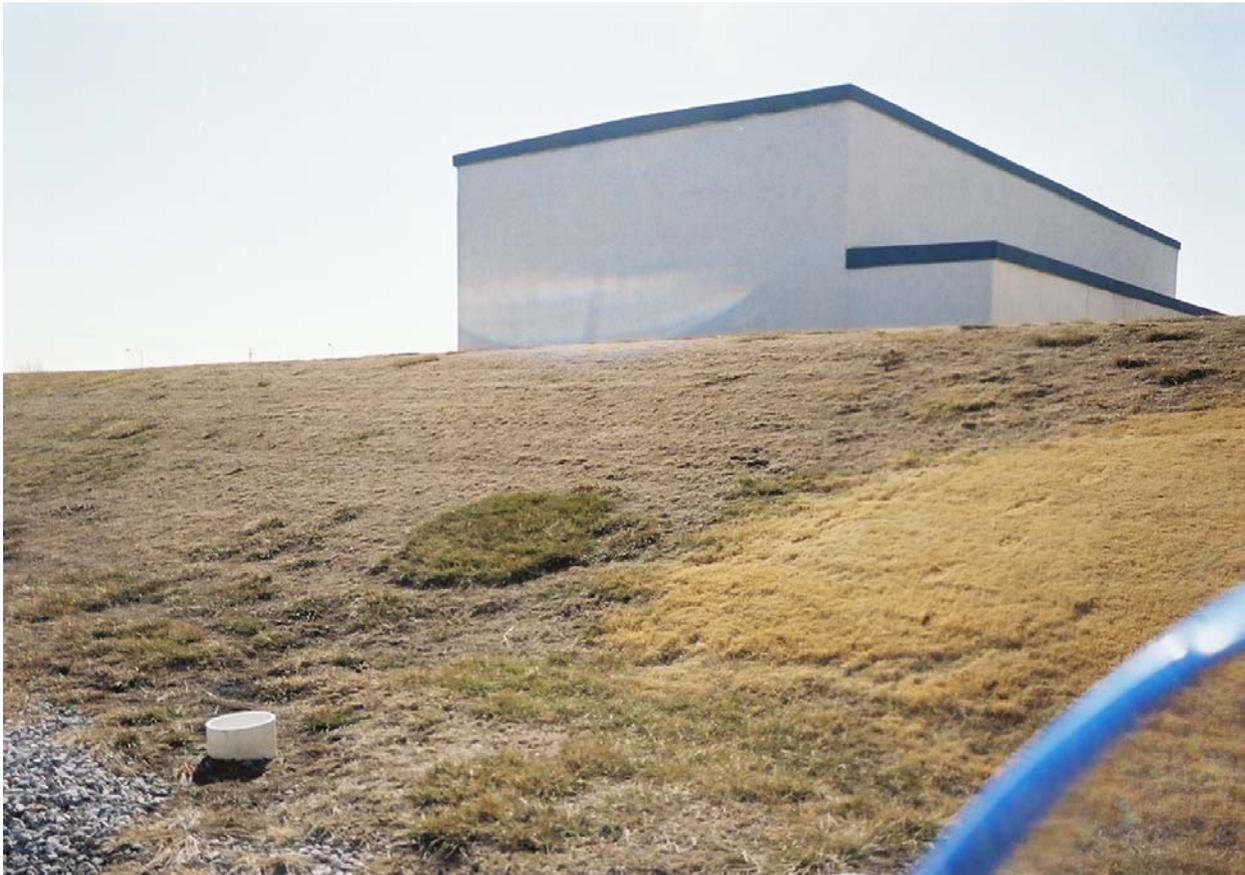
The old reactor foundation is buried beneath a waterproof membrane, soil, and grass. Today the buried structure appears as a low, flat-topped, grassed knoll, 1.4 acres in extent, immediately south of the IHX. The grass is a well-established lawn, and is generally in good condition. Grass on the side slope of the northeast corner of the knoll appears to have died (PL-1), most likely as a result of last year's drought. NPPD personnel replanted the grass in the autumn of 2002, but the success of this effort cannot be determined until the 2003 growing season has commenced. NPPD personnel said they would evaluate the grass in the spring and replant it if necessary.

1. Grass on the side slope of the northeast corner of the knoll has died and subsequently been reseeded (page 2).

HAL 3/2003. PL-1. Stressed vegetation on northeastern edge of the mound.

**Recommendation:** Monitor the success of reseeded during the 2003 growing season; replant if necessary.

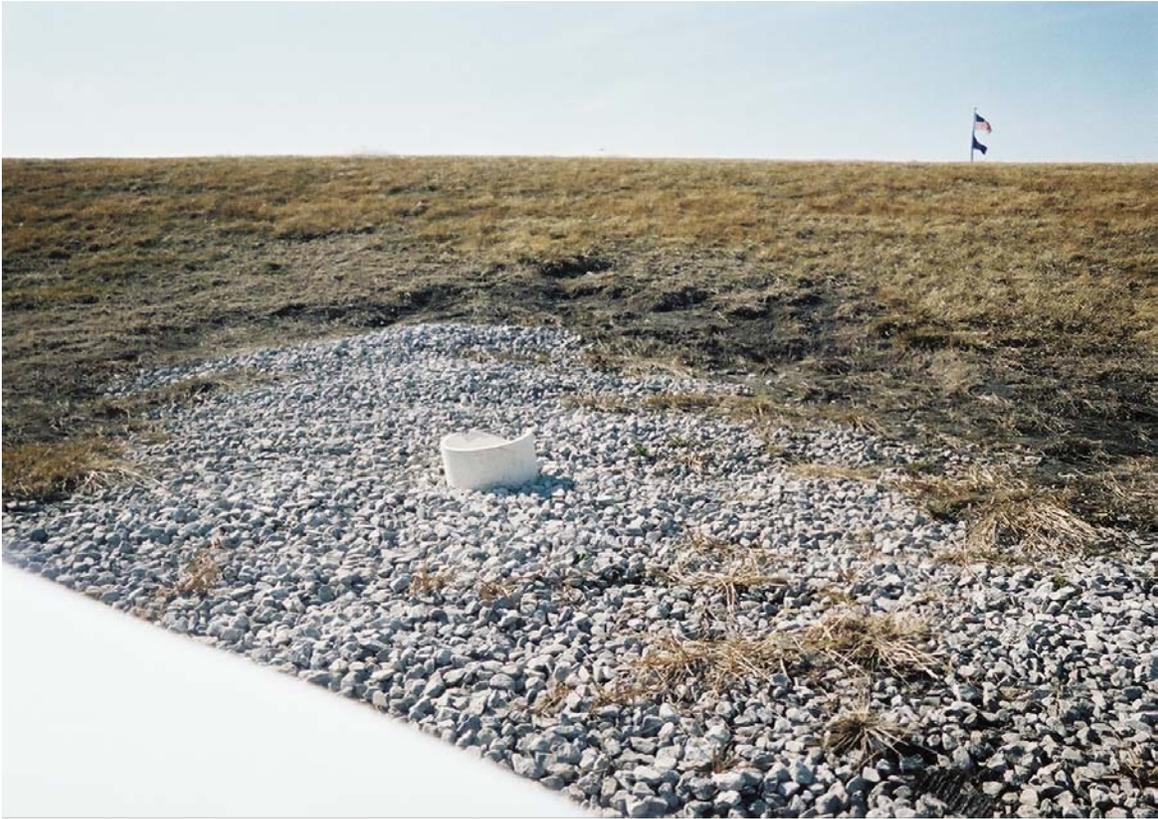
Gravel was identified on the east side slope of the knoll (PL-2). NPPD personnel reported that ash from the power plant had been placed at this location. When the material was removed, the front-end loader inadvertently removed some of the grass cover. The resulting divot was filled with gravel to bring it to grade and prevent erosion. This gravel should be replaced with topsoil and replanted in accordance with the cover design.

2. Gravel was placed in a divot created on the east side slope of the knoll by NPPD personnel (page 2).

HAL 03/2003. PL-2. Gravel fill replacing over-excavated area on the edge of the mound.

**Recommendation:** Request NPPD personnel to remove the gravel, fill the divot with topsoil, and replant grass.

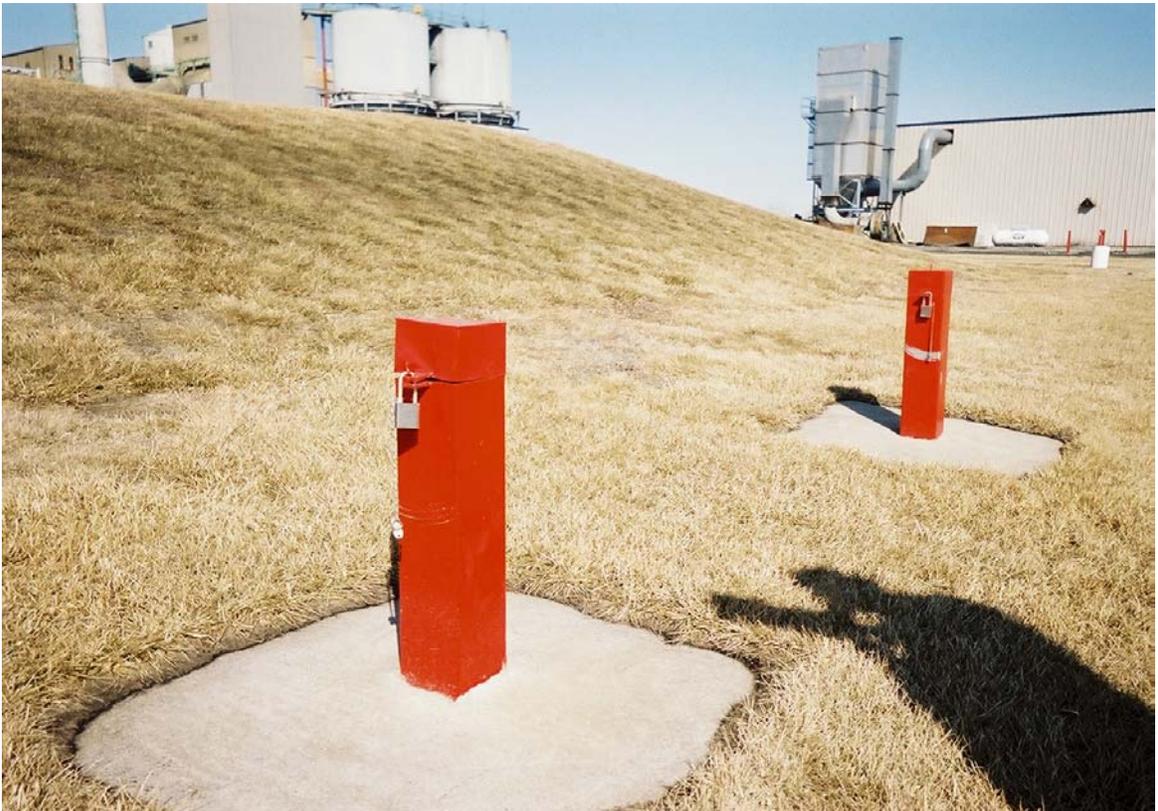
Monitor well OBS 3B had a damaged casing cover at the time of the 2002 inspection. NPPD personnel repaired the damage to this well casing and painted all of the above ground well casings bright red to make them more visible (PL-3). Flush mounted wells in high traffic areas (e.g., OBS 5A and OBS 5B) are covered with gravel and are difficult to locate. All wells are in excellent condition.

HAL 03/2003. PL-3. Repaired and repainted well casings.
