2004 Annual Inspection and Status Report for the Site A/Plot M, Cook County, Illinois Decontamination and Decommissioning Program Site

2004 ANNUAL INSPECTION DRAWING
SITE A-PLOT M, CHICAGO, ILLINOIS
DISPOSAL SITE

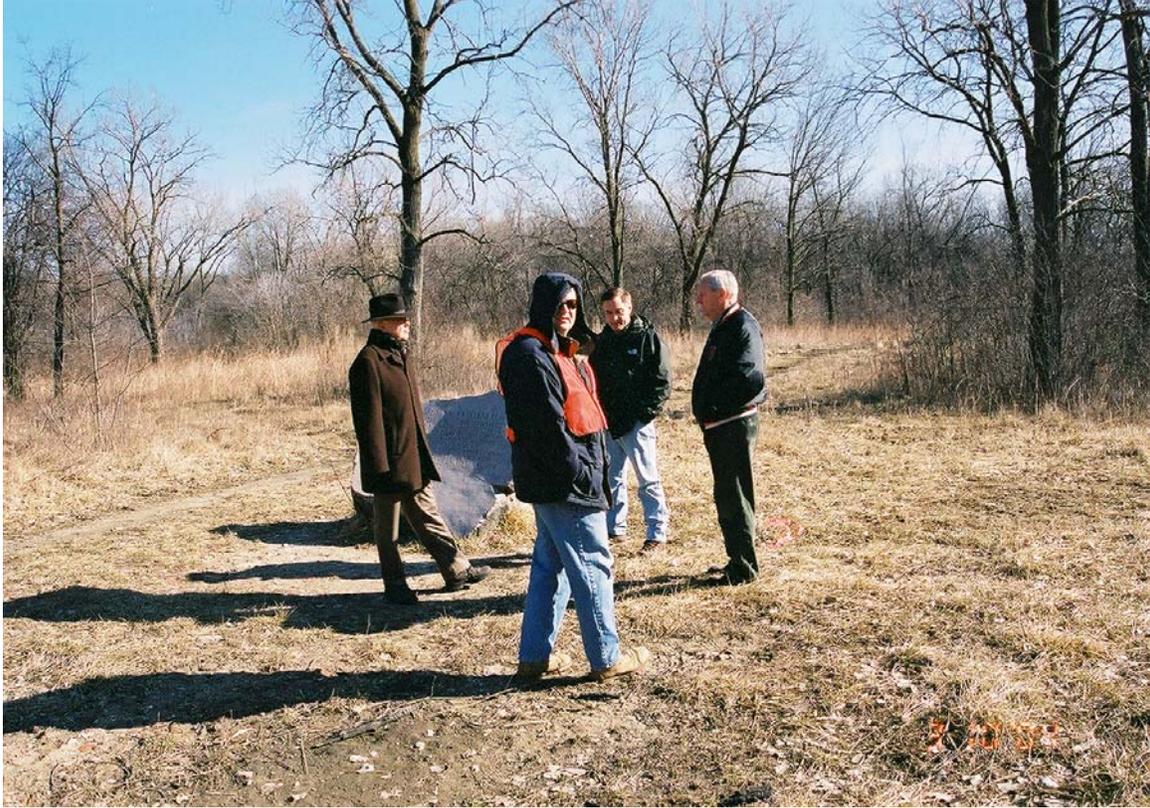
Inspectors drove to Site A, walked to the center of the area, and examined the monument and some of the monitor wells (PL-1). The team walked the perimeter roads of Site A, inspecting monitor wells and observing the general condition of the site. Next, the team drove to the junction with the road leading to Plot M. Because the steep road to Plot M was muddy, inspectors walked to that location.

SAM 03/2004. PL-1. Inspection team by Site A marker.

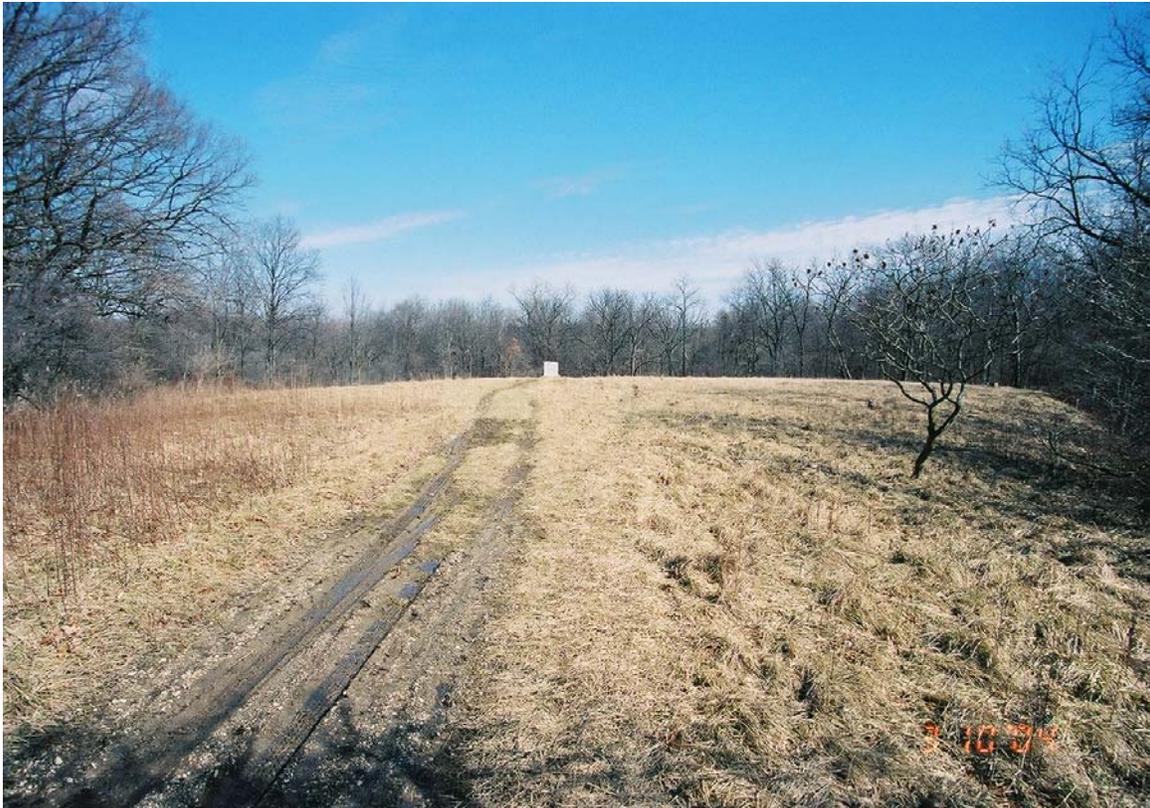
2. Plot M was a series of trenches used to bury radioactive wastes. Plot M is less than 1 acre in area. A granite monument and six boundary monuments mark the site, which consists of a mounded earth cover planted in grass (PL-2), placed over a concrete cap. The cap was constructed in 1956.

Erosion persists along the paths crossing Plot M between the monument and the south and west sides of the site. The inspector noted limestone rock, approximately 1.5 inches in diameter, in the exposed soil in the bottom of the eroded ruts. Previously, DOE had requested that the forest preserve district place a soil/rock mixture in the ruts to try to stabilize the trails. The concrete cover is not yet exposed or threatened but erosion again is approximately one foot deep and the

earth cover over the concrete cap is only two feet thick. DOE should continue to monitor this area and ensure the concrete cap is not exposed. The ANL representative will request that the Palos Forest Preserve District repair the erosion again. These trails are used frequently and vegetation will not survive the traffic. Measures will be considered to reduce the velocity of runoff water.

SAM 03/2004. PL-2. Plot M.

Recommendation: Enough traffic passes over these paths to preclude successfully repairing the erosion by filling the depression with soil and reseeded. A soil/rock mixture also failed to stabilize the trails. Therefore, DOE will discuss with the Palos Forest Preserve District and the ANL representative other alternatives for preventing erosion over the Plot M cover.

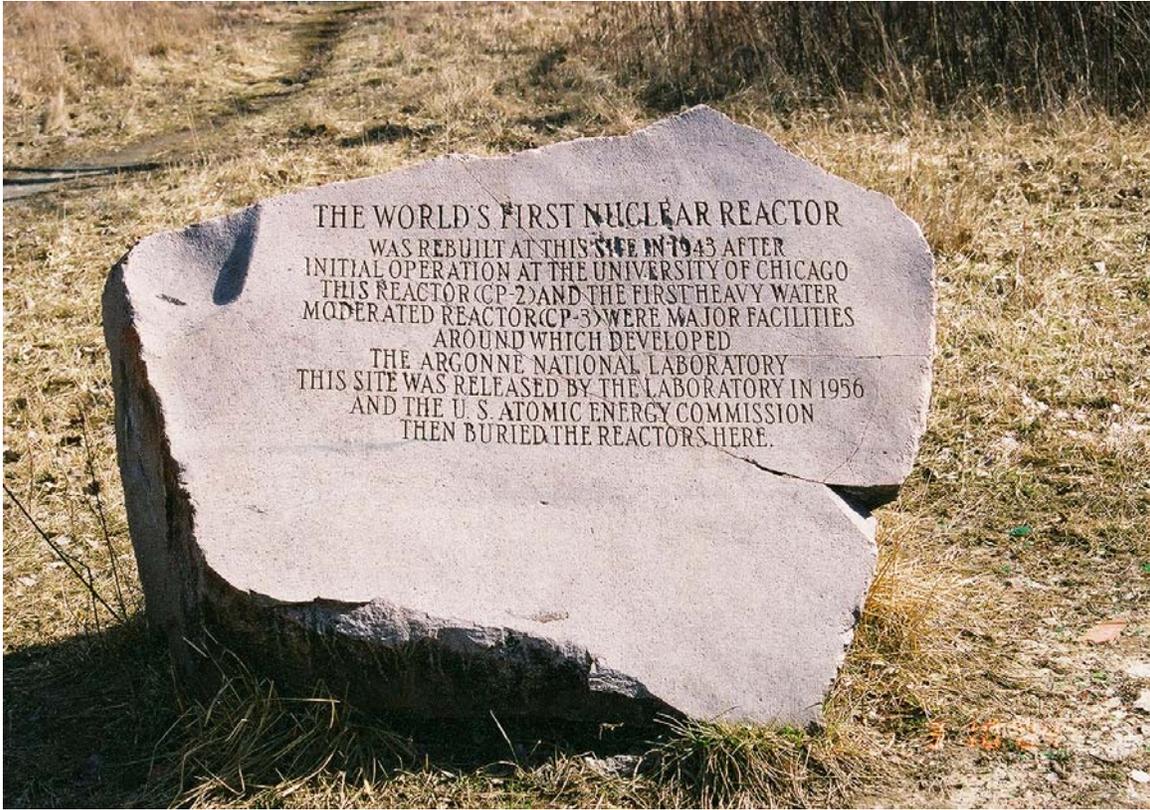
A subset of the currently active monitor wells and boreholes was inspected and is in good condition. Minor vandalism, such as the graffiti on the Site A and Plot M monuments, continues (PL-3 and PL-4). No other vandalism was noted.

SAM 03/2004. PL-3. Site A marker.

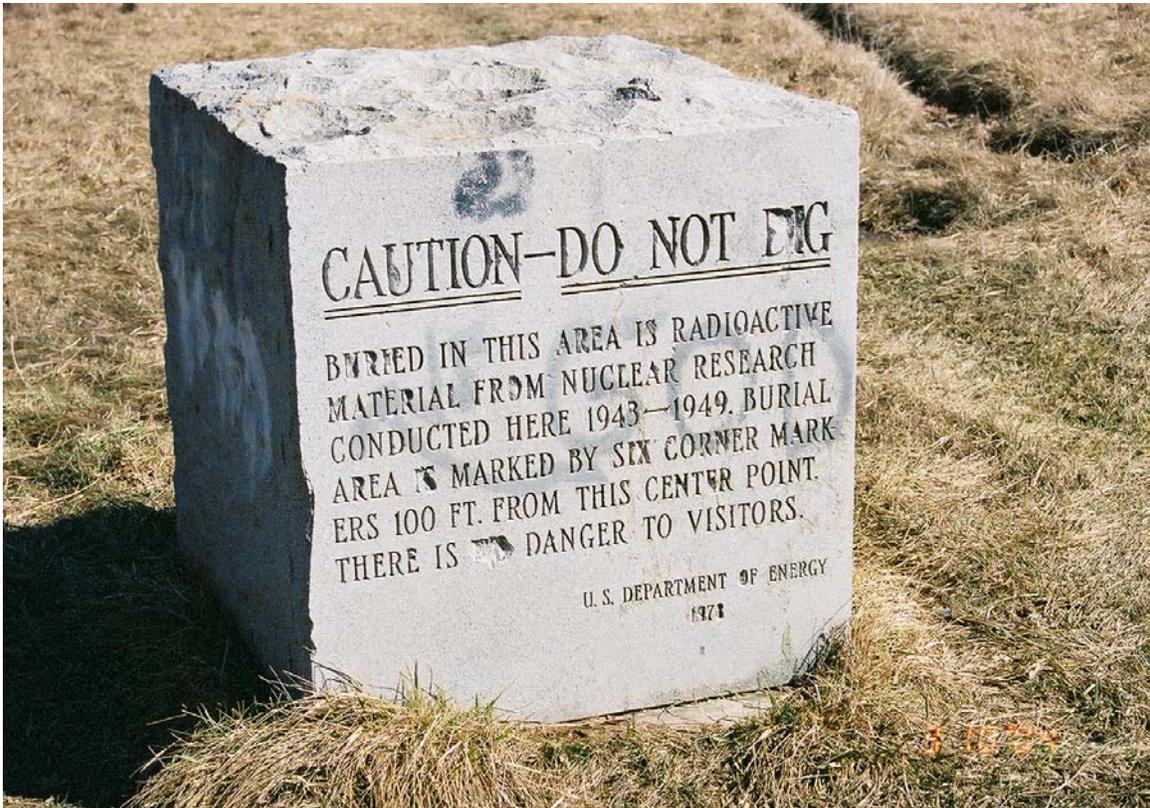
SAM 03/2004. PL-4. Plot M marker.

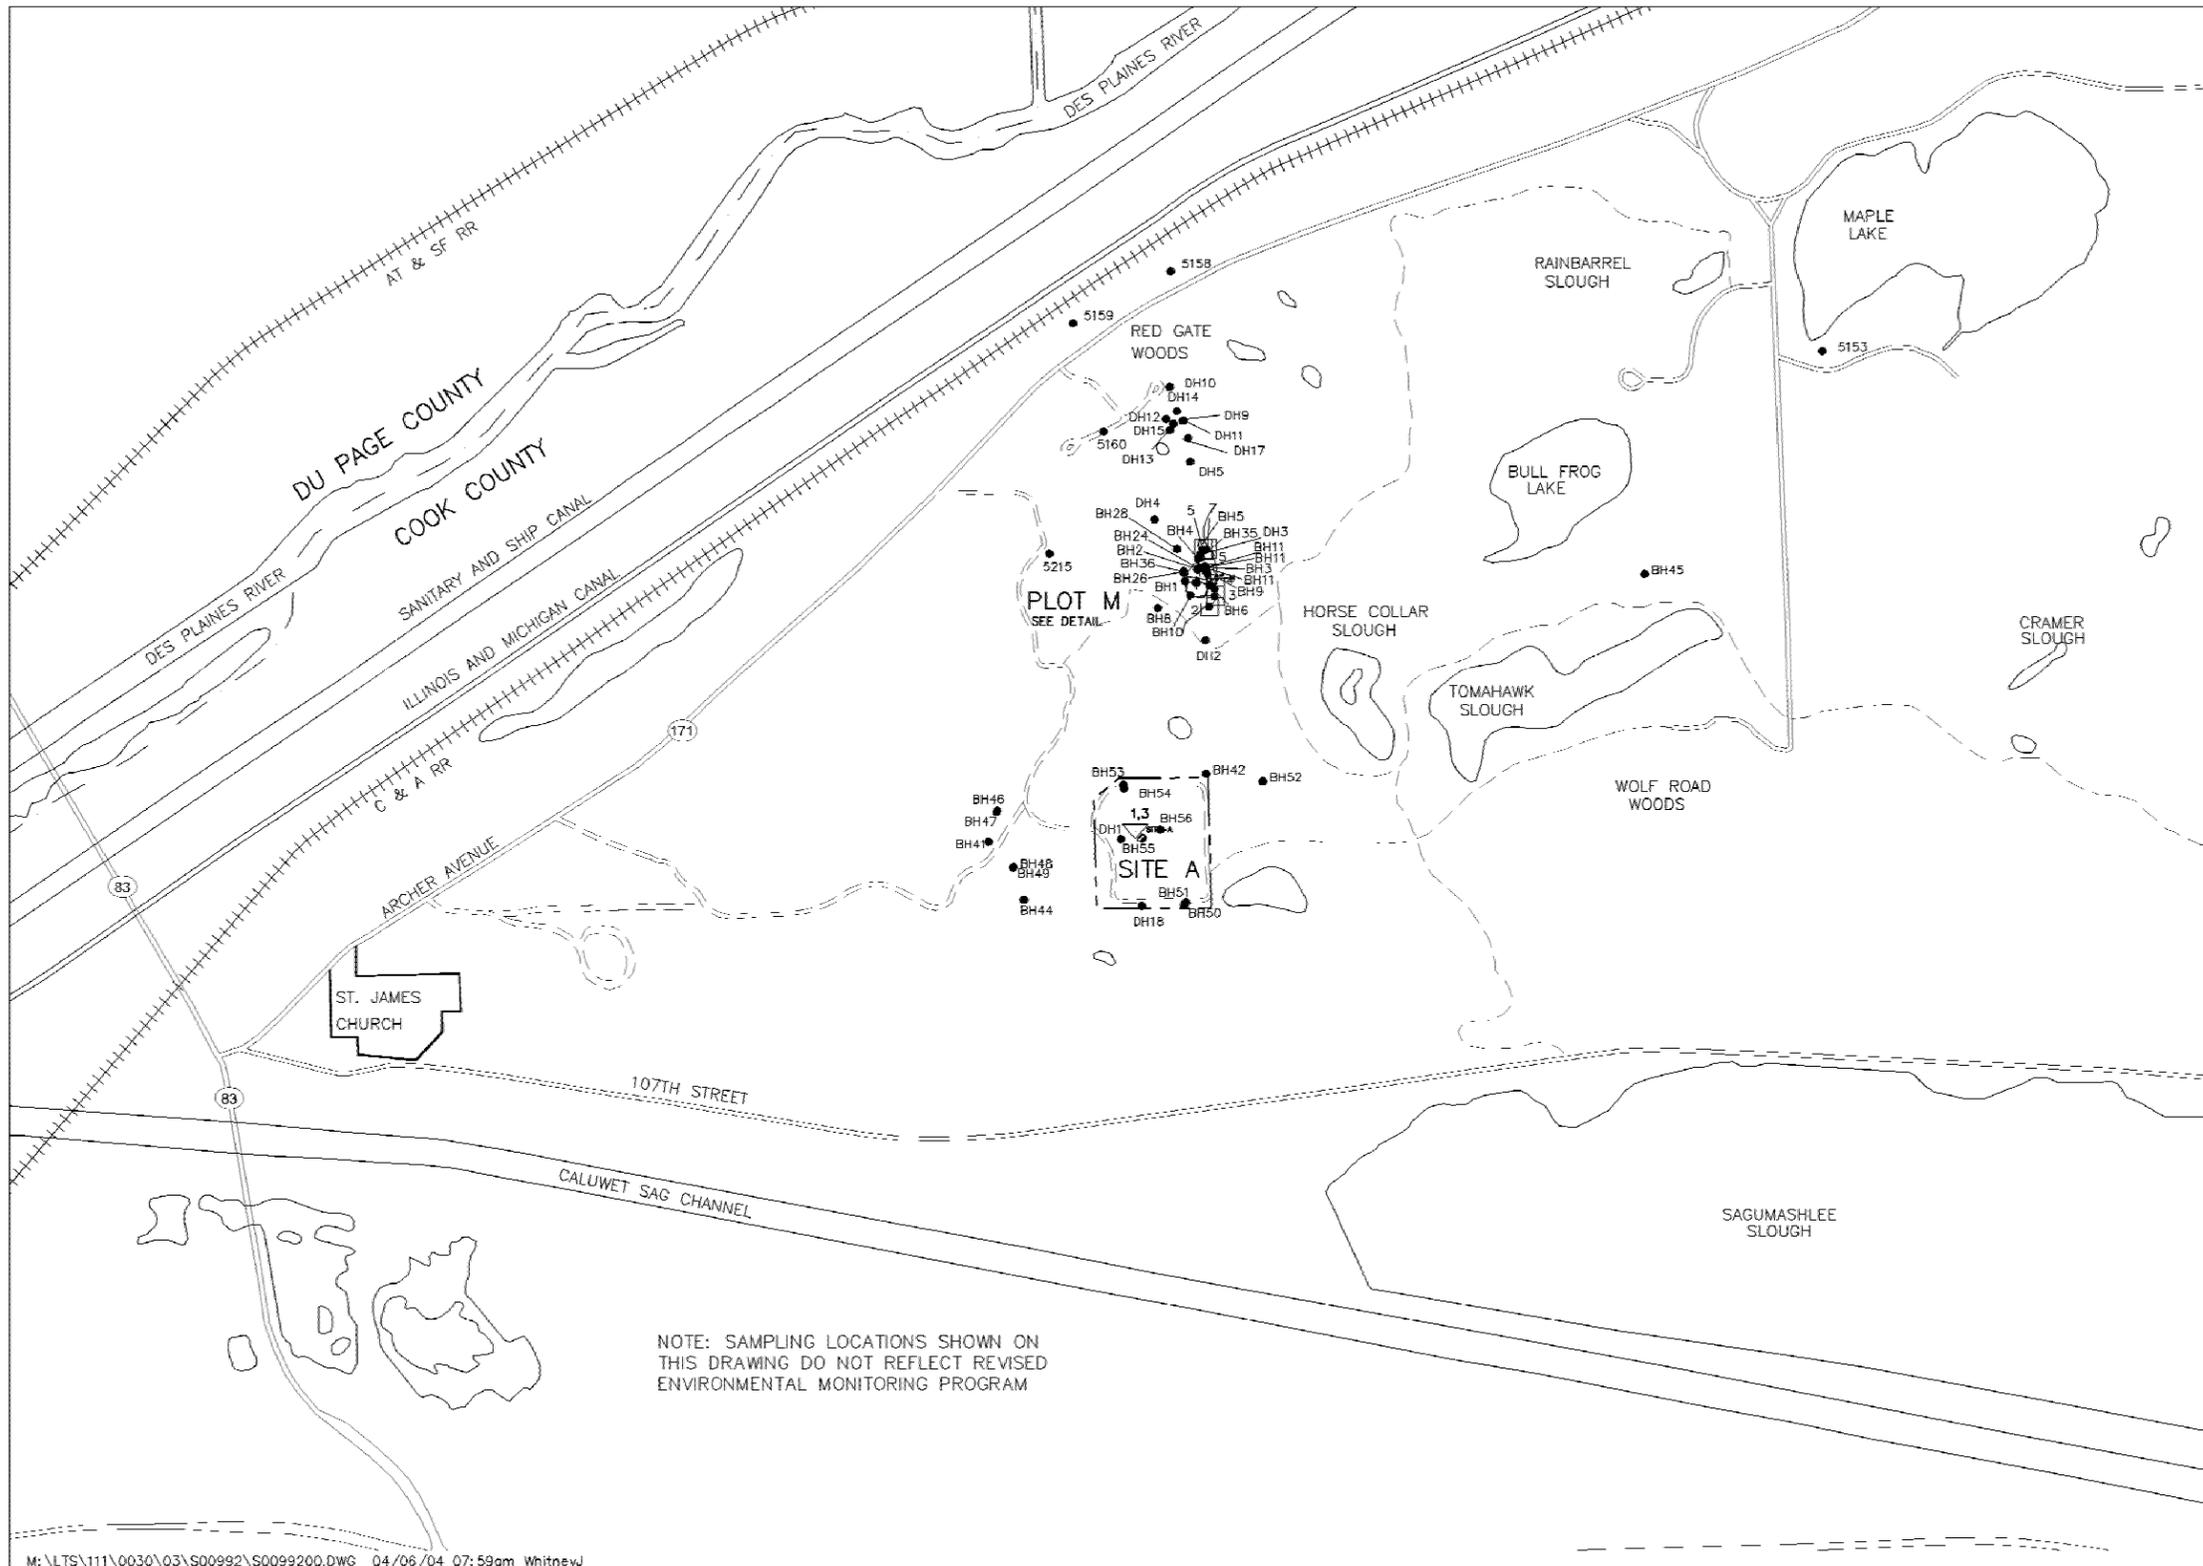
The attached drawing depicts most of the active monitoring locations for Site A/Plot M, as established with a global positioning system unit in 1999.
