2004 Annual Inspection and Radiological Survey for the Piqua Nuclear Power Facility, Piqua, Ohio, Decommissioned Reactor Site

Summary

1.0 Introduction

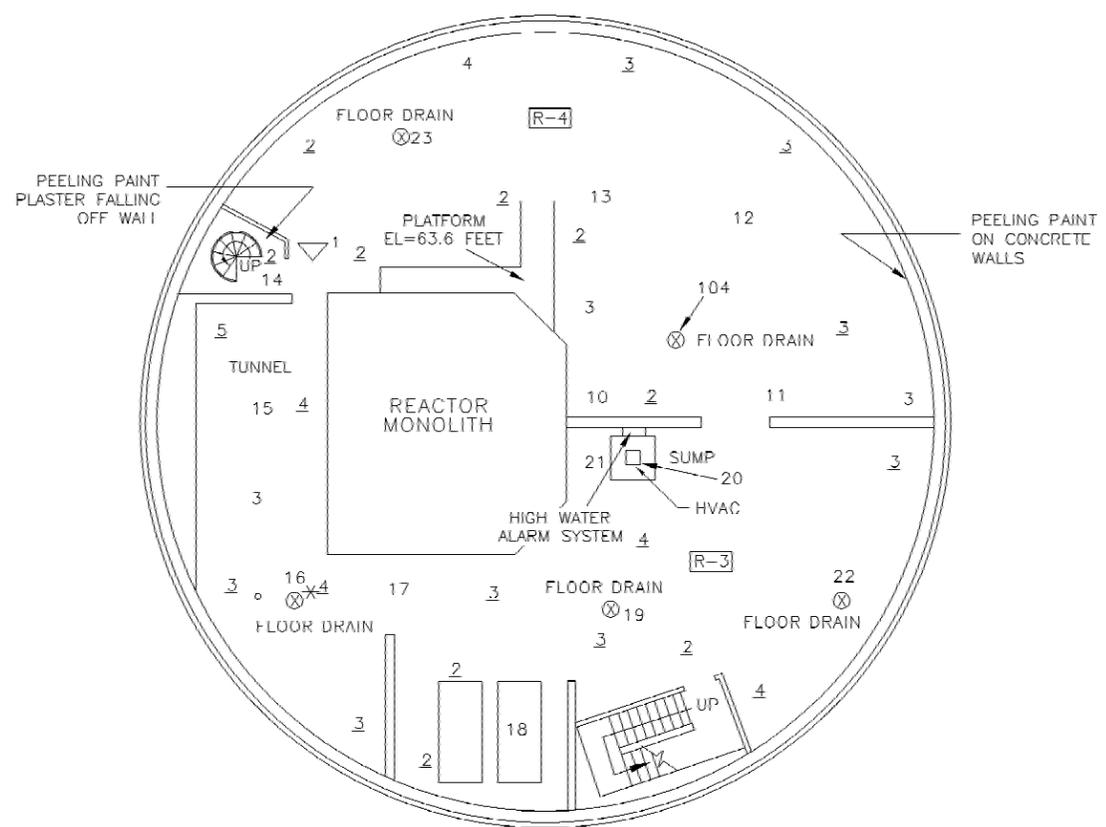
PLAN - 56 FOOT LEVEL

The reactor containment building and an associated auxiliary building are used by PPS as office, shop, and storage space. The inspectors walked around the outside of the facility to examine the exterior condition of the PNPF. The concrete decking between the auxiliary building and the reactor containment building that had significant deterioration during the 2003 inspection has been repaired. The inspectors also examined the facility interior looking for evidence of structural deterioration. Inspectors observed falling plaster and peeling paint at the bottom of the spiral staircase on the 56-foot level of the containment building (PL-1) as well as on the 79-foot

level wall of the auxiliary building (PL-2), which might be evidence of water damage. This damage has been noted on prior inspections and the condition remains unchanged. Peeling paint was observed on most areas of the interior dome walls; this condition also has been noted on prior inspections and the condition remains unchanged. During the 2003 inspection it was noted that on the 111-foot elevation of the reactor containment building insulation had fallen off piping components and could be potentially friable asbestos. PPS removed the existing plenum structure and piping insulation and converted the area to a storage location with shelving and a new stairwell for access. No evidence of activities that might affect the integrity of the PNPf was observed either on site or off site in the immediate surrounding area. No follow-up inspection is required.

[Table 2](#) presents direct surface and removable activity results. No removable contamination was found at any of the 111 sampling points. Direct surface reading results indicate the floor drain at the lowest level of the containment building exhibited a direct beta reading of 2,740 disintegrations per minute per 100 square centimeters, the smear from this location indicated that no removable activity is present. This result is consistent with previous surveys. All other readings were below the minimum detectable activity (MDA) level.

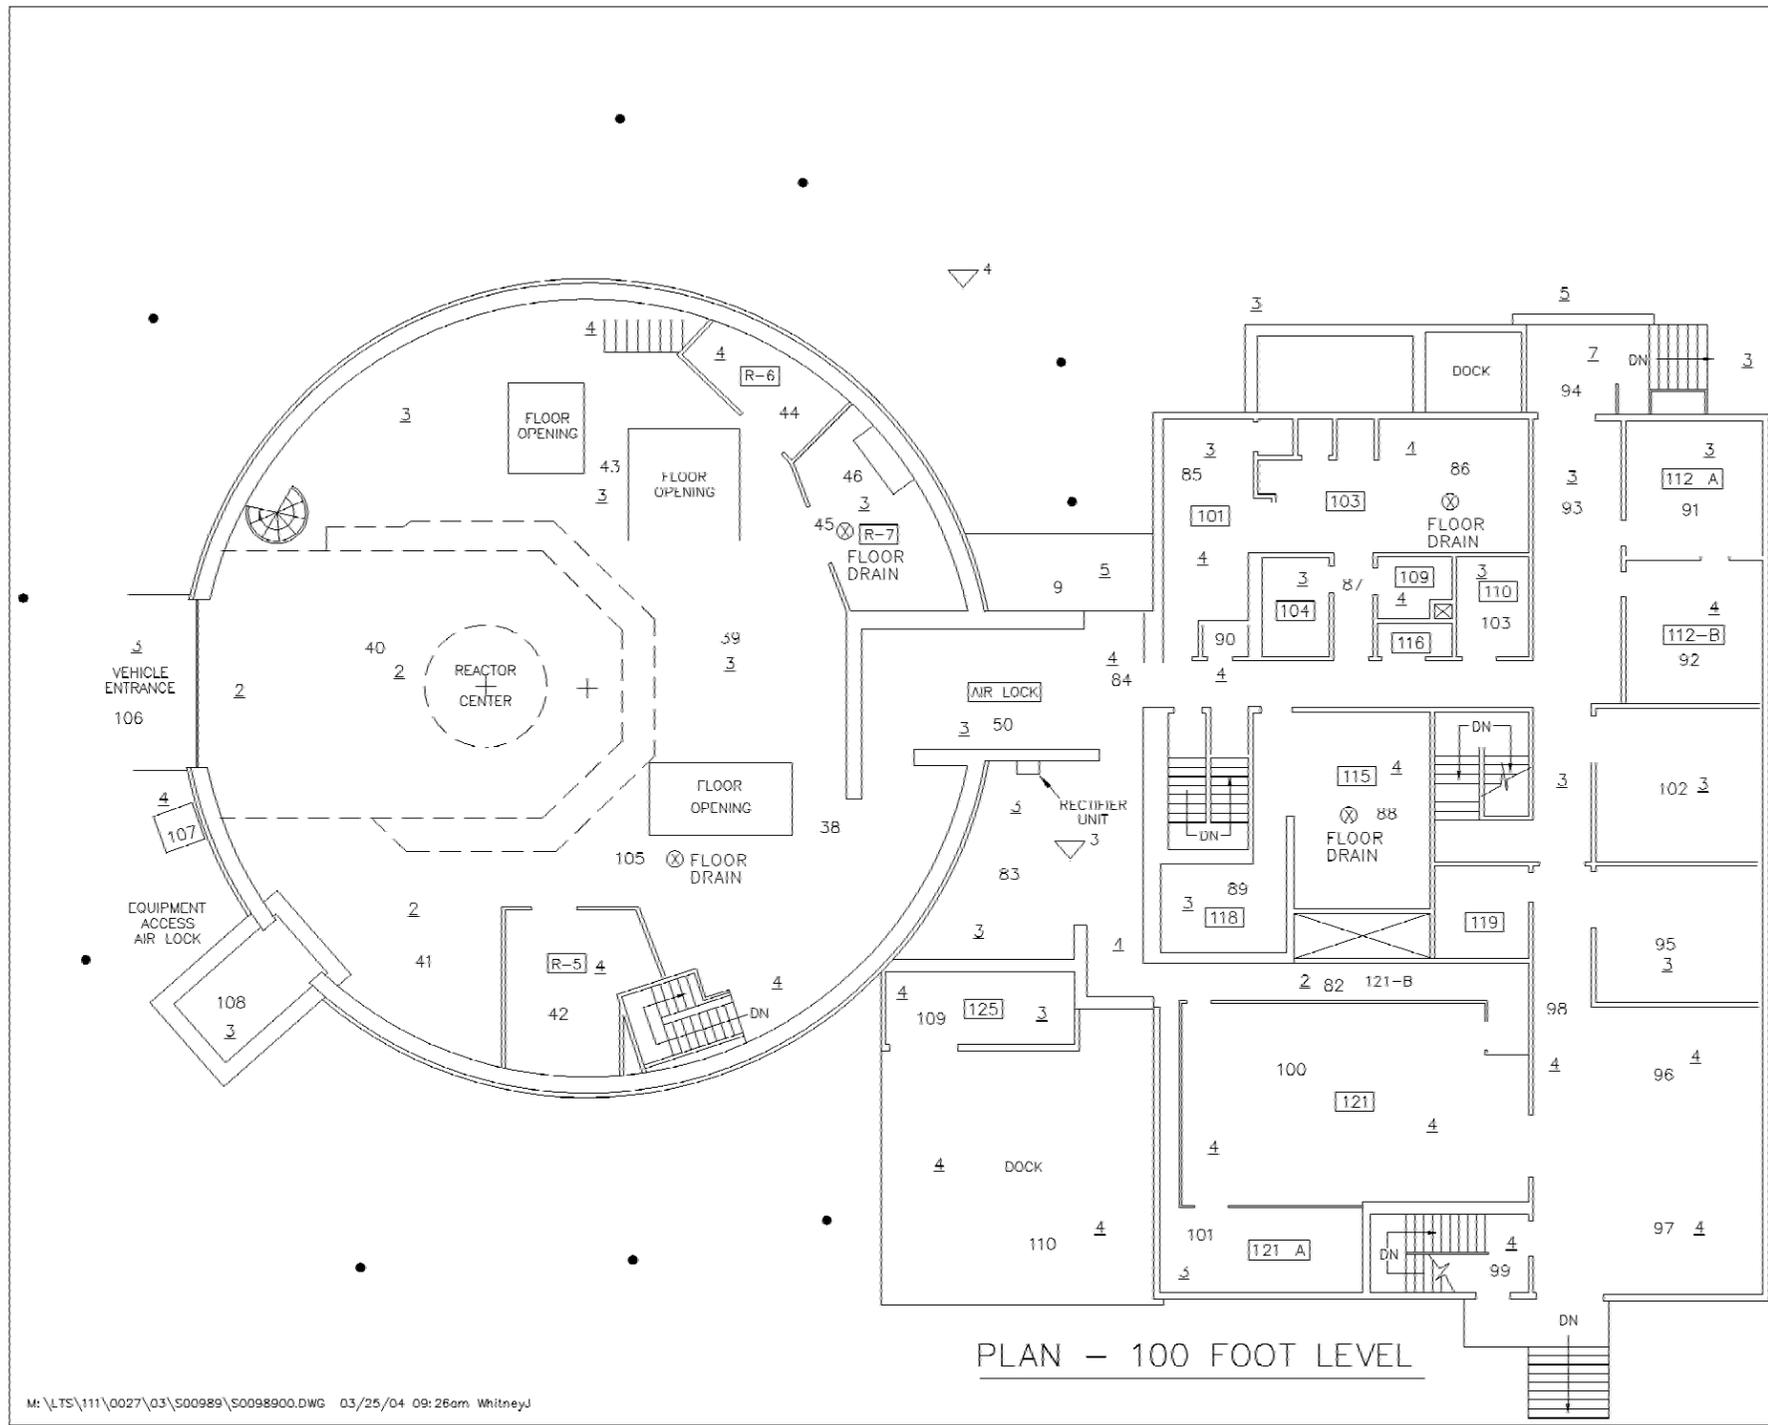
PLAN - 100 FOOT LEVEL

The system consists of 10 carbon (graphite) electrodes, buried radially approximately 10 to 20 feet from the building foundation, and a rectifier unit (PL-3) for providing DC current. The rectifier unit is mounted in the break room south of and outside the airlock on the 100-foot level. Each carbon electrode is 3 inches in diameter and 60 inches long. The electrodes are connected to the rectifier unit by a header cable; splices are protected in flush-mounted boxes (PL-4). A structure contact point for monitoring potential can be found on the shell associated with each electrode; some of the contact points also have cables remaining from an abandoned zinc anode protection system. The system also includes reference electrodes and test holes.

Inspectors found that output from the rectifier unit was recorded monthly. Mr. Sommer had received notification that the system was due for inspection and he intended to request budget for that purpose the following year. DOE will request a copy of the inspection results.

Recommendation: Mr. Sommer (PPS Director) had received notification that the system is due for inspection and he intends to request budget for that purpose. DOE will request a copy of the inspection results.
