4.0 Durango, Colorado, Disposal Site

4.1 Compliance Summary

The site, located southwest of Durango, Colorado, was inspected on June 17, 2003. Results of the inspection are described below. Features and photograph locations (PLs) discussed in this report are shown on Figure 4–1. Numbers in the left margin of this report refer to items summarized in the Executive Summary table.

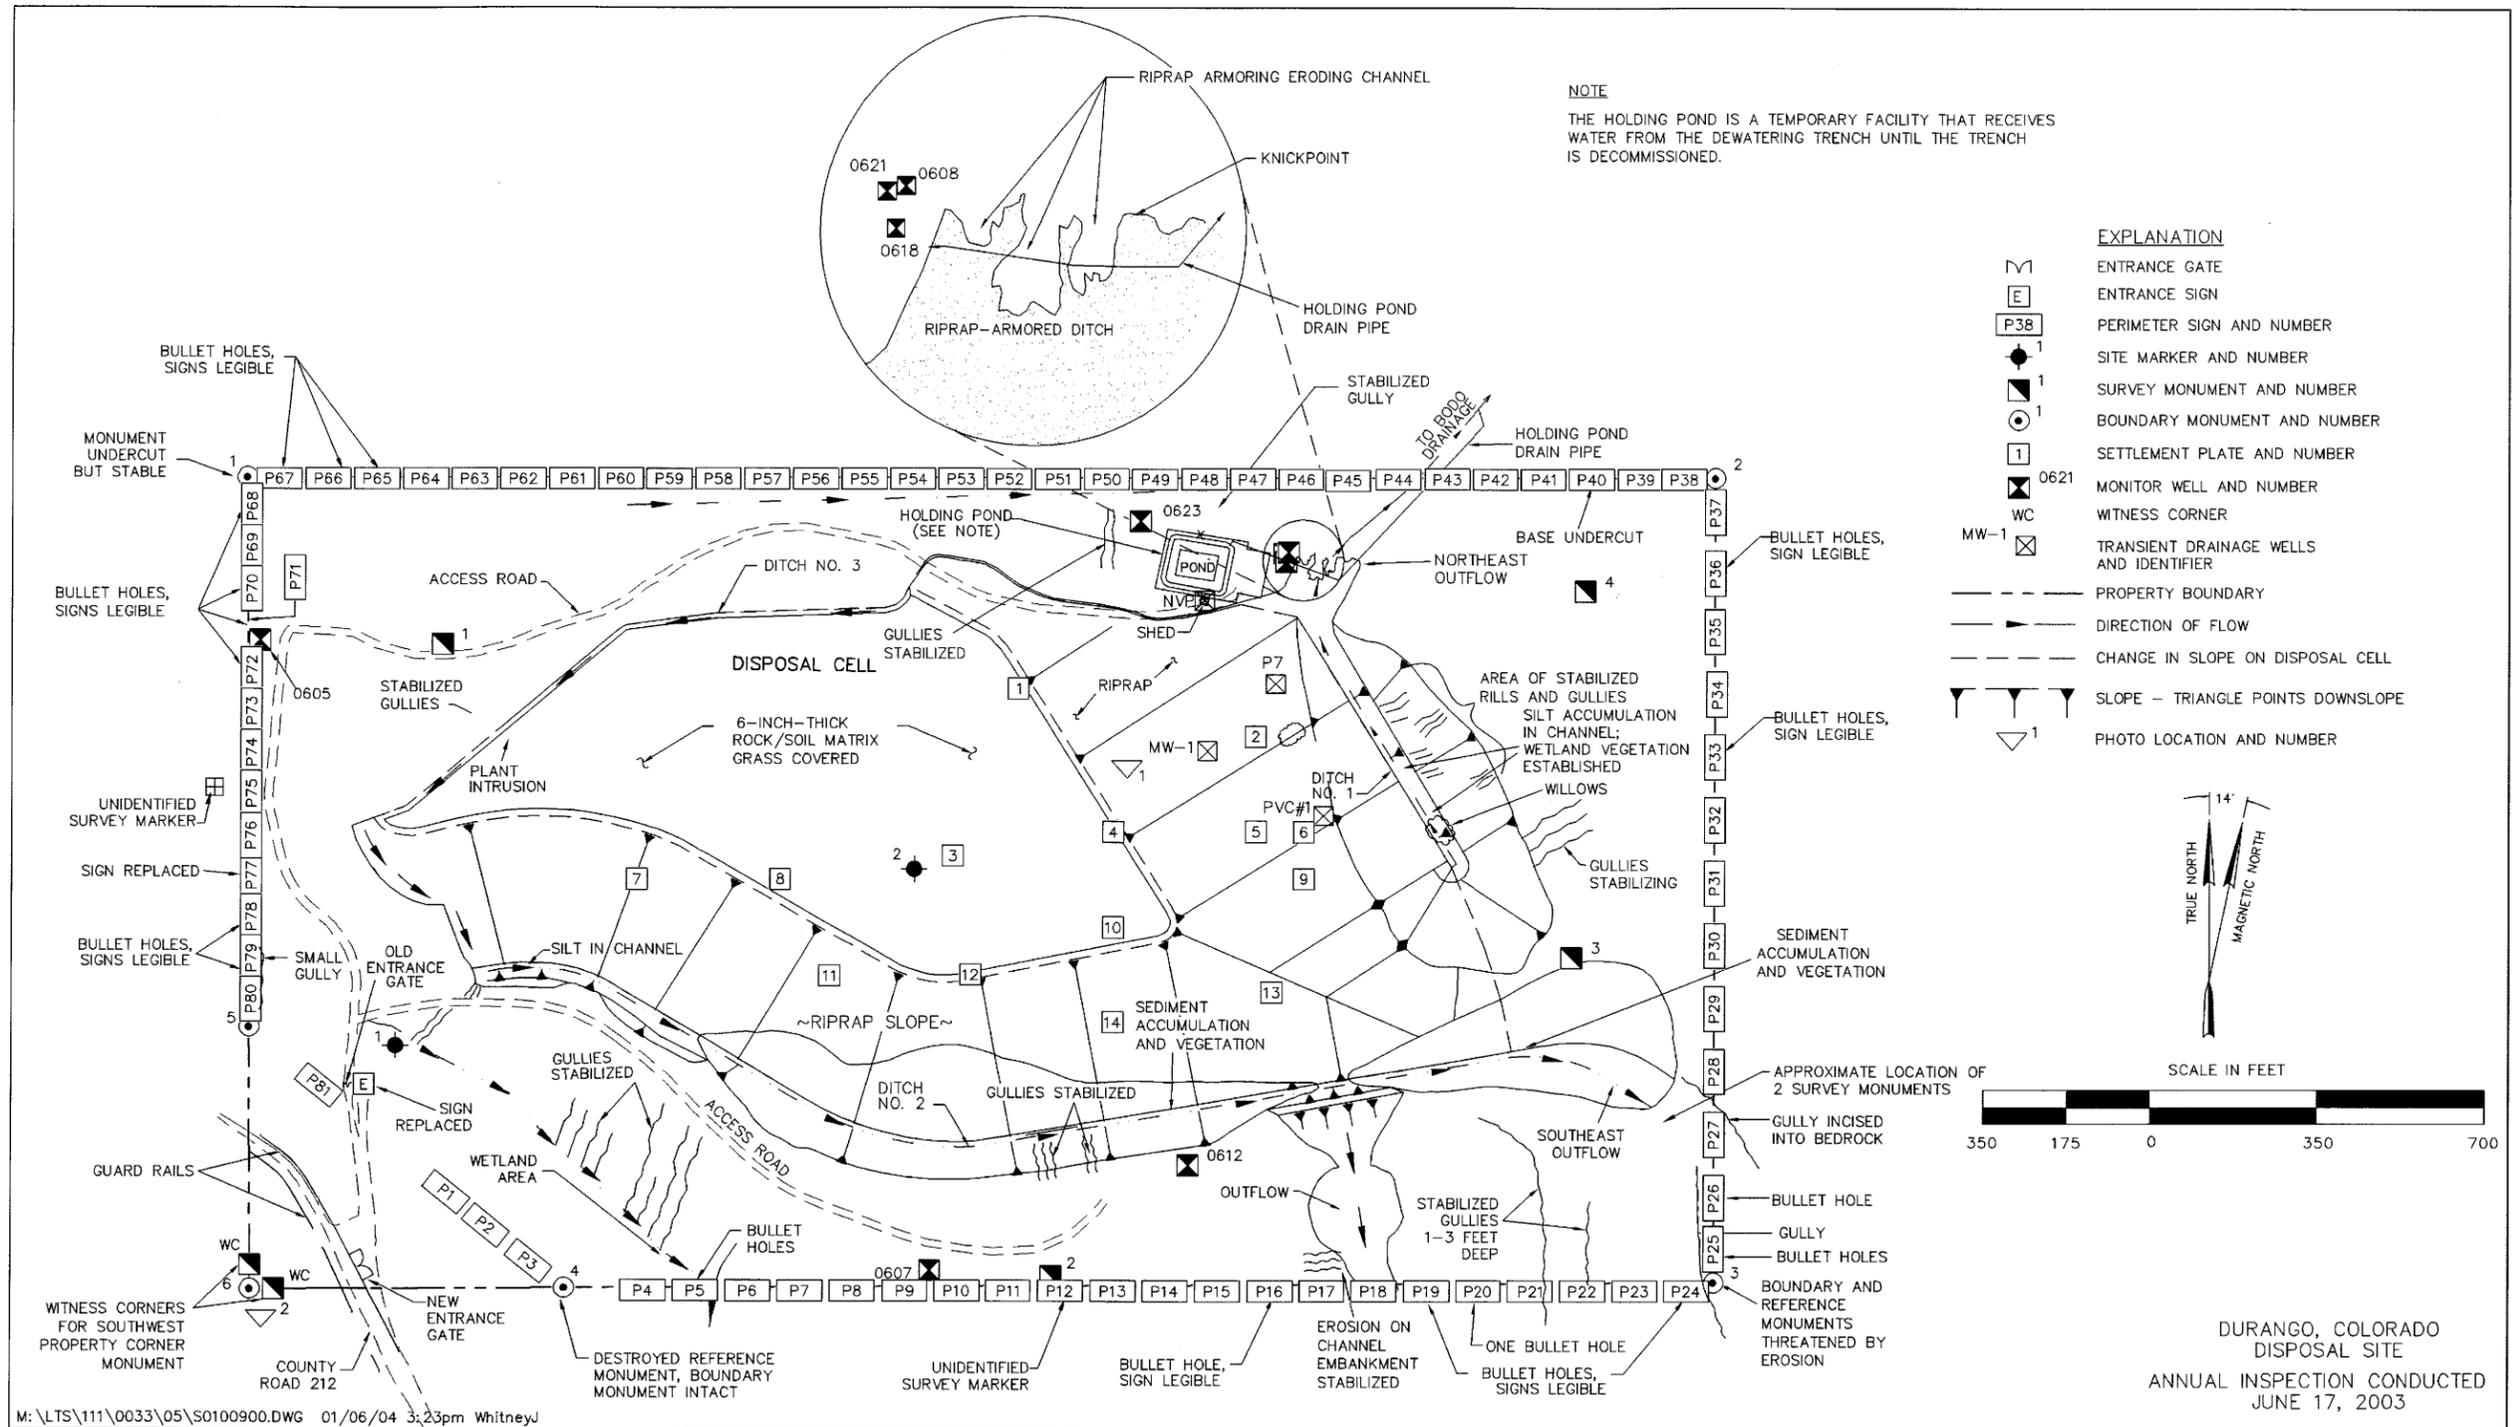
Figure 4-1. 2003 Annual Compliance Drawing for the Durango, Colorado, Disposal Site

Top of Disposal Cell—The top of the disposal cell was in excellent condition. No evidence of settling, slumping, or erosion was observed.

Vegetation on top of the cell was in good condition and had recovered from the stresses caused by the 2002 drought. The vegetation consisted of seeded grasses and several volunteer species including deep-rooted shrubs. Woody species of trees and shrubs found during the 2002 inspection subsequently were cut and treated with herbicide, and none were found during the 2003 inspection. A few plants of two noxious weed species, musk thistle and houndstongue, were found on top of the cell during the 2003 inspection. The musk thistle was cut and treated with herbicide, and the houndstongue was treated later in the month by a certified applicator.
