12.0 Mexican Hat, Utah, Disposal Site

12.1 Compliance Summary

Figure 12-1. 2003 Annual Compliance Drawing for the Mexican Hat, Utah, Disposal Site

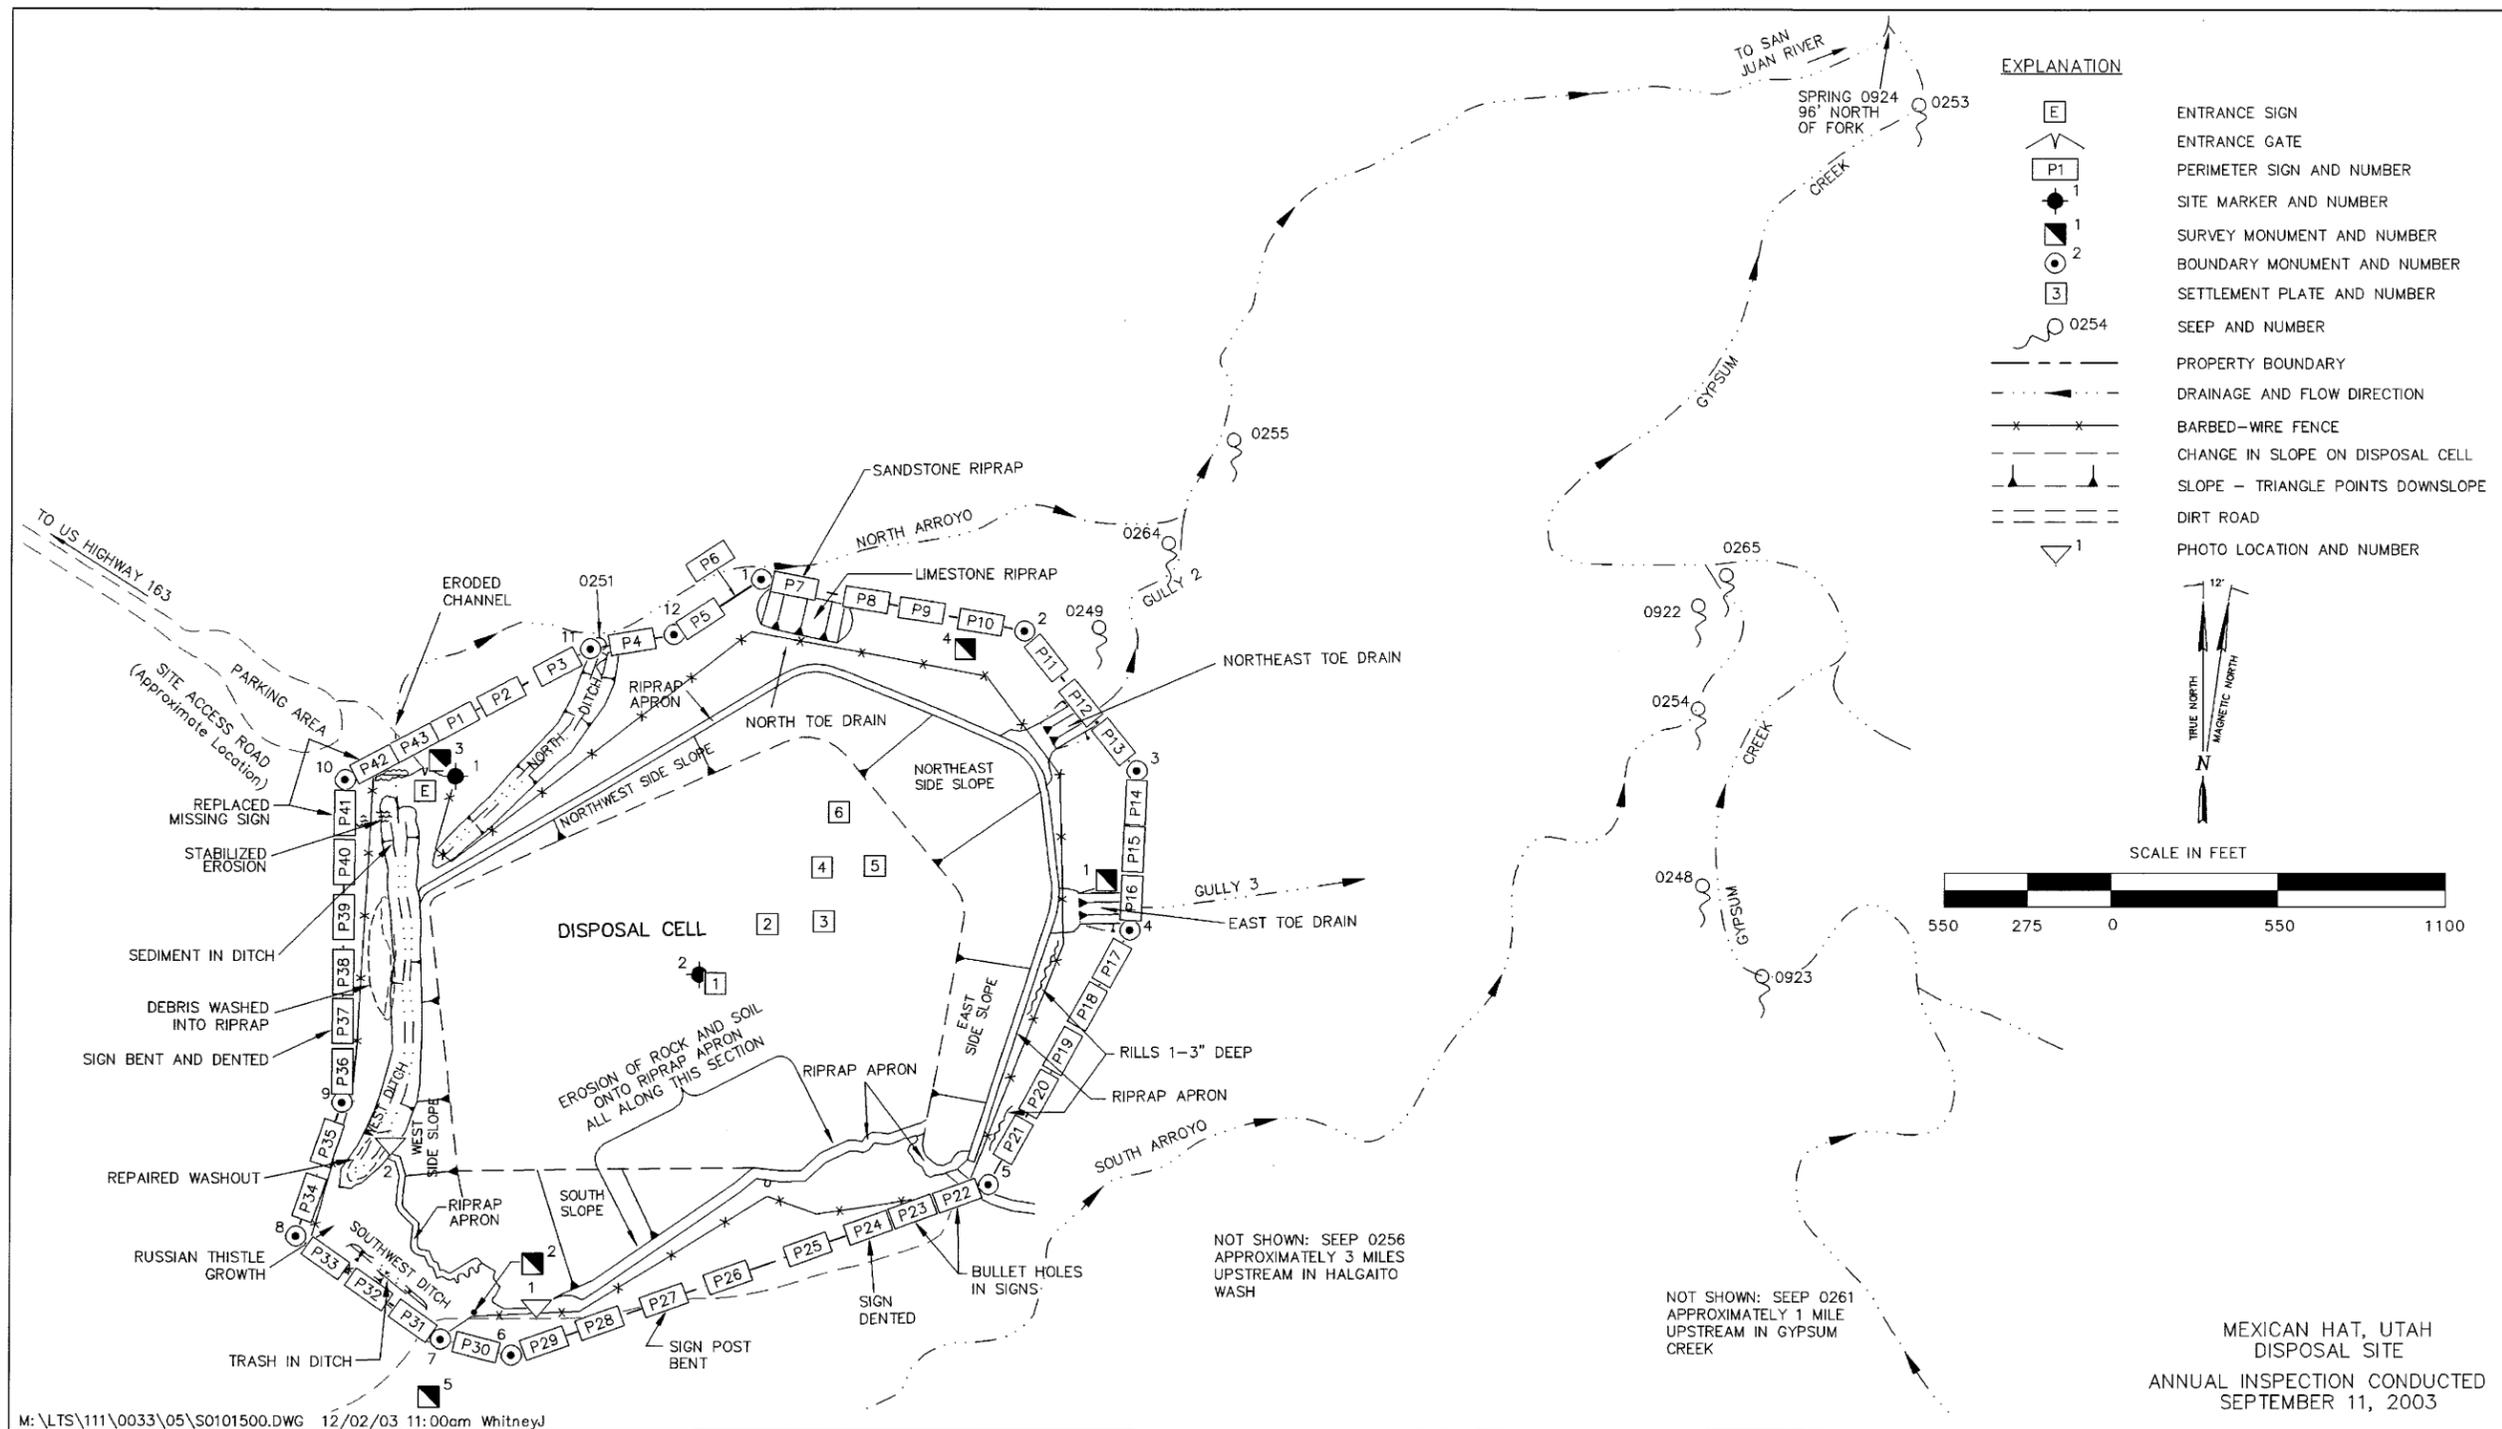
12A There are 43 perimeter sign locations and each location has a pair of signs: an upper property ownership sign and a lower radioactive materials disposal site warning sign. The lower sign was missing at locations P41 and P42 but the signs were found nearby and replaced. Some perimeter signs have bullet holes but all signs are legible. Perimeter sign P4, noted as unstable during the 2002 inspection, had been stabilized and was in good condition.

12B Rock was placed around boundary monument BM-11 and grading was performed to divert runoff around the monument to protect it from damage by erosion.

The sloughing of red country rock and soil along the south apron did not increase significantly during the past year; the accumulation remains approximately 18- to 24-inches high against the base of the adjacent hill slope (PL-1). As in previous years, inspectors did not find evidence of channel erosion in this area, and the sloughed material does not appear to have filled the void spaces in the riprap beyond the toe of the hill slope. A photograph will be taken for the record annually until conditions stabilize.

12C Substantial erosional damage to the upper section of the West Ditch caused by a severe storm in 2002 was repaired following a geotechnical evaluation of the damage. Another severe storm totaling 1.25 inches of rainfall in the town of Mexican Hat occurred on September 9, 2003. The repaired washout area of the West Ditch was intact (PL-2), and no evidence of erosion, settling, or slumping was observed on the side slopes or in the diversion ditches. Some sediment and weeds were present in the lower end of West Ditch but do not affect the performance of the diversion ditch.

Area Between the Disposal Cell and the Site Boundary—Minor rills were present upstream of West Ditch and along the east side slope. Trash (primarily cans and bottles) had washed onto the site in the vicinity of West Ditch. Hill slopes around the disposal cell remain stable with only minor accumulations of loose material at the toe of the slopes.

All damages resulting from the 2002 storm were repaired prior to the 2003 inspection. Two missing perimeter signs were replaced during the 2003 inspection.
