3.0 Sherwood

Sherwood Site Long-Term Custody Compliance Requirements

Sherwood Site Inspection Results

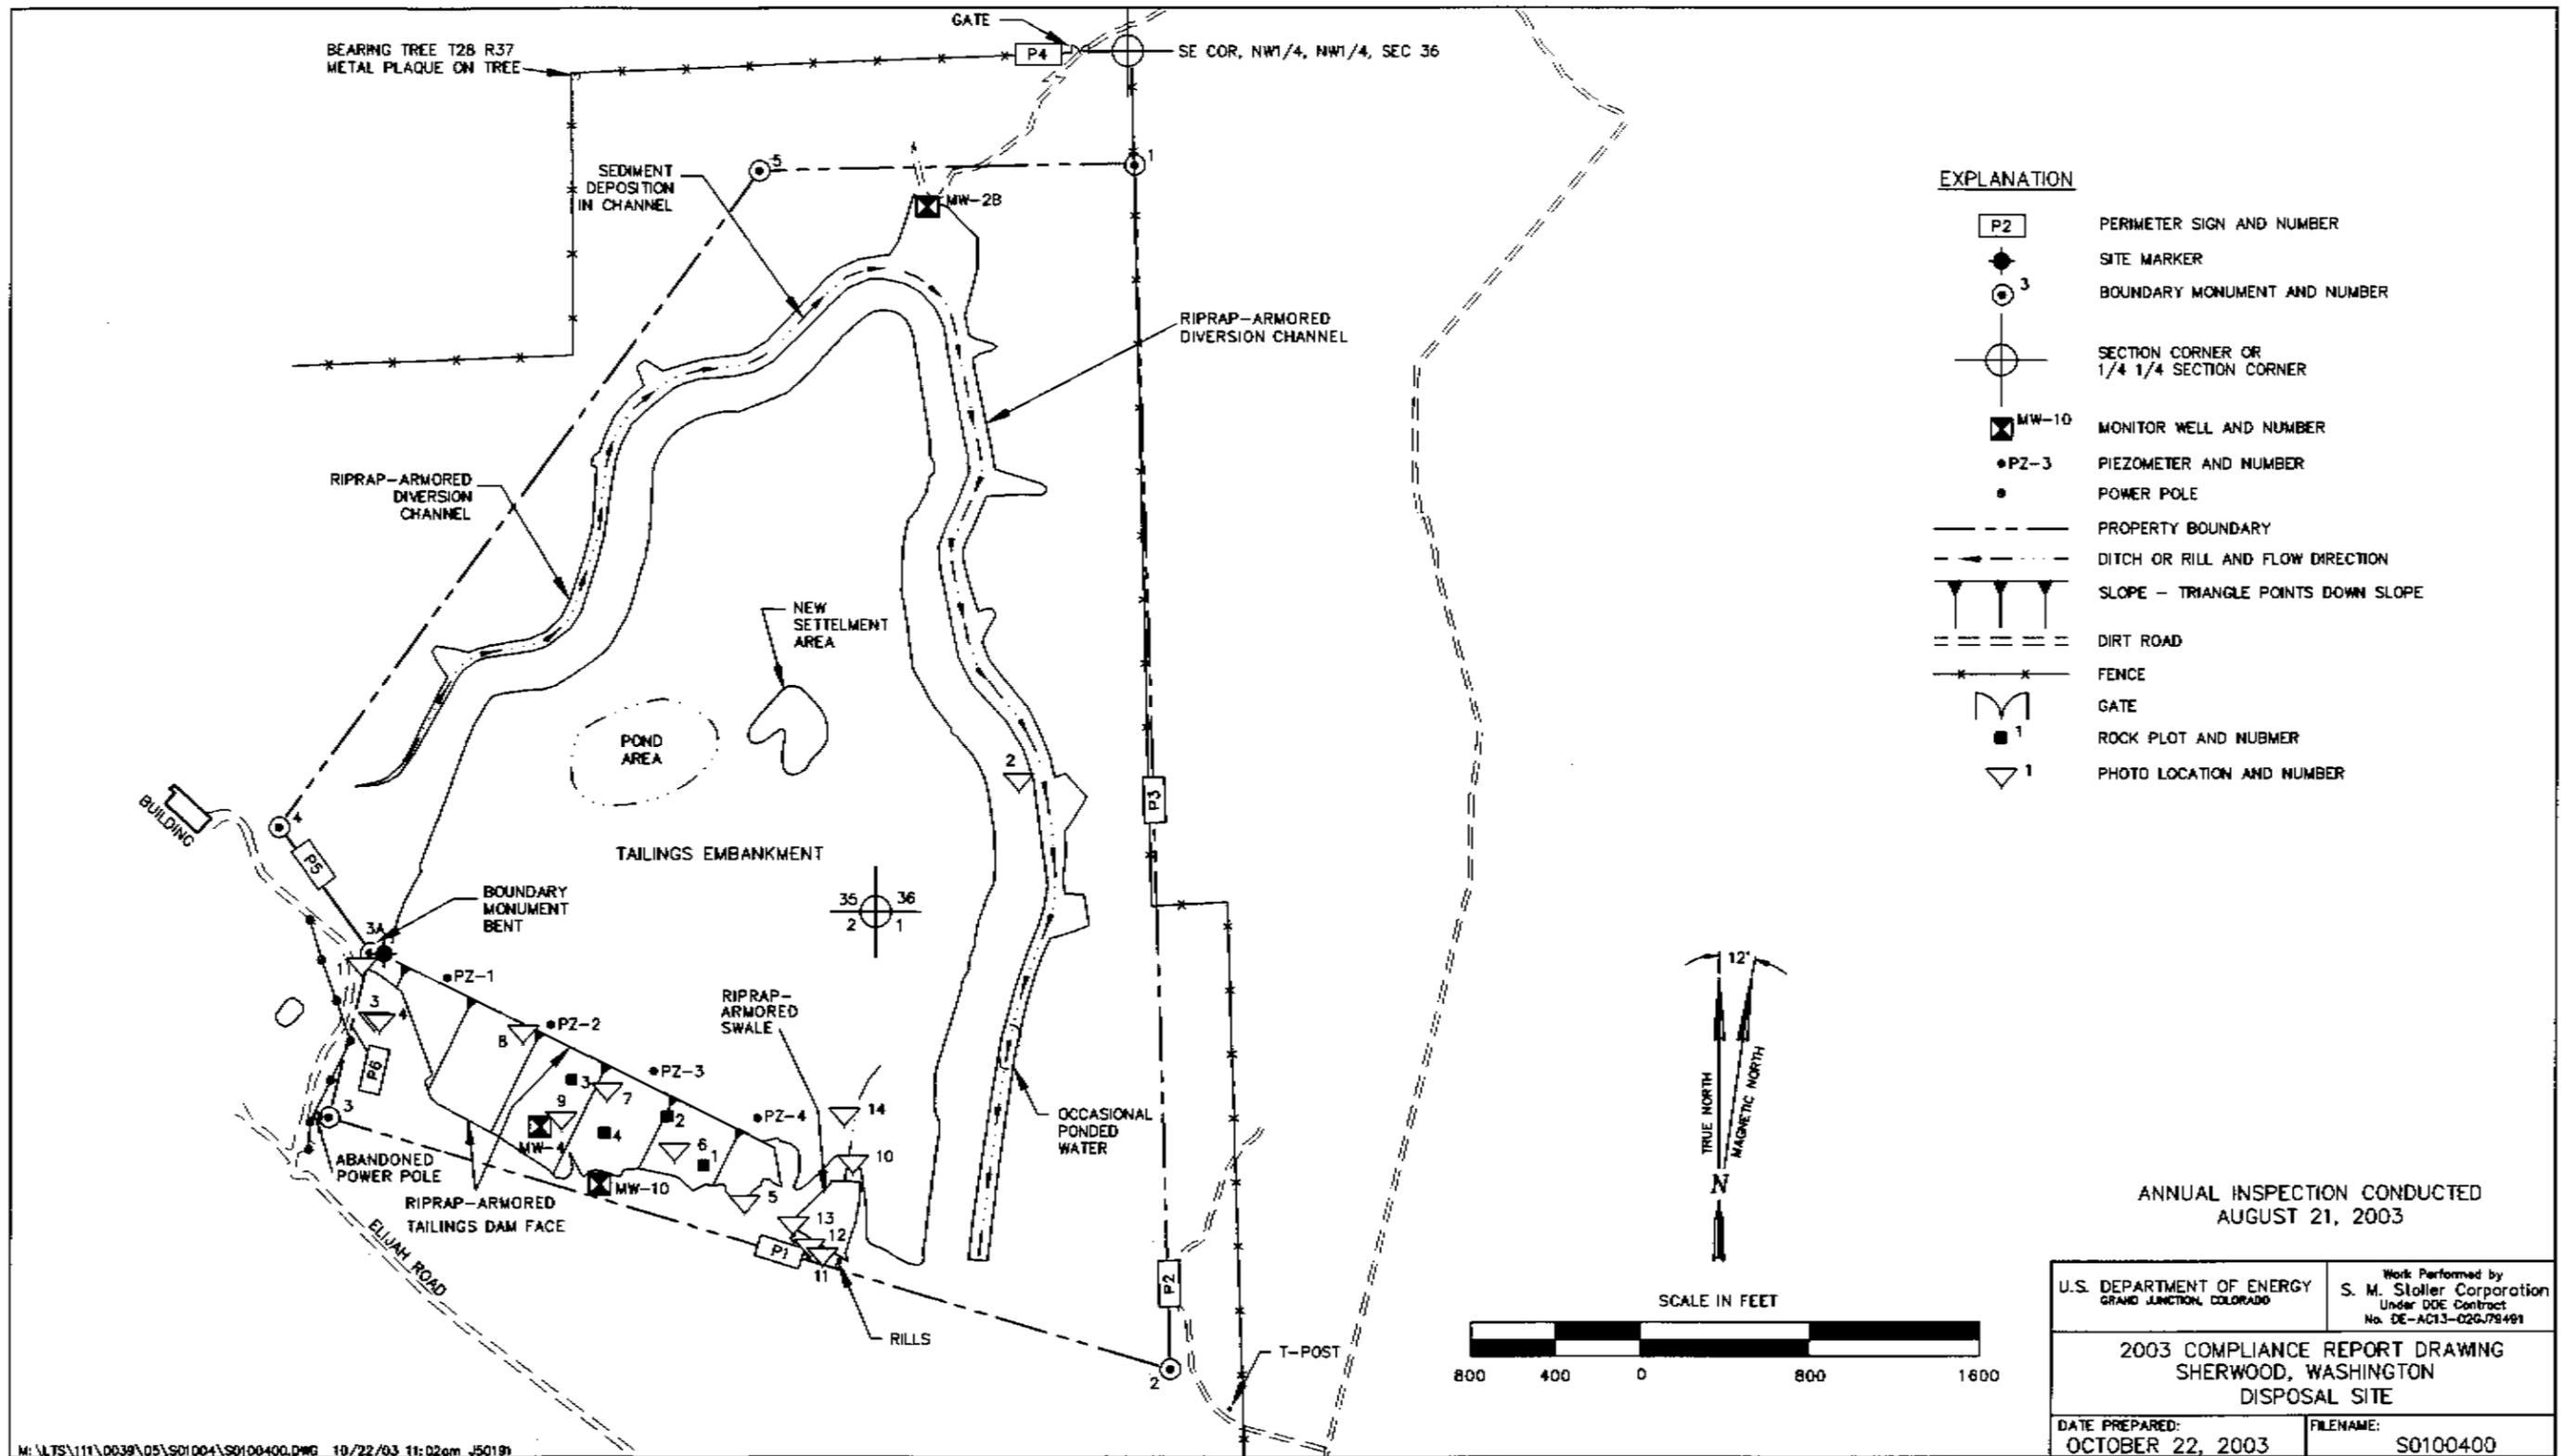
Figure 3-1. Sherwood, Washington, 2003

Designers of the cell predicted that up to 10 feet of settlement could occur on the cover. Settlement has occurred over an approximate 7-acre area that has been referred to as the "pond area" and is shown on Figure 3-1. The pond area contained about 0.5 acre of standing water at the time of the inspection. The pond area was dry during the 2002 inspection. The plant species present indicate that there is year-round moisture below the surface. Vegetation in the pond area is composed primarily of native wetland species such as hardstem bulrush (*Scirpus acutus*), Olney threesquare (*Scirpus americanus*), common spikerush (*Elyocharis palustris*), sandbar willow (*Salix exigua*), and plantain (*Plantago eriopoda*). The pond provides habitat for small mammals, birds, and reptiles and appears to be a water source for larger mammals such as deer and elk, whose sign was abundant in this area.

Inspectors noted an additional settlement area east of the existing pond area (PL-2). This low-lying area, 3 to 5 acres in size, contains riparian vegetation and shows indications of having saturated soils during certain times of the year. There was no water in this settled area at the time of the inspection.

Inspectors walked the length of the diversion channel. Volunteer plant intrusion within the diversion channel is evident in most areas of the channel; however, because the channel is oversized, this intrusion is not expected to interfere with the channel's design function. Rock condition is good and is the same as observed during earlier inspections. Sediment deposition is evident in places on the west side of the diversion channel, but currently does not interfere with the channel's design function. The degree of sediment deposition should be noted during future inspections although it is not expected to increase to the degree that it could become a maintenance issue. At times, standing water has been observed in the channel along the east side of the impoundment (see Figure 3-1); this area was dry during the 2003 inspection.
