# 2003 Annual Site Inspection and Monitoring Report for Uranium Mill Tailings Radiation Control Act Title I Disposal Sites

January 2004

Work Performed by S.M. Stoller Corporation under DOE Contract No. DE-AC01-02GJ79491  
for the U.S. Department of Energy, Grand Junction, Colorado

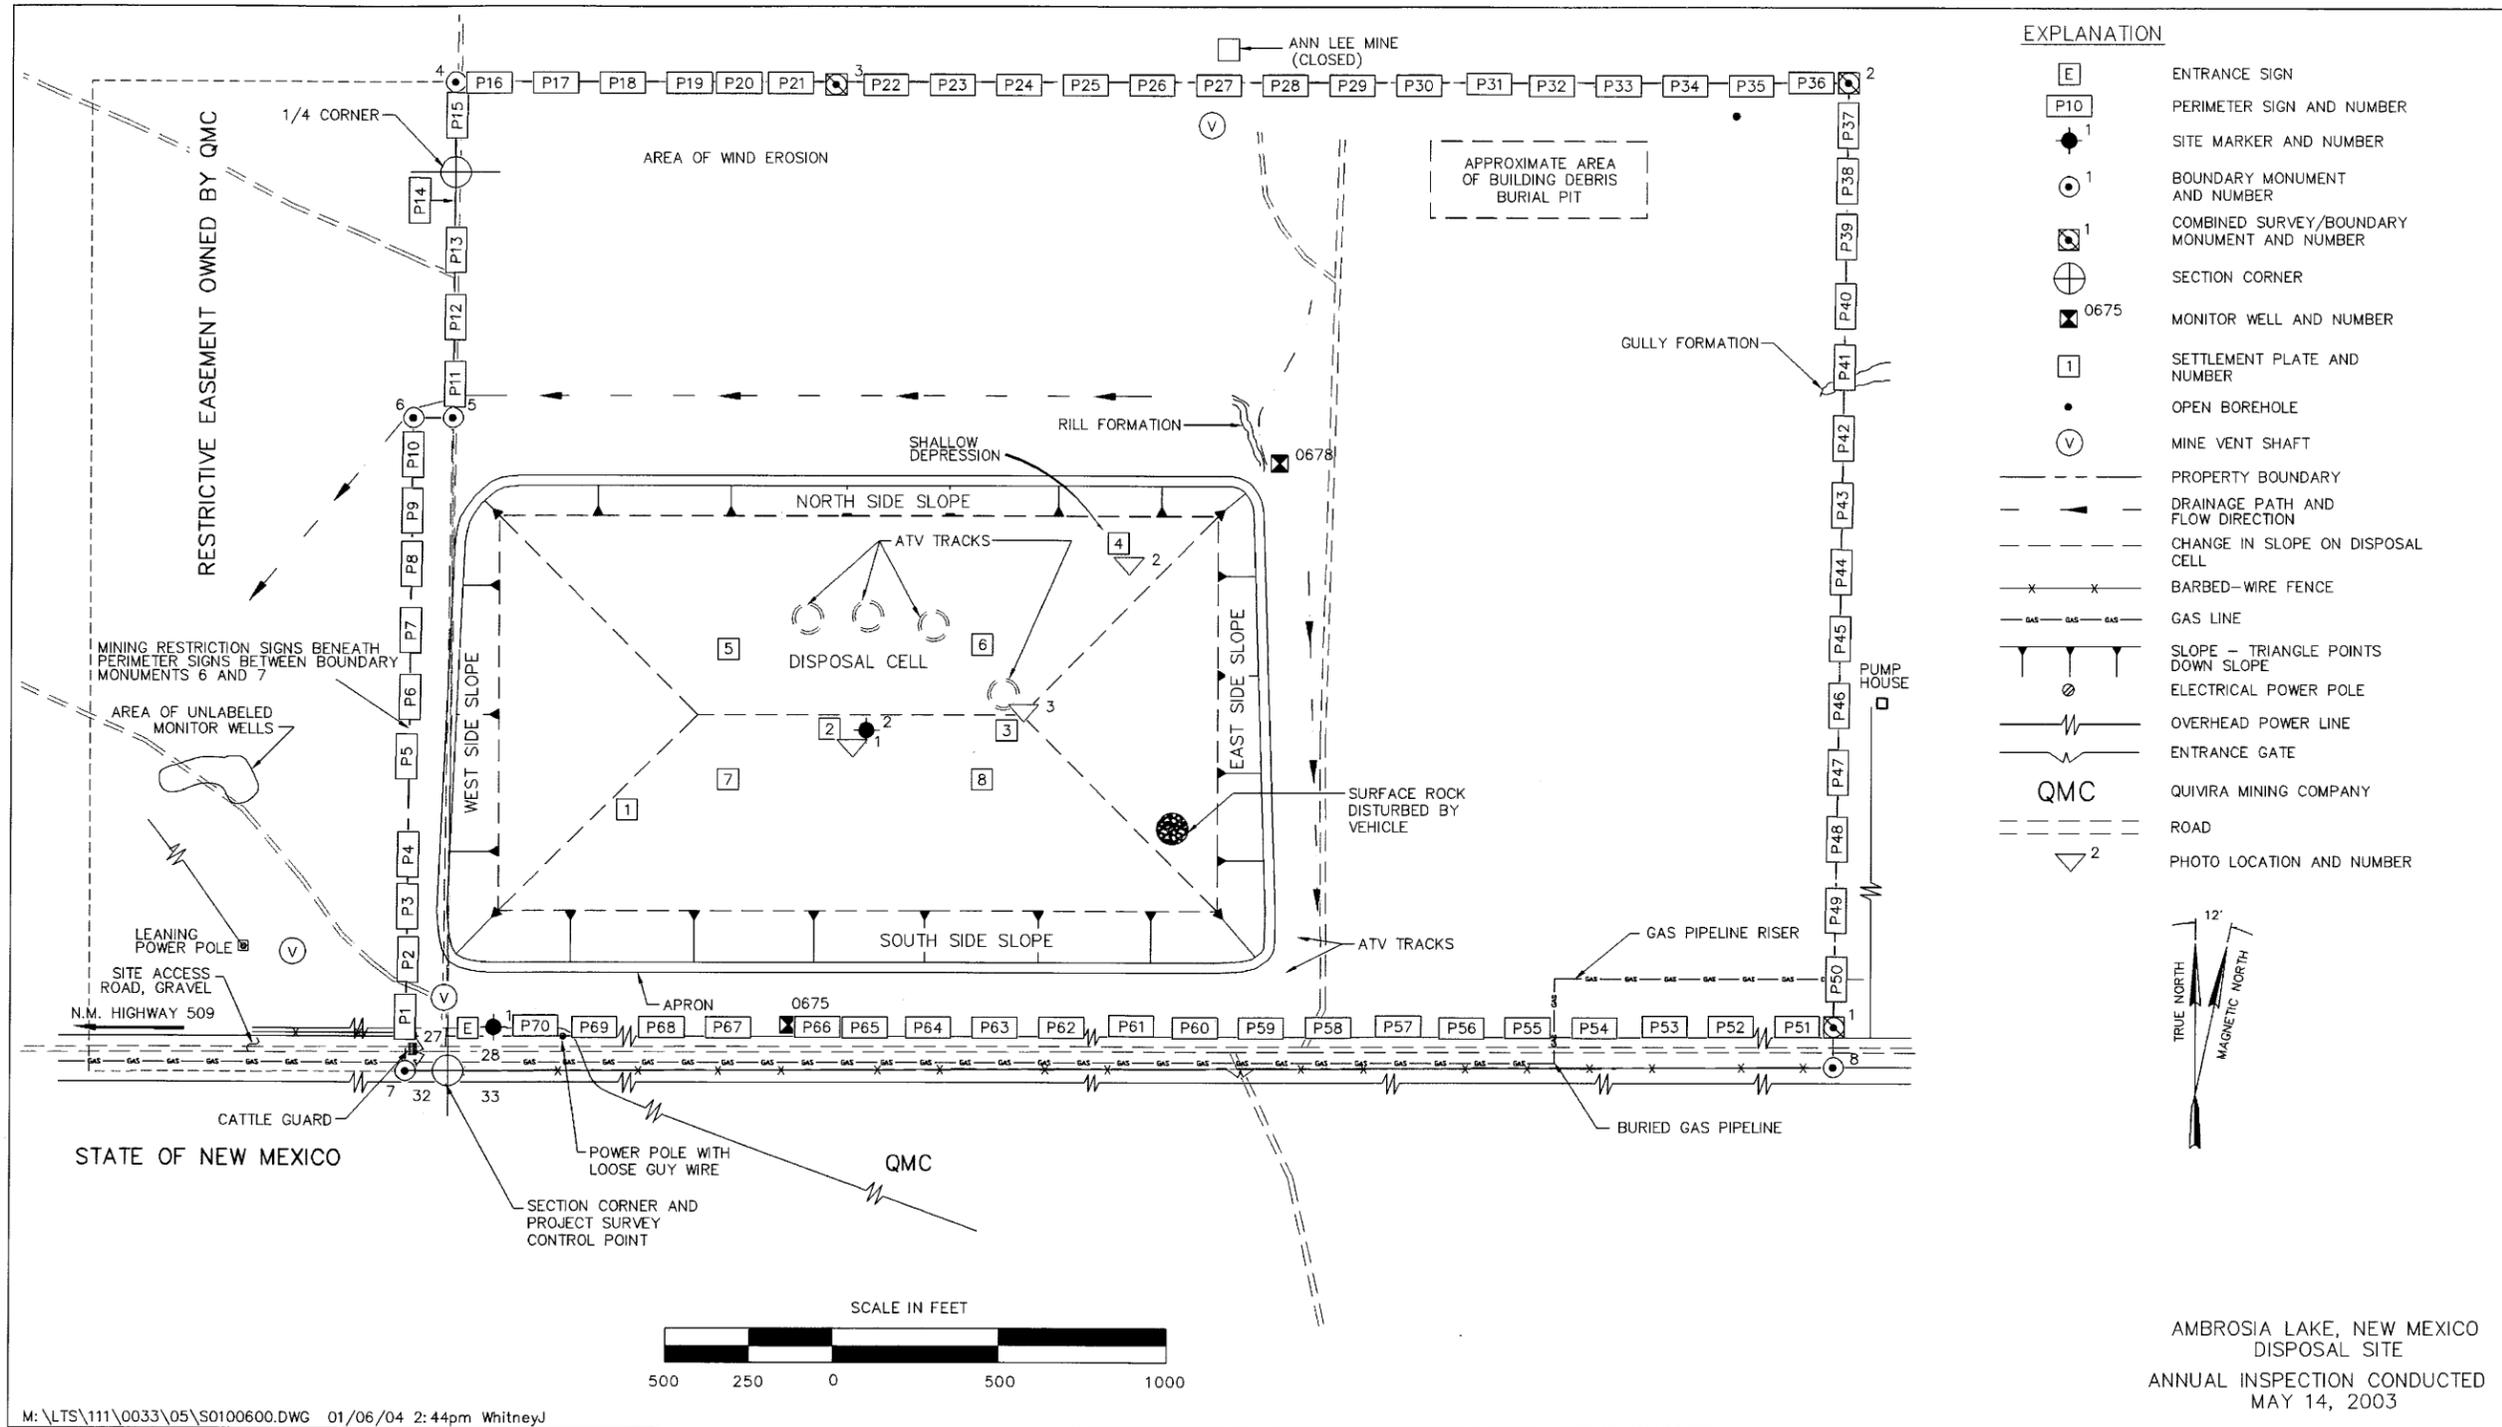
Figure 1-1. 2003 Annual Compliance Drawing for the Ambrosia Lake, New Mexico, Disposal Site

Trespassing was evident on top of the disposal cell. An all-terrain vehicle (ATV) had been driven to the top of the cell and used to mark four circles with diameters between 40 and 60 feet (PL-3). Another area of surface disturbance was noted near the southeast corner of the cell top. The tracks were very shallow and do not impair the integrity or performance of the cover.

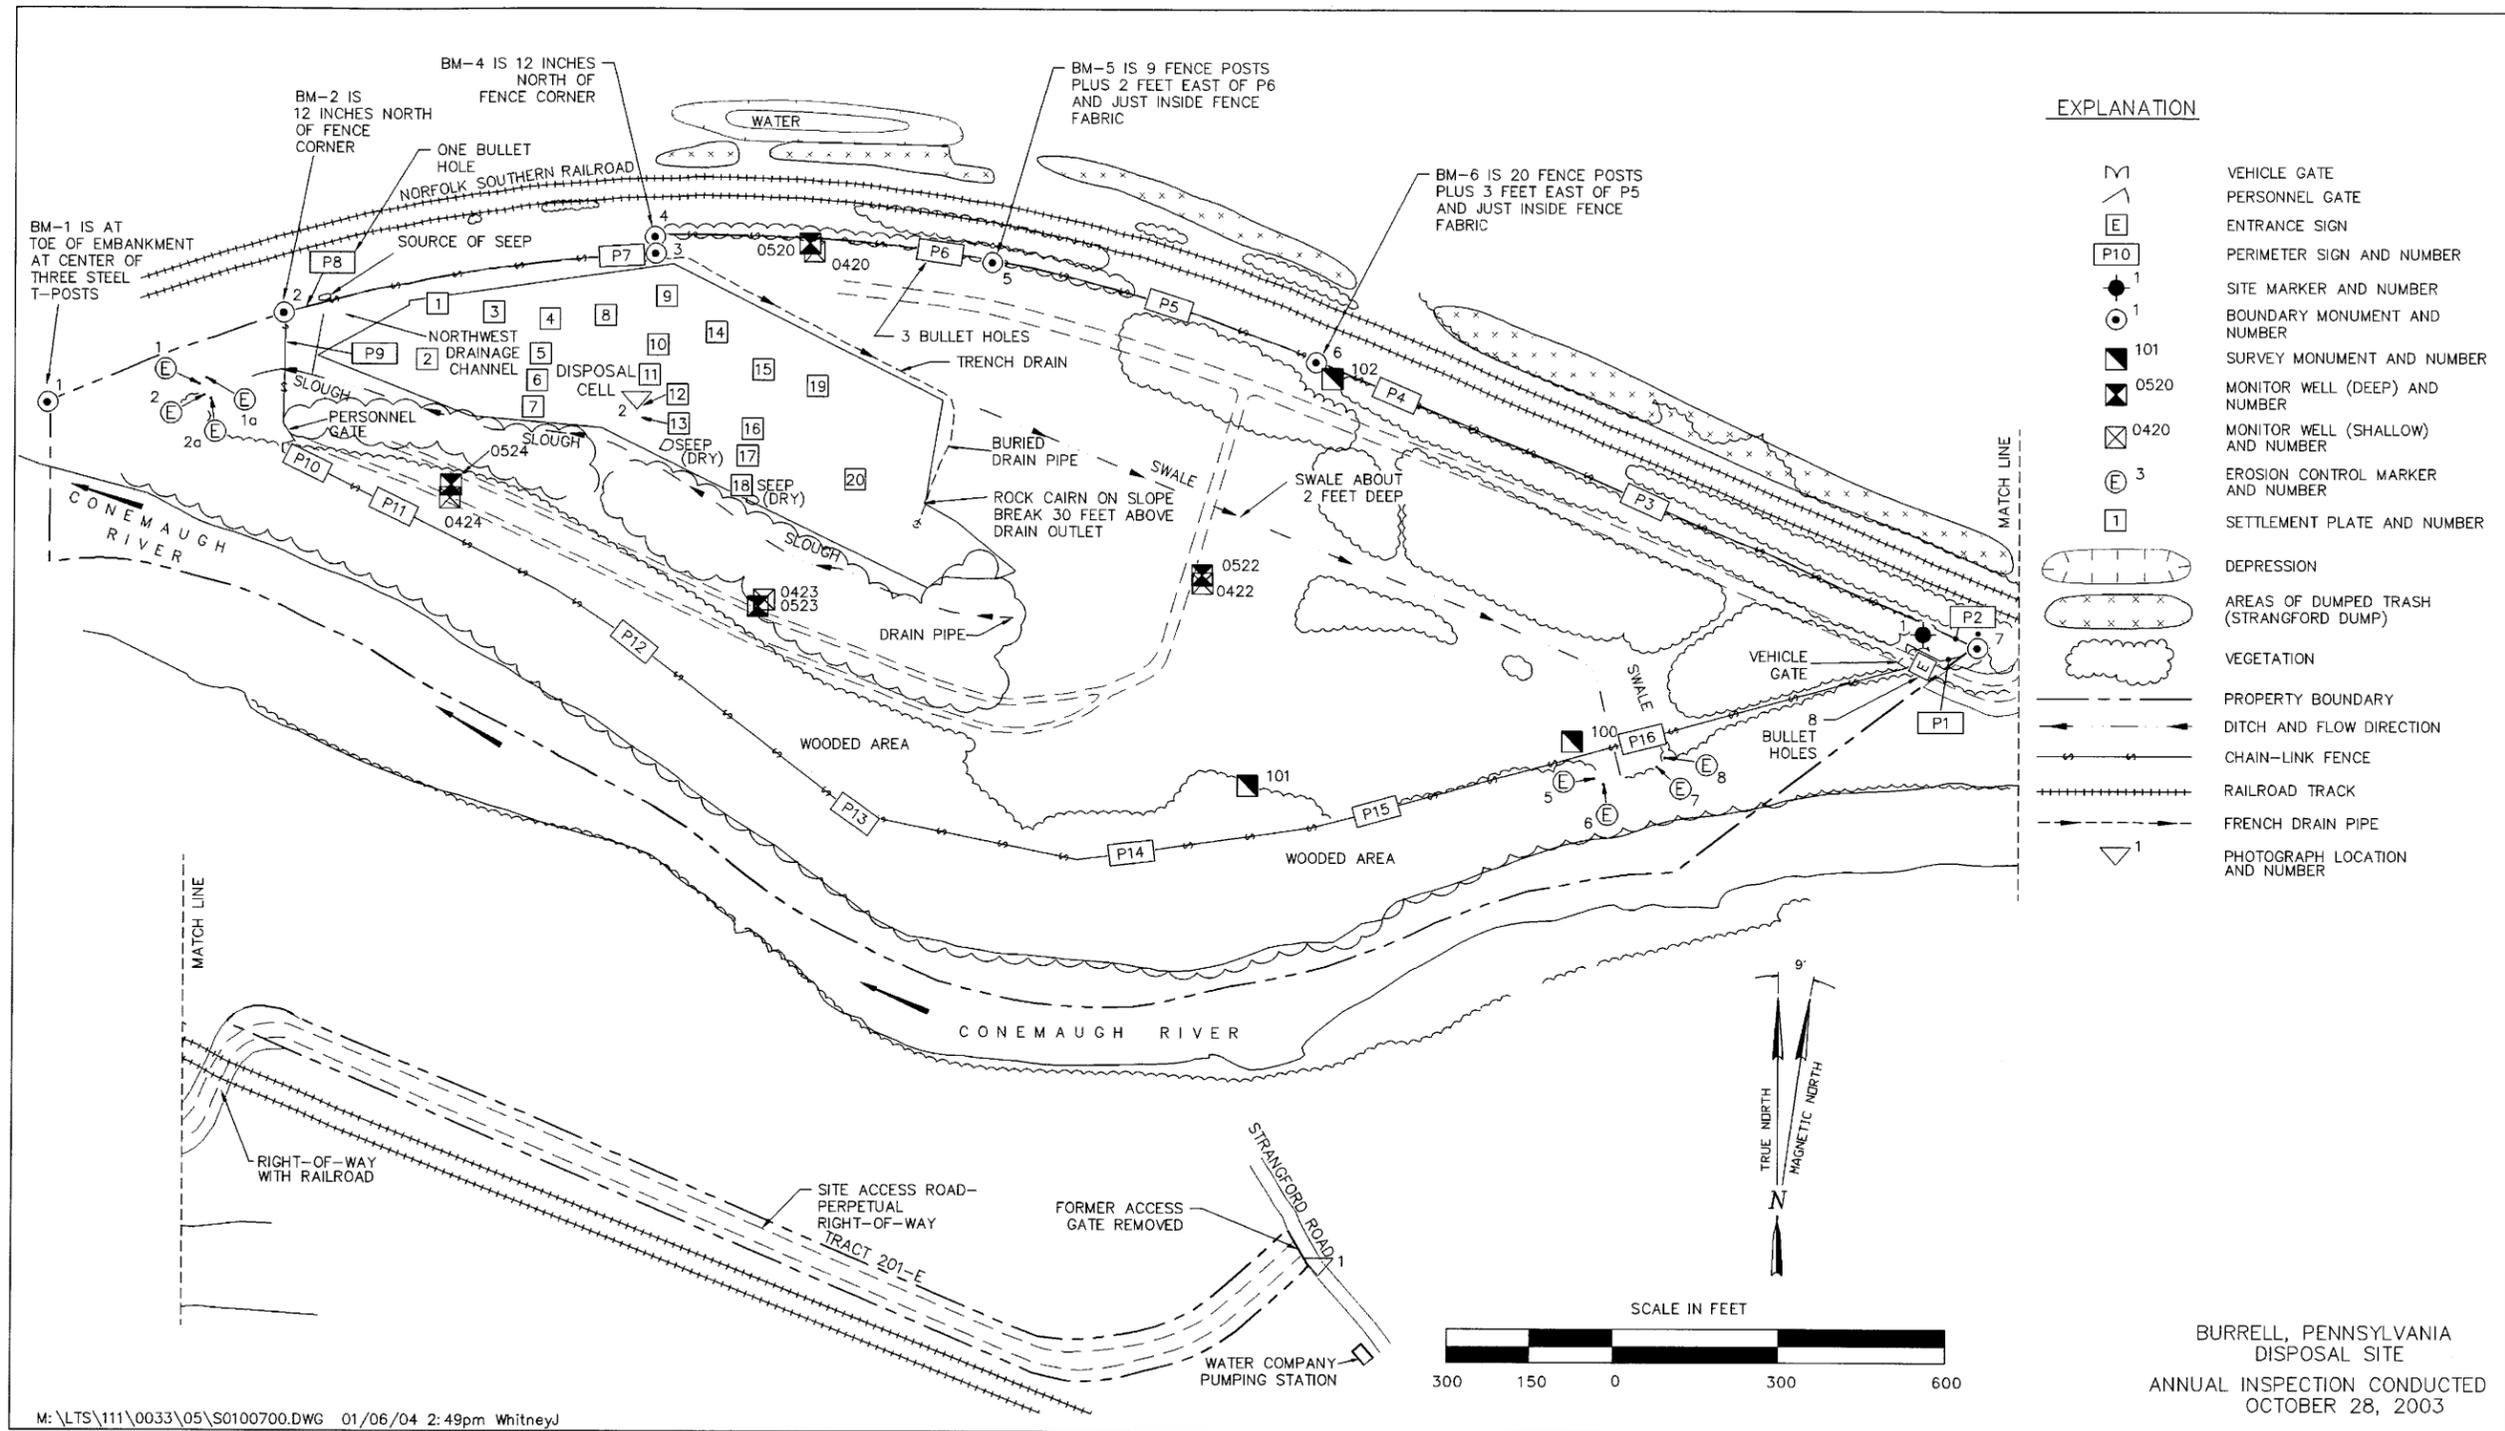
Figure 2-1. 2003 Annual Compliance Drawing for the Burrell, Pennsylvania, Disposal Site

Trees and shrubs continue to establish in the riprap (PL-2). In the past, this vegetation was aggressively controlled with massive applications of herbicide. A study that evaluated risks posed by encroachment of plants on the disposal cell demonstrated that the plants will not degrade the long-term performance of the cell and may improve performance by reducing moisture in the cover through evapotranspiration.

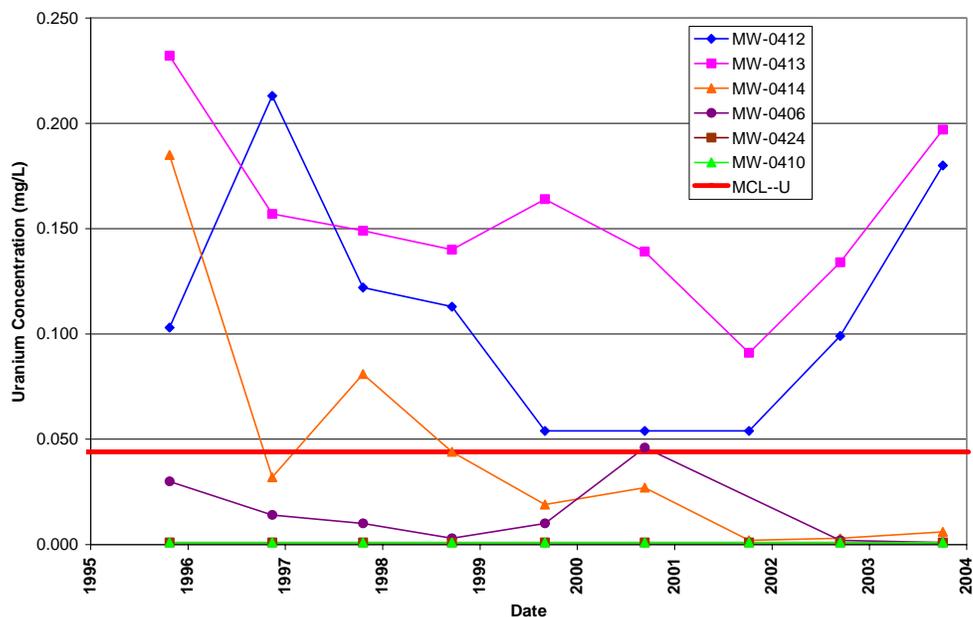
Figure 3-2. Uranium in Ground Water at the Canonsburg, Pennsylvania, Disposal Site

Uranium is the analyte of primary concern at this site because of the frequency with which it has exceeded its maximum concentration limit of 0.044 mg/L; time-concentration plots for uranium in ground water are shown in Figure 3-2. Uranium concentrations in ground water exceeded the standard at two of the downgradient wells (MW-0412 and MW-0413). Concentrations at these two locations have increased during the last 2 years and future results will be evaluated to determine if there is a trend. Uranium levels were substantially below the standard at the rest of the locations in 2003. Uranium concentrations were below the laboratory detection limit at all sampling locations in Chartiers Creek.

DOE continues to consider the risk associated with uranium in ground water to be negligible because institutional controls, in the form of government ownership of the site, prevent access to the ground water, and because uranium concentrations are below detection limits in Chartiers Creek. Therefore, public health and the environment are adequately protected.

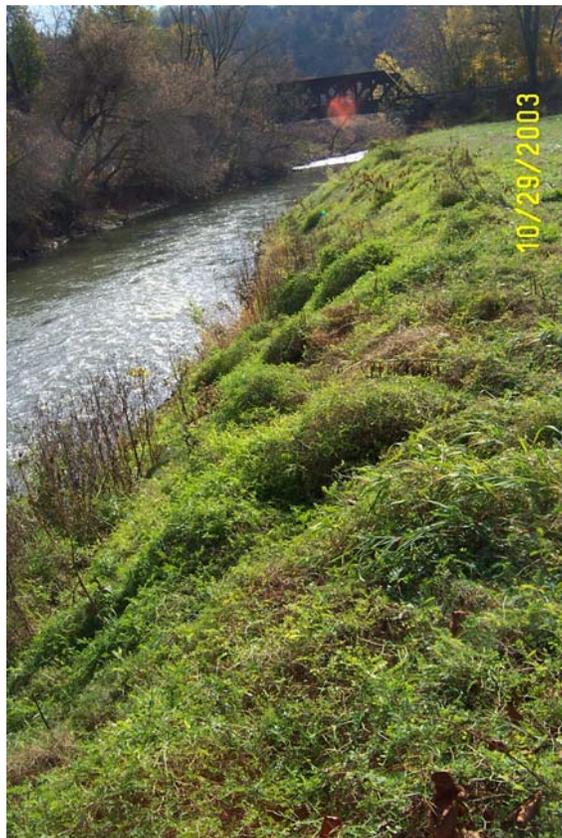
*CAN 10/2003. PL-2. The stabilized bank of Chartiers Creek along Area C.*

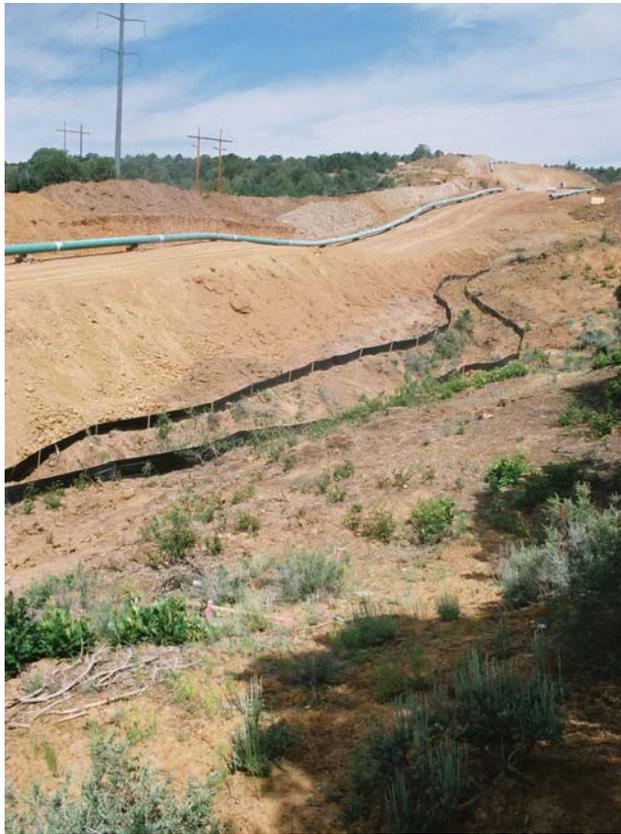
*DUR 6/2003. PL-2. Utility construction along the west side of the property.*

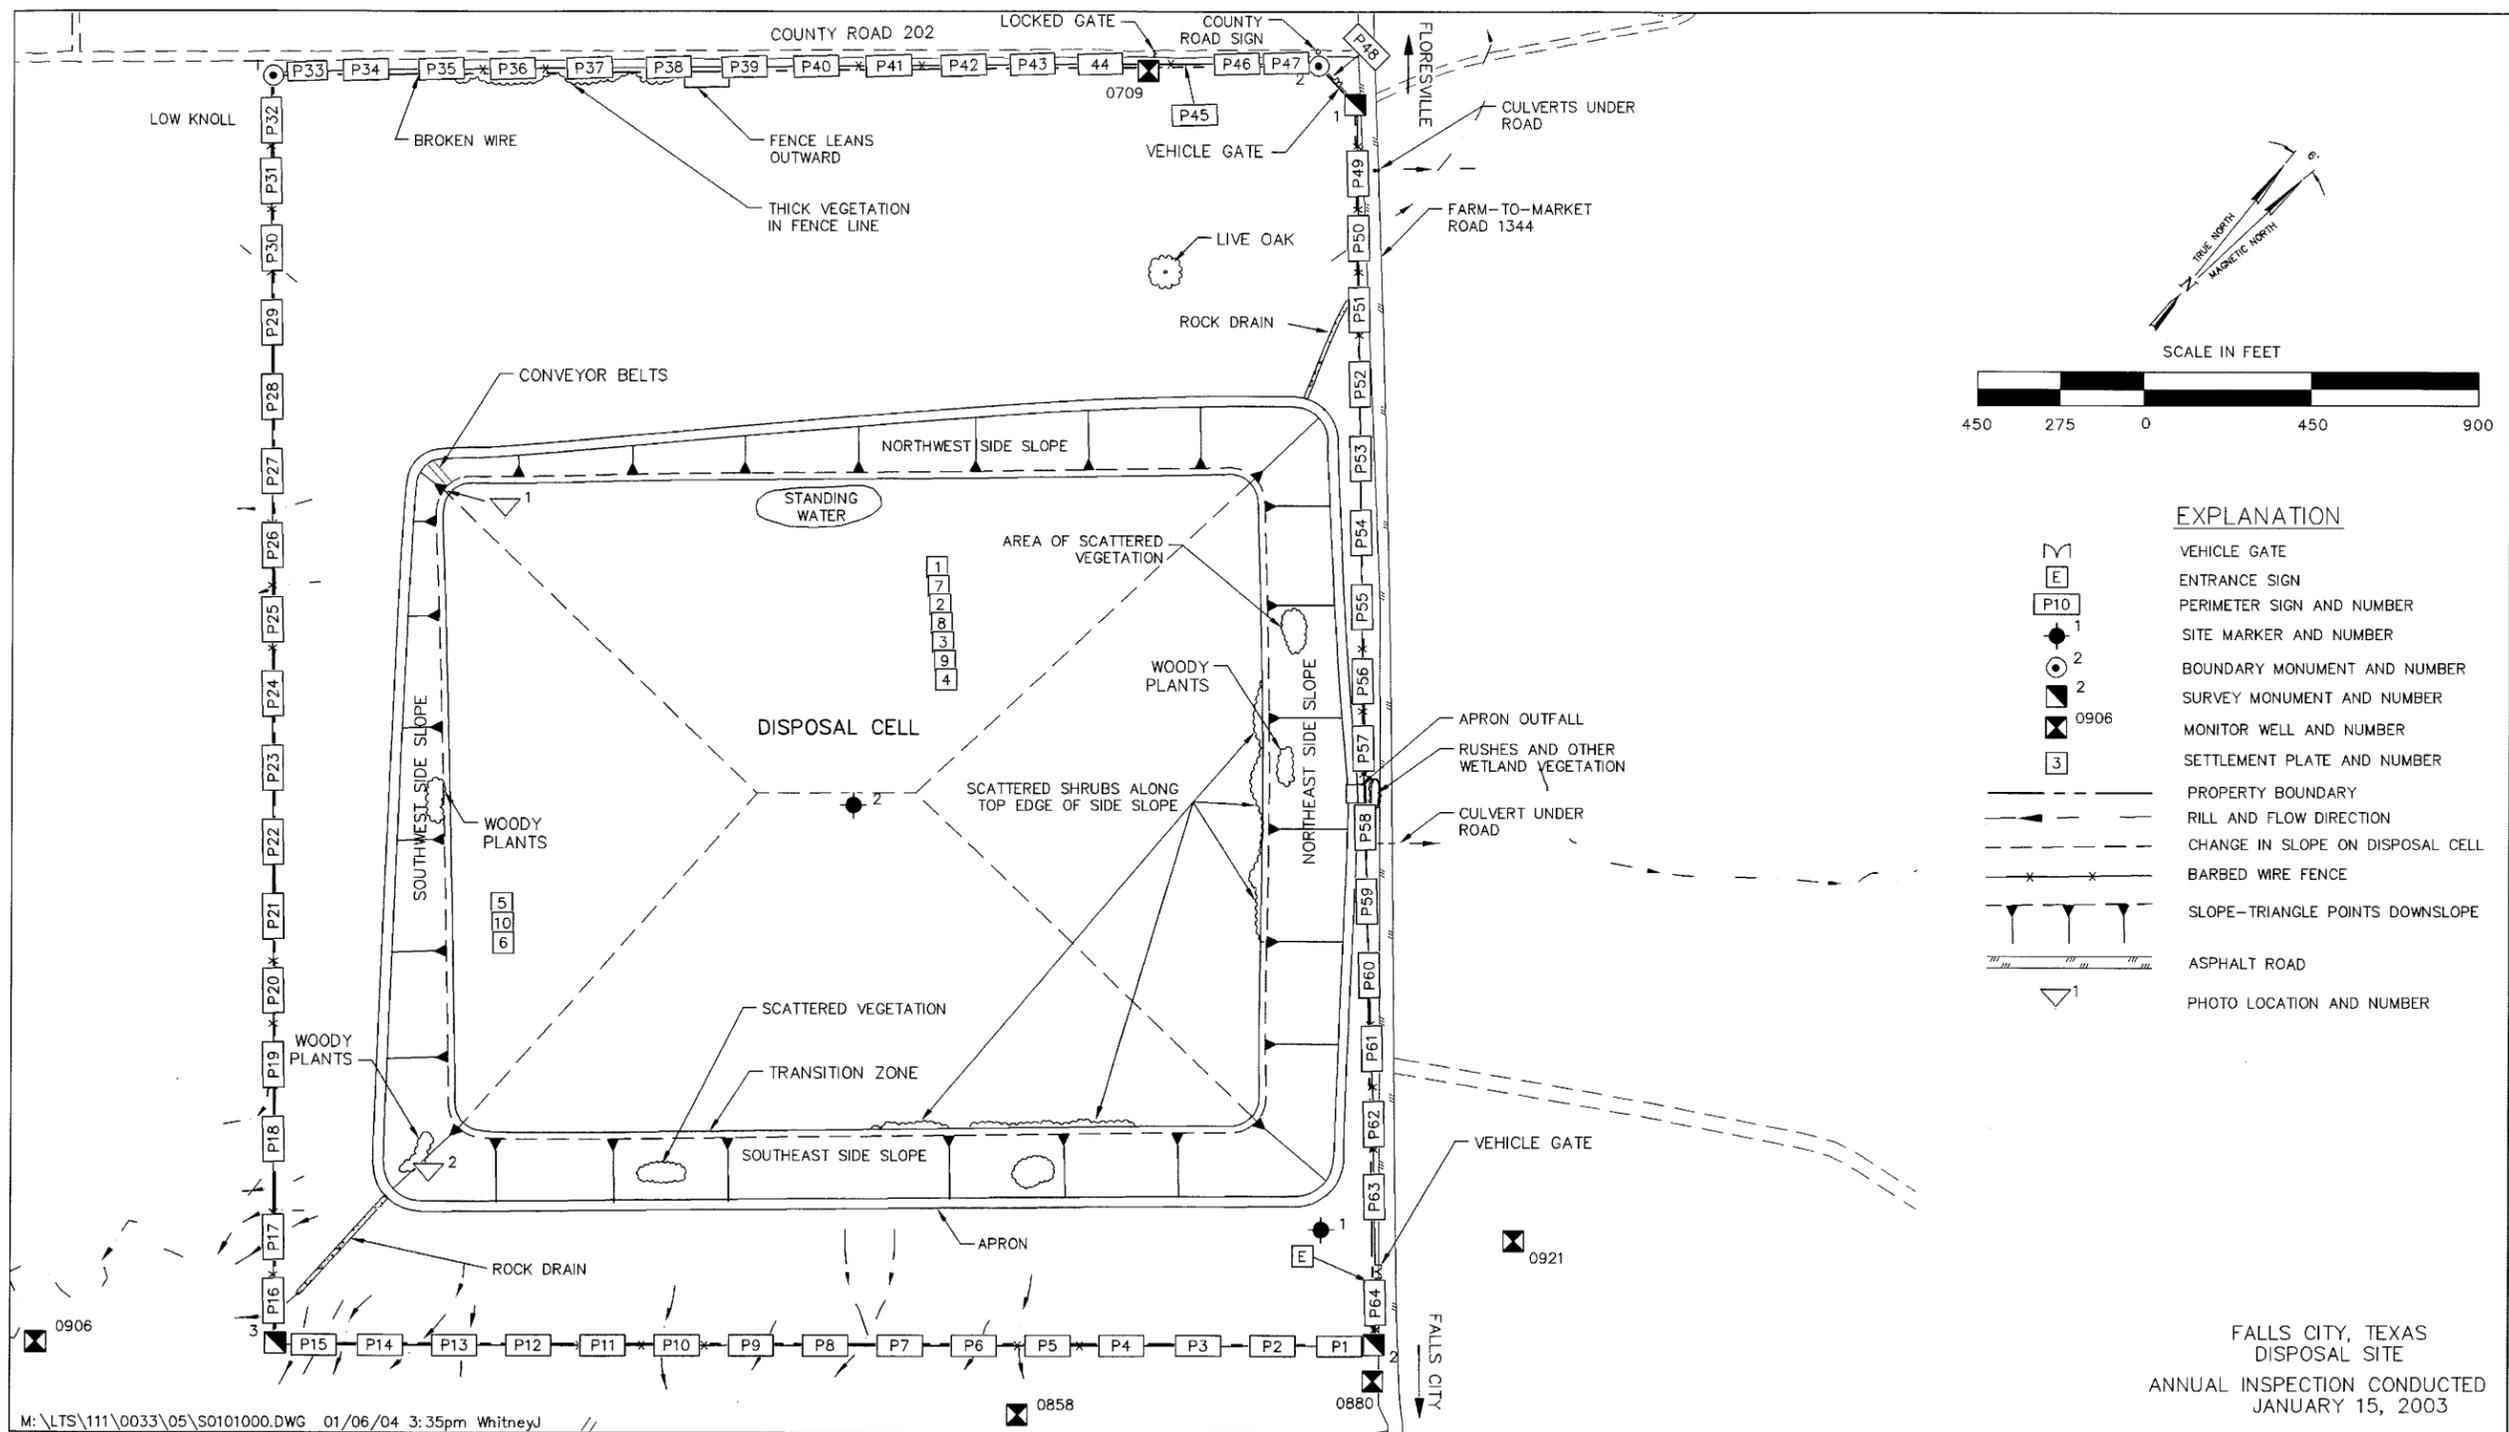
Figure 5-1. 2003 Annual Compliance Drawing for the Falls City, Texas, Disposal Site

Two tracks of steel-belted rubber conveyor belt material were placed on the west corner of the disposal cell by the hay farmer (PL-1). The conveyor belt material appears to keep the rocks from being overturned as farm equipment is driven up and down the side slope, and does not adversely affect the function of the disposal cell. The material may be left in place as long as it does not fragment into smaller pieces and become distributed as litter.

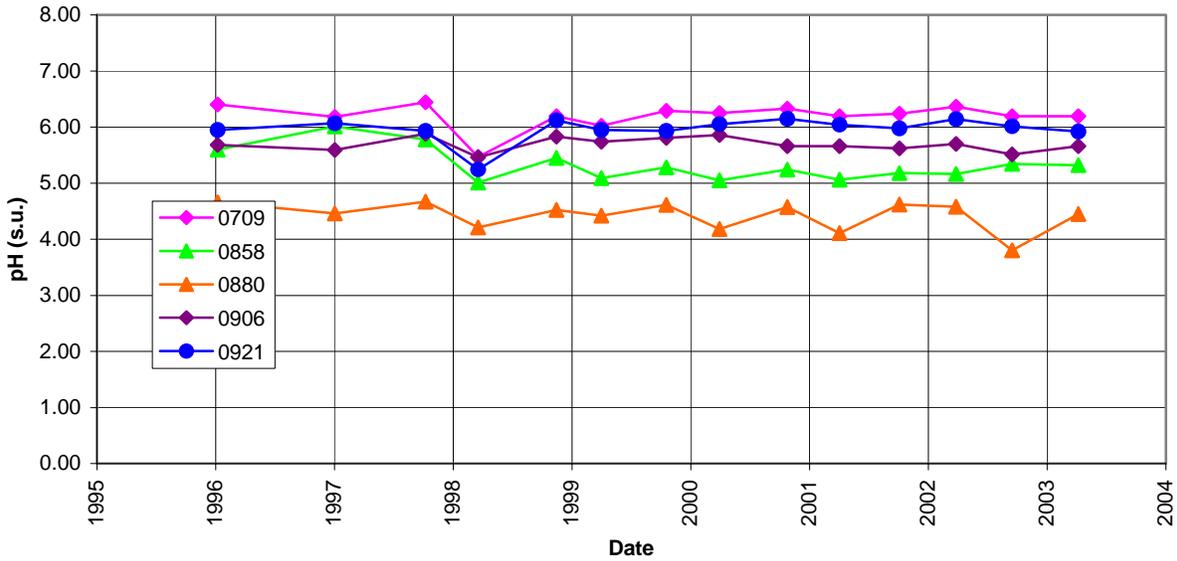
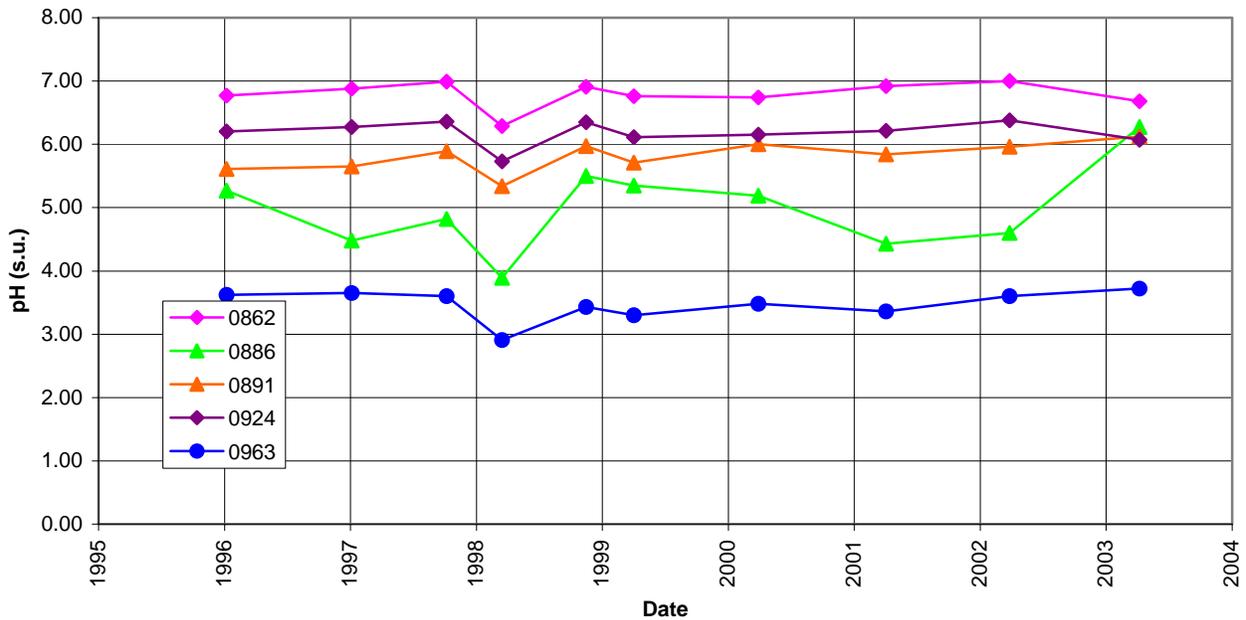
Analytical results from 2003 generally are consistent with previous results and what would be expected of ground water conditions in a naturally mineralized area that has been impacted by uranium exploration and mining activities. Levels of pH have not varied significantly in recent years (Figures 5-3 and 5-4) and it does not appear that pH is a good indicator for what is occurring with concentrations of uranium or other select constituents in ground water. There is no statistical correlation between changes in pH and changes with the select constituents.

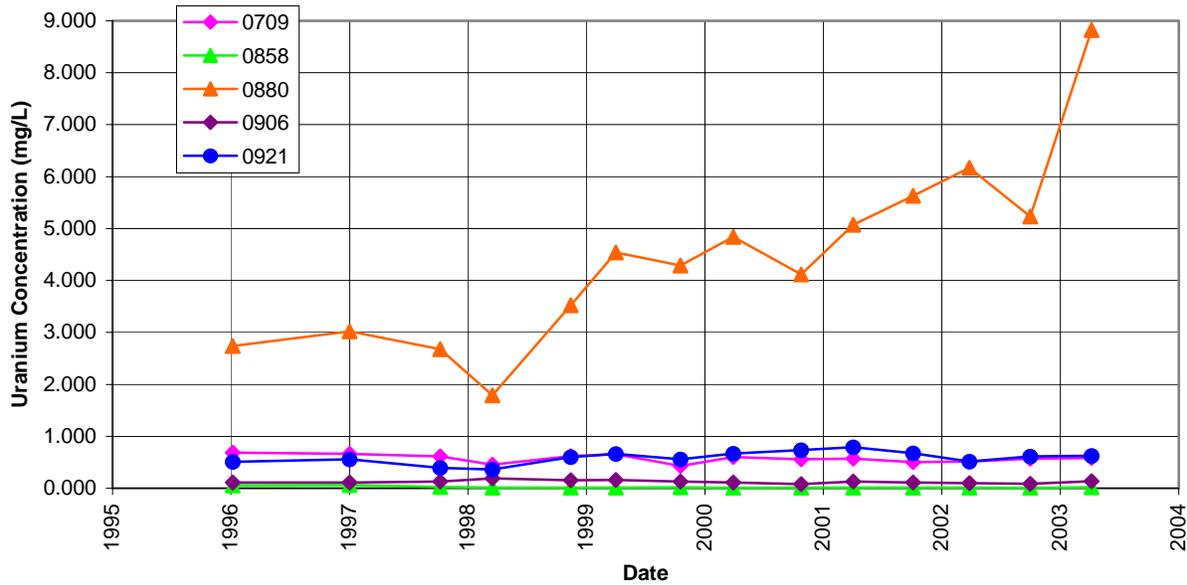
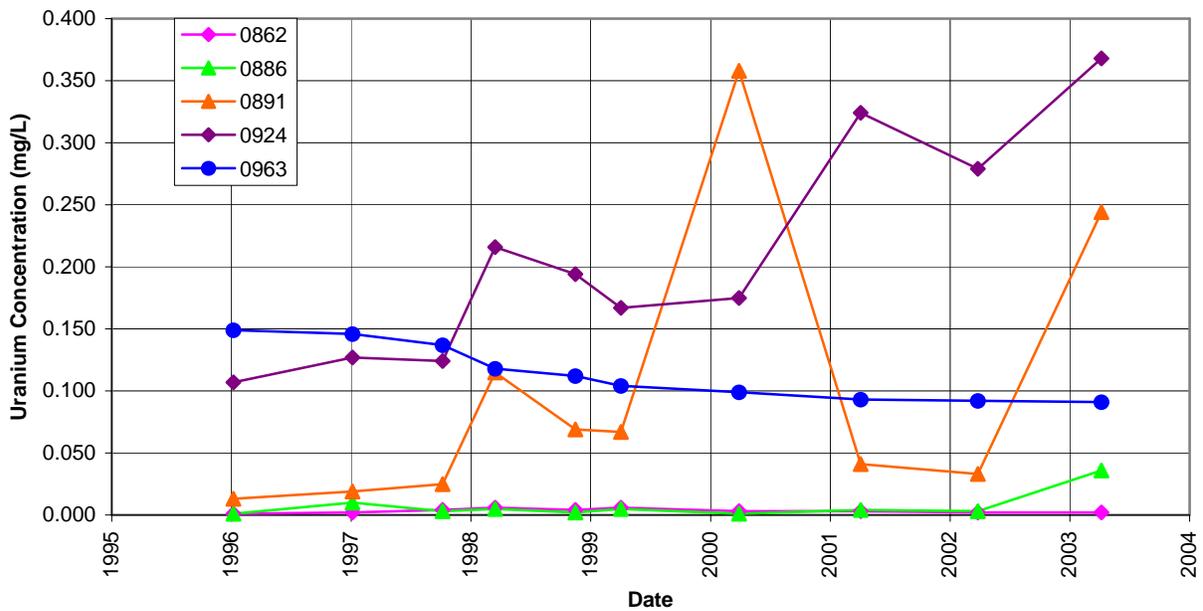
Uranium concentrations in ground water in the vicinity of the disposal cell are consistent with previous results with the exception of monitor well MW-0880, where concentrations continue to increase (Figure 5-5). This increase may be an indication of seepage from the disposal cell, as expected; there is no risk however, because ground water is not used in the area. Uranium in ground water in the compliance monitoring network has varied substantially in two wells (MW-0891 and MW-0924) since 1997 and exceeded the maximum concentration limit of 0.044 mg/L in three wells (MW-0891, 0924, and 0963) in 2003 (Figure 5-6). Concentrations of other analytes in ground water are similar to previous results.

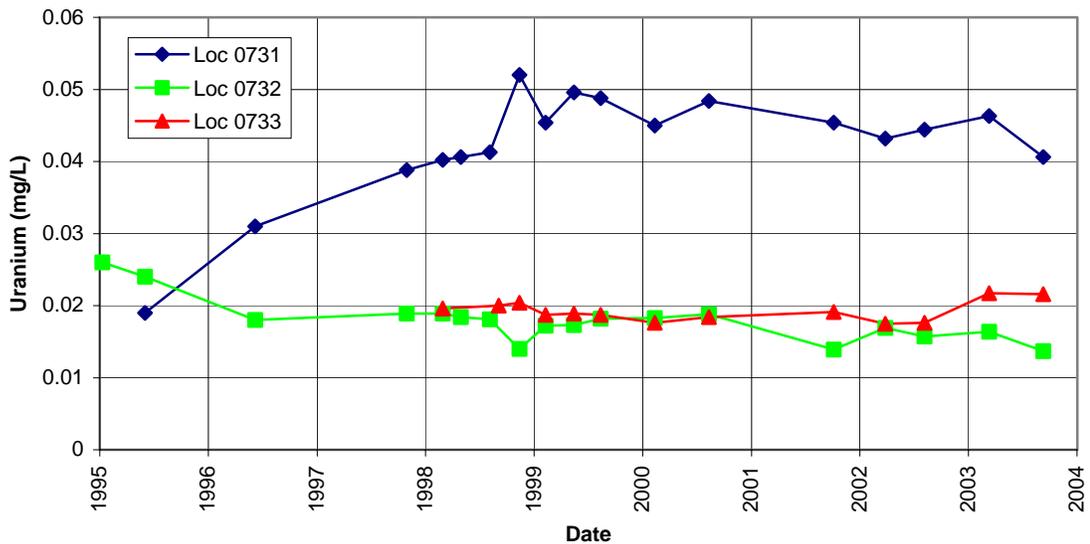
Figure 6-5. Time-Concentration Plots of Uranium in Ground Water at the Grand Junction, Colorado, Disposal Site

Results from sampling in 2003 were consistent with results from the past several years. Molybdenum and vanadium concentrations in ground water continued to be near or below the required laboratory detection limits and significantly below the MCL or risk-based standard at all wells. Nitrate concentrations exceeded the MCL of 44 mg/L in MW-0732 and MW-0733, but were below the MCL in MW-0731 (Figure 6-3). Selenium levels continued to exceed the MCL of 0.01 mg/L at both downgradient wells and remained below the standard at MW-0733 (Figure 6-4). Sulfate concentrations continued to be relatively high in all wells, at approximately 6,700 mg/L in the disposal cell, and just below 4,000 mg/L in the paleochannel wells. High sulfate concentrations are typical of the regional soils, which contain gypsum. Concentrations of TDS continued above 10,000 mg/L in the disposal cell well. Concentrations of TDS in ground water in the paleochannel wells were around 7,000 mg/L. Uranium concentrations were just below the MCL of 0.044 mg/L in MW-0731, and were substantially below the MCL in MW-0732 and MW-0733 (Figure 6-5). PCBs were not detected in the samples from any of the wells.

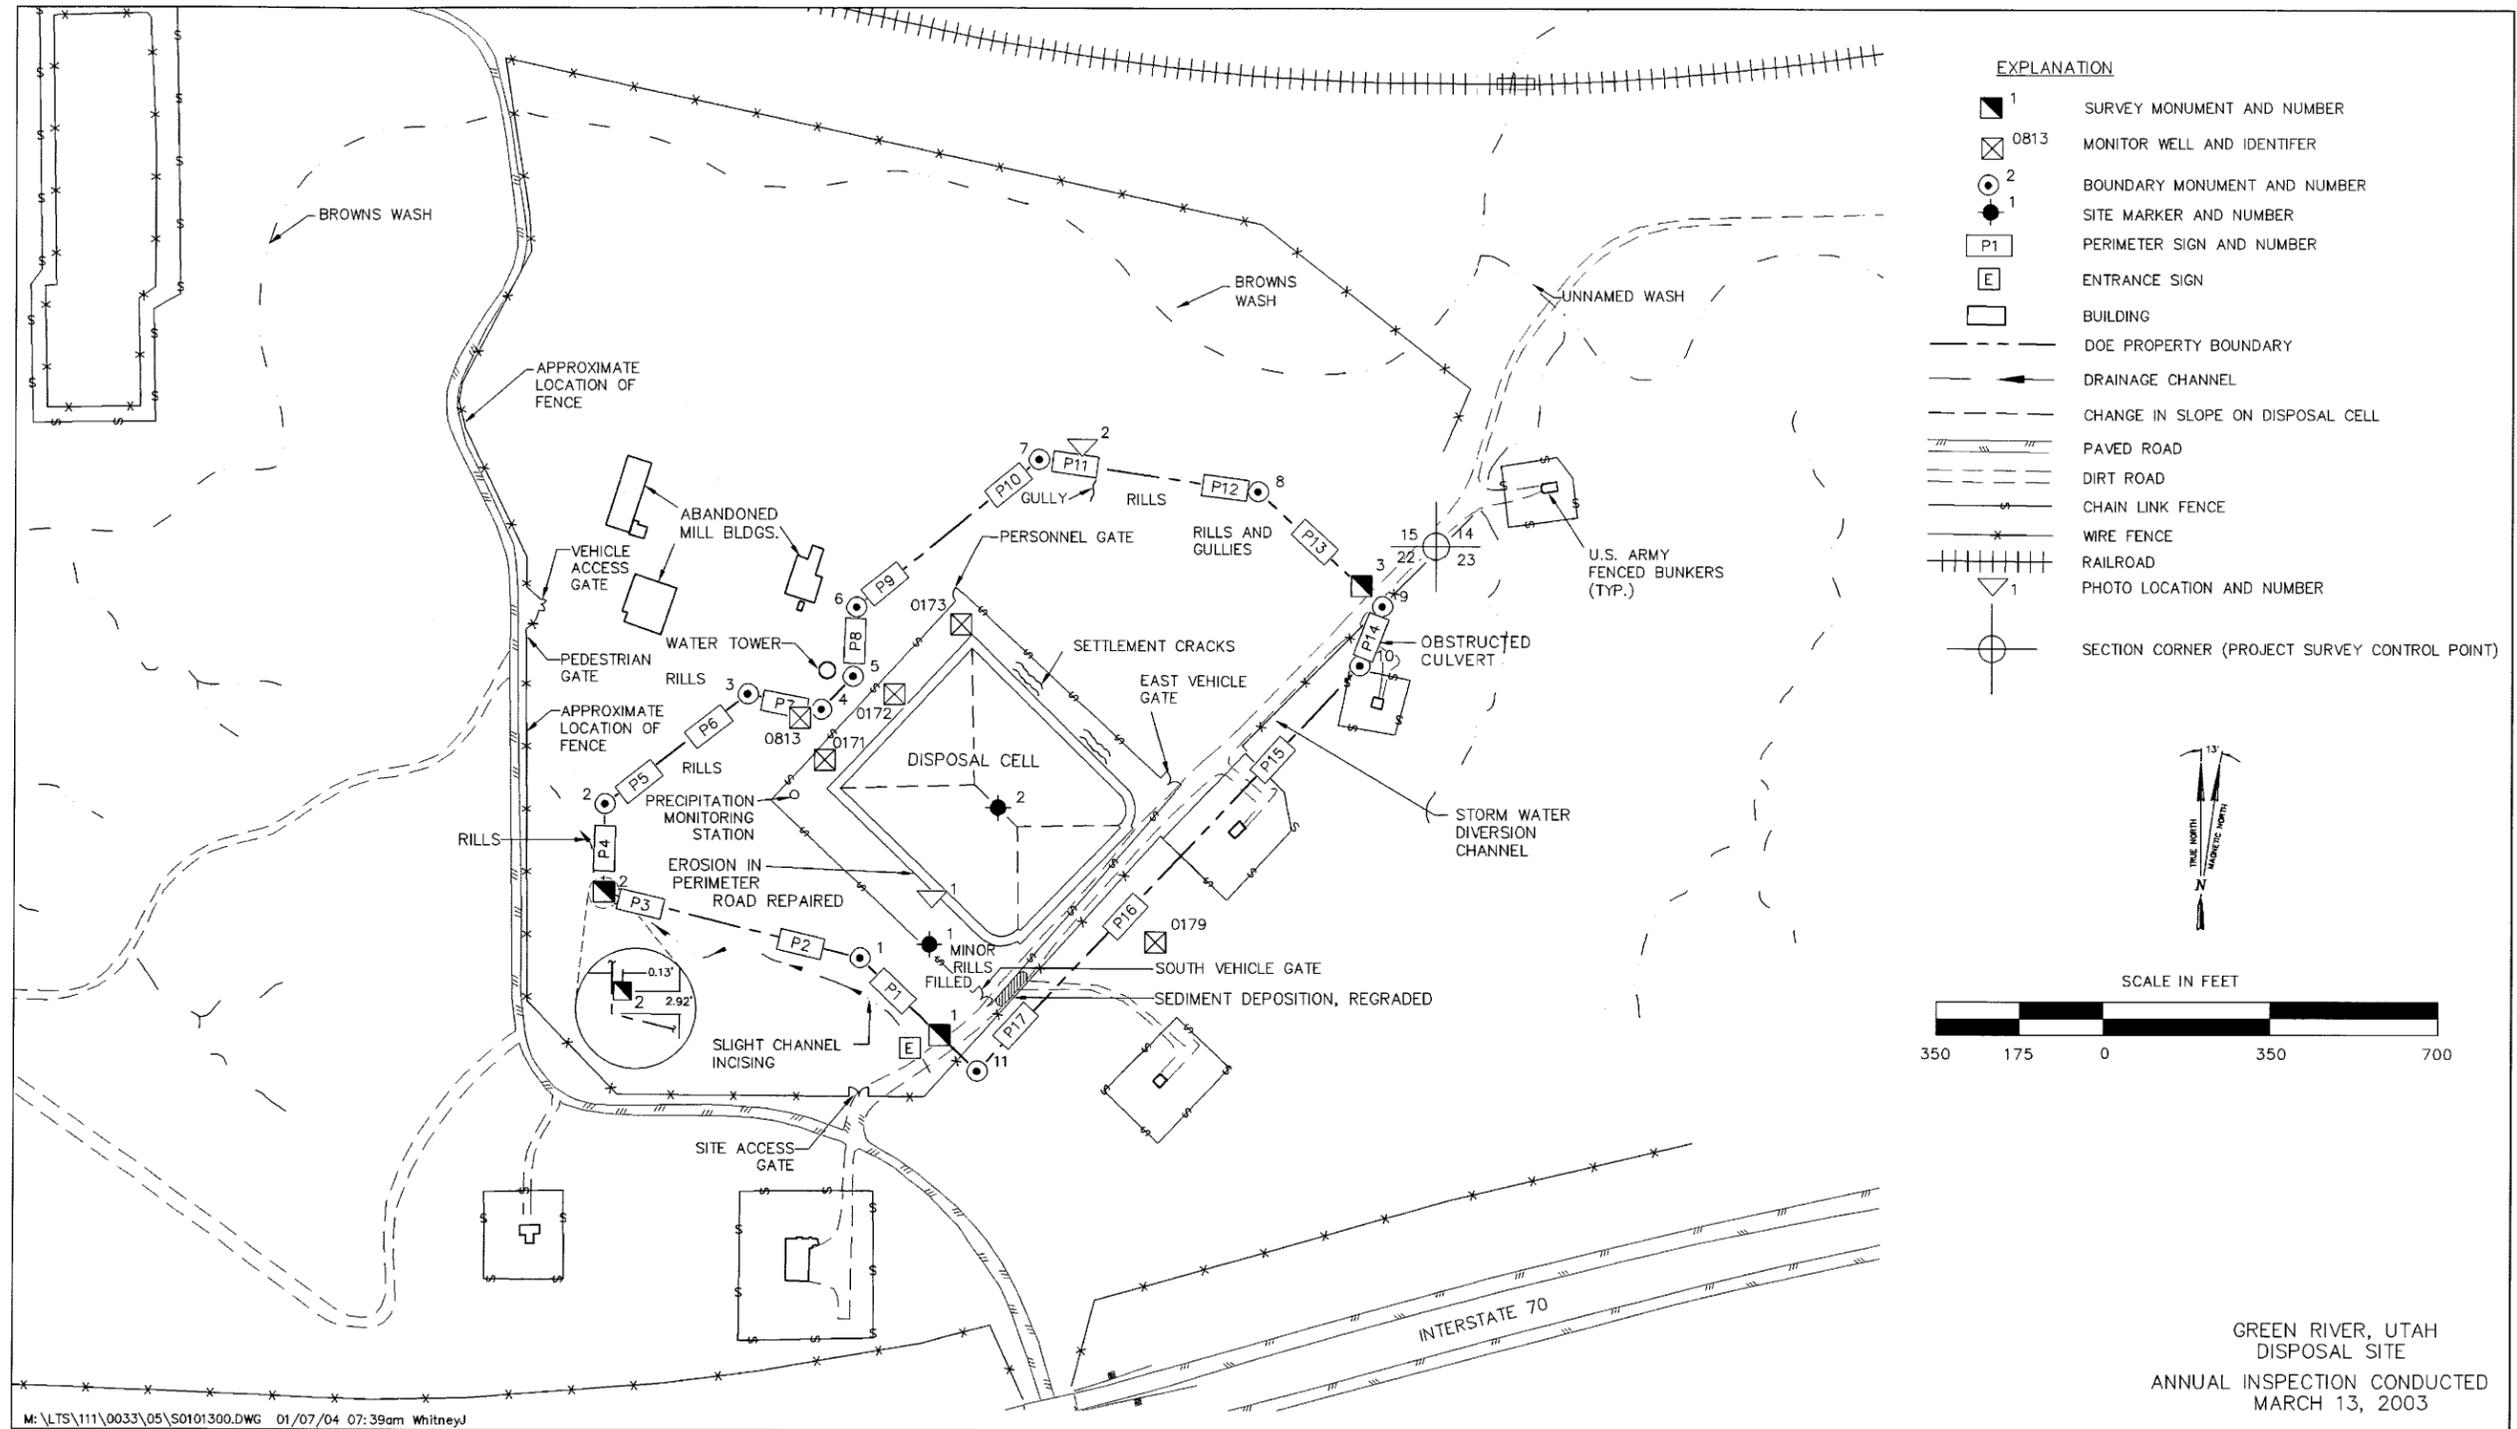
Figure 7-1. 2003 Annual Compliance Drawing for the Green River, Utah, Disposal Site

**7B** Rill erosion on the west side of the property appears to have increased but does not pose a threat to the integrity of the cell. Site grading was performed to repair erosion damage and to divert runoff away from perimeter sign P4 and boundary monument BM-3.

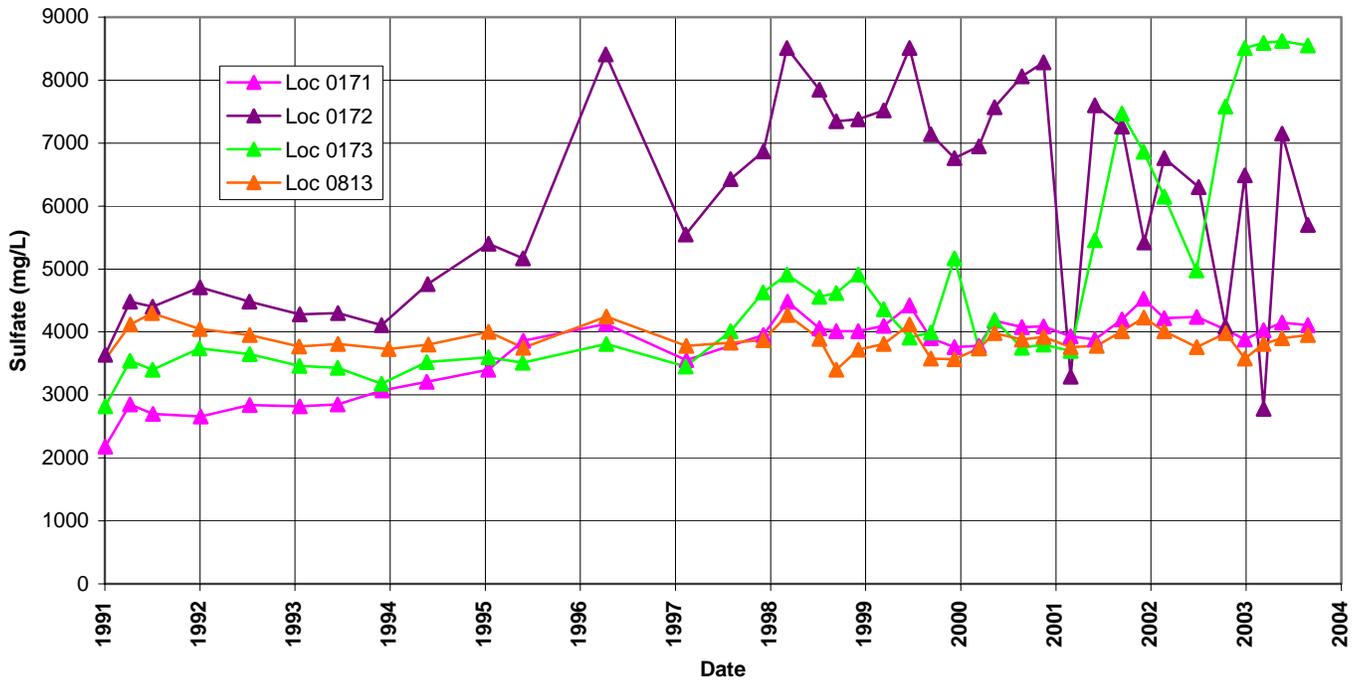
Figure 7-3. Time-Concentration Plots of Sulfate in Ground Water at the Green River, Utah, Disposal Site

Sulfate concentrations in ground water have remained relatively constant in wells MW-0171 and MW-0813 since the disposal cell was constructed (Figure 7-3). Concentrations in wells MW-0172 and MW-0173 have fluctuated substantially since 1996. Concentrations in 2003 continued above the proposed concentration limits (Table 7-2) in wells MW-0171, MW-0172, and MW-0173. Sulfate concentration was below the proposed limit in well MW-0813.

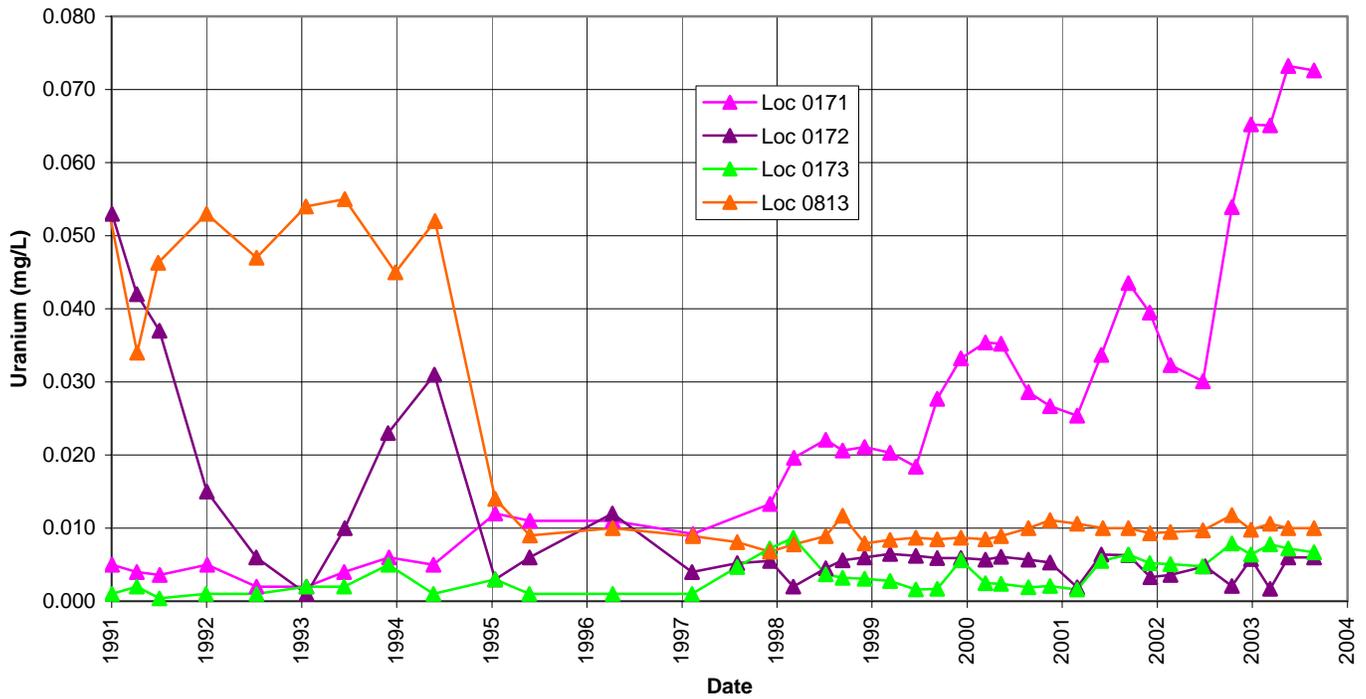
Figure 7-4. Time-Concentration Plots of Uranium in Ground Water at the Green River, Utah, Disposal Site

Uranium concentrations in ground water were below the proposed concentration limits (Table 7–2) in all four point-of-compliance wells from 1995 until October 2002, when levels exceeded the maximum concentration limit in well MW–0171 (Figure 7–4). The increasing uranium concentration in MW–0171 may be an indication of seepage from the disposal cell, as expected on the basis of the cell design and construction. Concentrations in the other wells remain fairly constant and at or below 0.010 milligrams per liter.
