# 2003 Annual Site Inspection and Monitoring Report for Uranium Mill Tailings Radiation Control Act Title I Disposal Sites

January 2004

Work Performed by S.M. Stoller Corporation under DOE Contract No. DE-AC01-02GJ79491  
for the U.S. Department of Energy, Grand Junction, Colorado

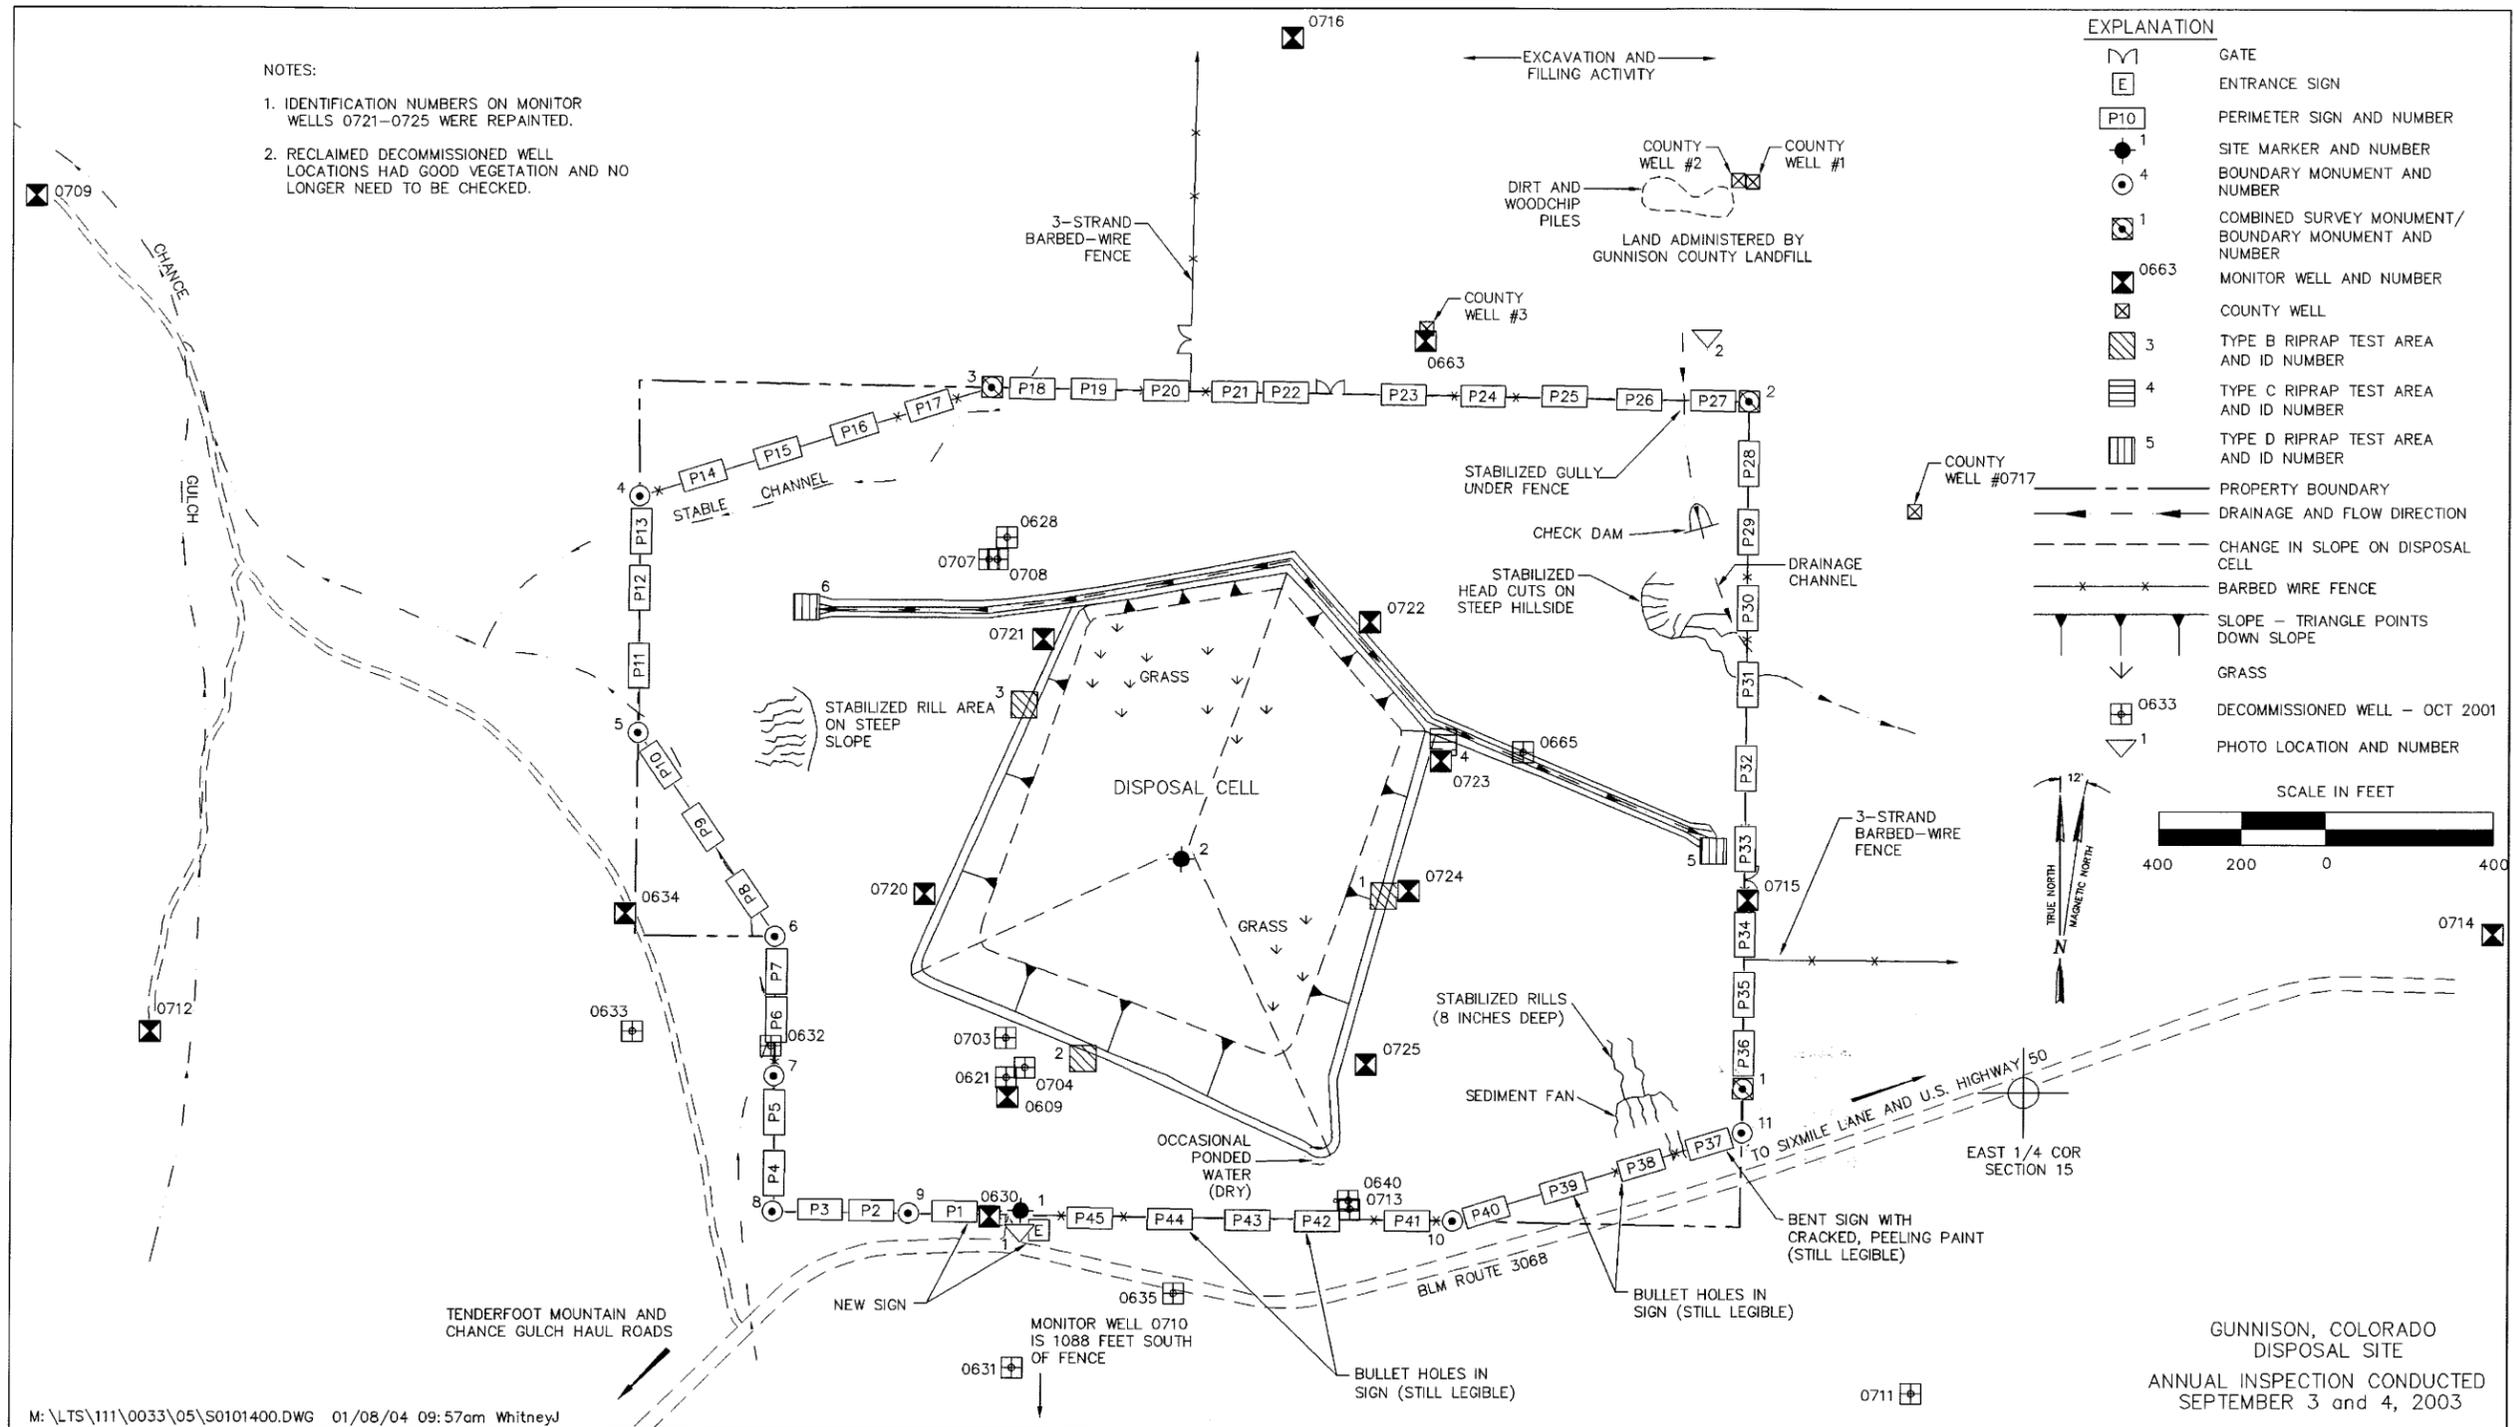
Figure 8-1. 2003 Annual Compliance Drawing for the Gunnison, Colorado, Disposal Site

8A An entrance sign and 45 perimeter signs are attached to the posts of the perimeter fence. The entrance sign, just east of the entrance gate, was replaced with a new sign (PL-1); the former sign identified DOE-Albuquerque as the owner. Perimeter sign P1 was missing and was replaced. Perimeter sign P37 is bent and has cracked paint, but was still legible. Perimeter signs P38, P39, P42, and P44 have bullet holes in them, but all were still legible. The other perimeter signs were in excellent condition.

8B **Monitor Wells**—The ground water monitoring network at the Gunnison disposal site consists of 16 wells. All monitor wells were secure and in excellent condition. Due to faded or peeled paint, the identification numbers on five of the compliance wells were repainted.

At the southeast corner of the cell apron, water draining from the cell occasionally ponds in a low-lying area along the edge of the riprap. The riparian-type vegetation that has established indicates this area retains moisture much of the time. Water collection in this area does not pose a problem because the cell is designed to drain to the southeast, and any water that ponds is below the elevation of the tailings. This area was dry at the time of the inspection.

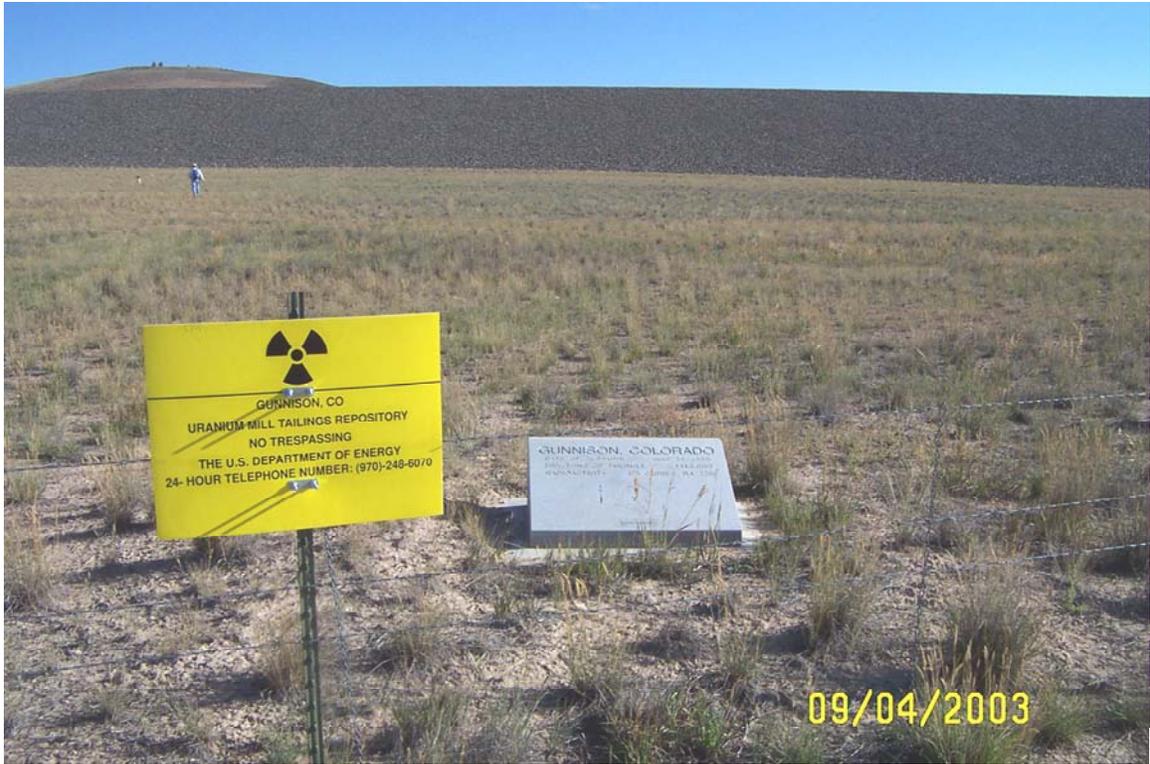
*GUN 9/2003. PL-1. Site marker SMK-1 and the new entrance sign.*

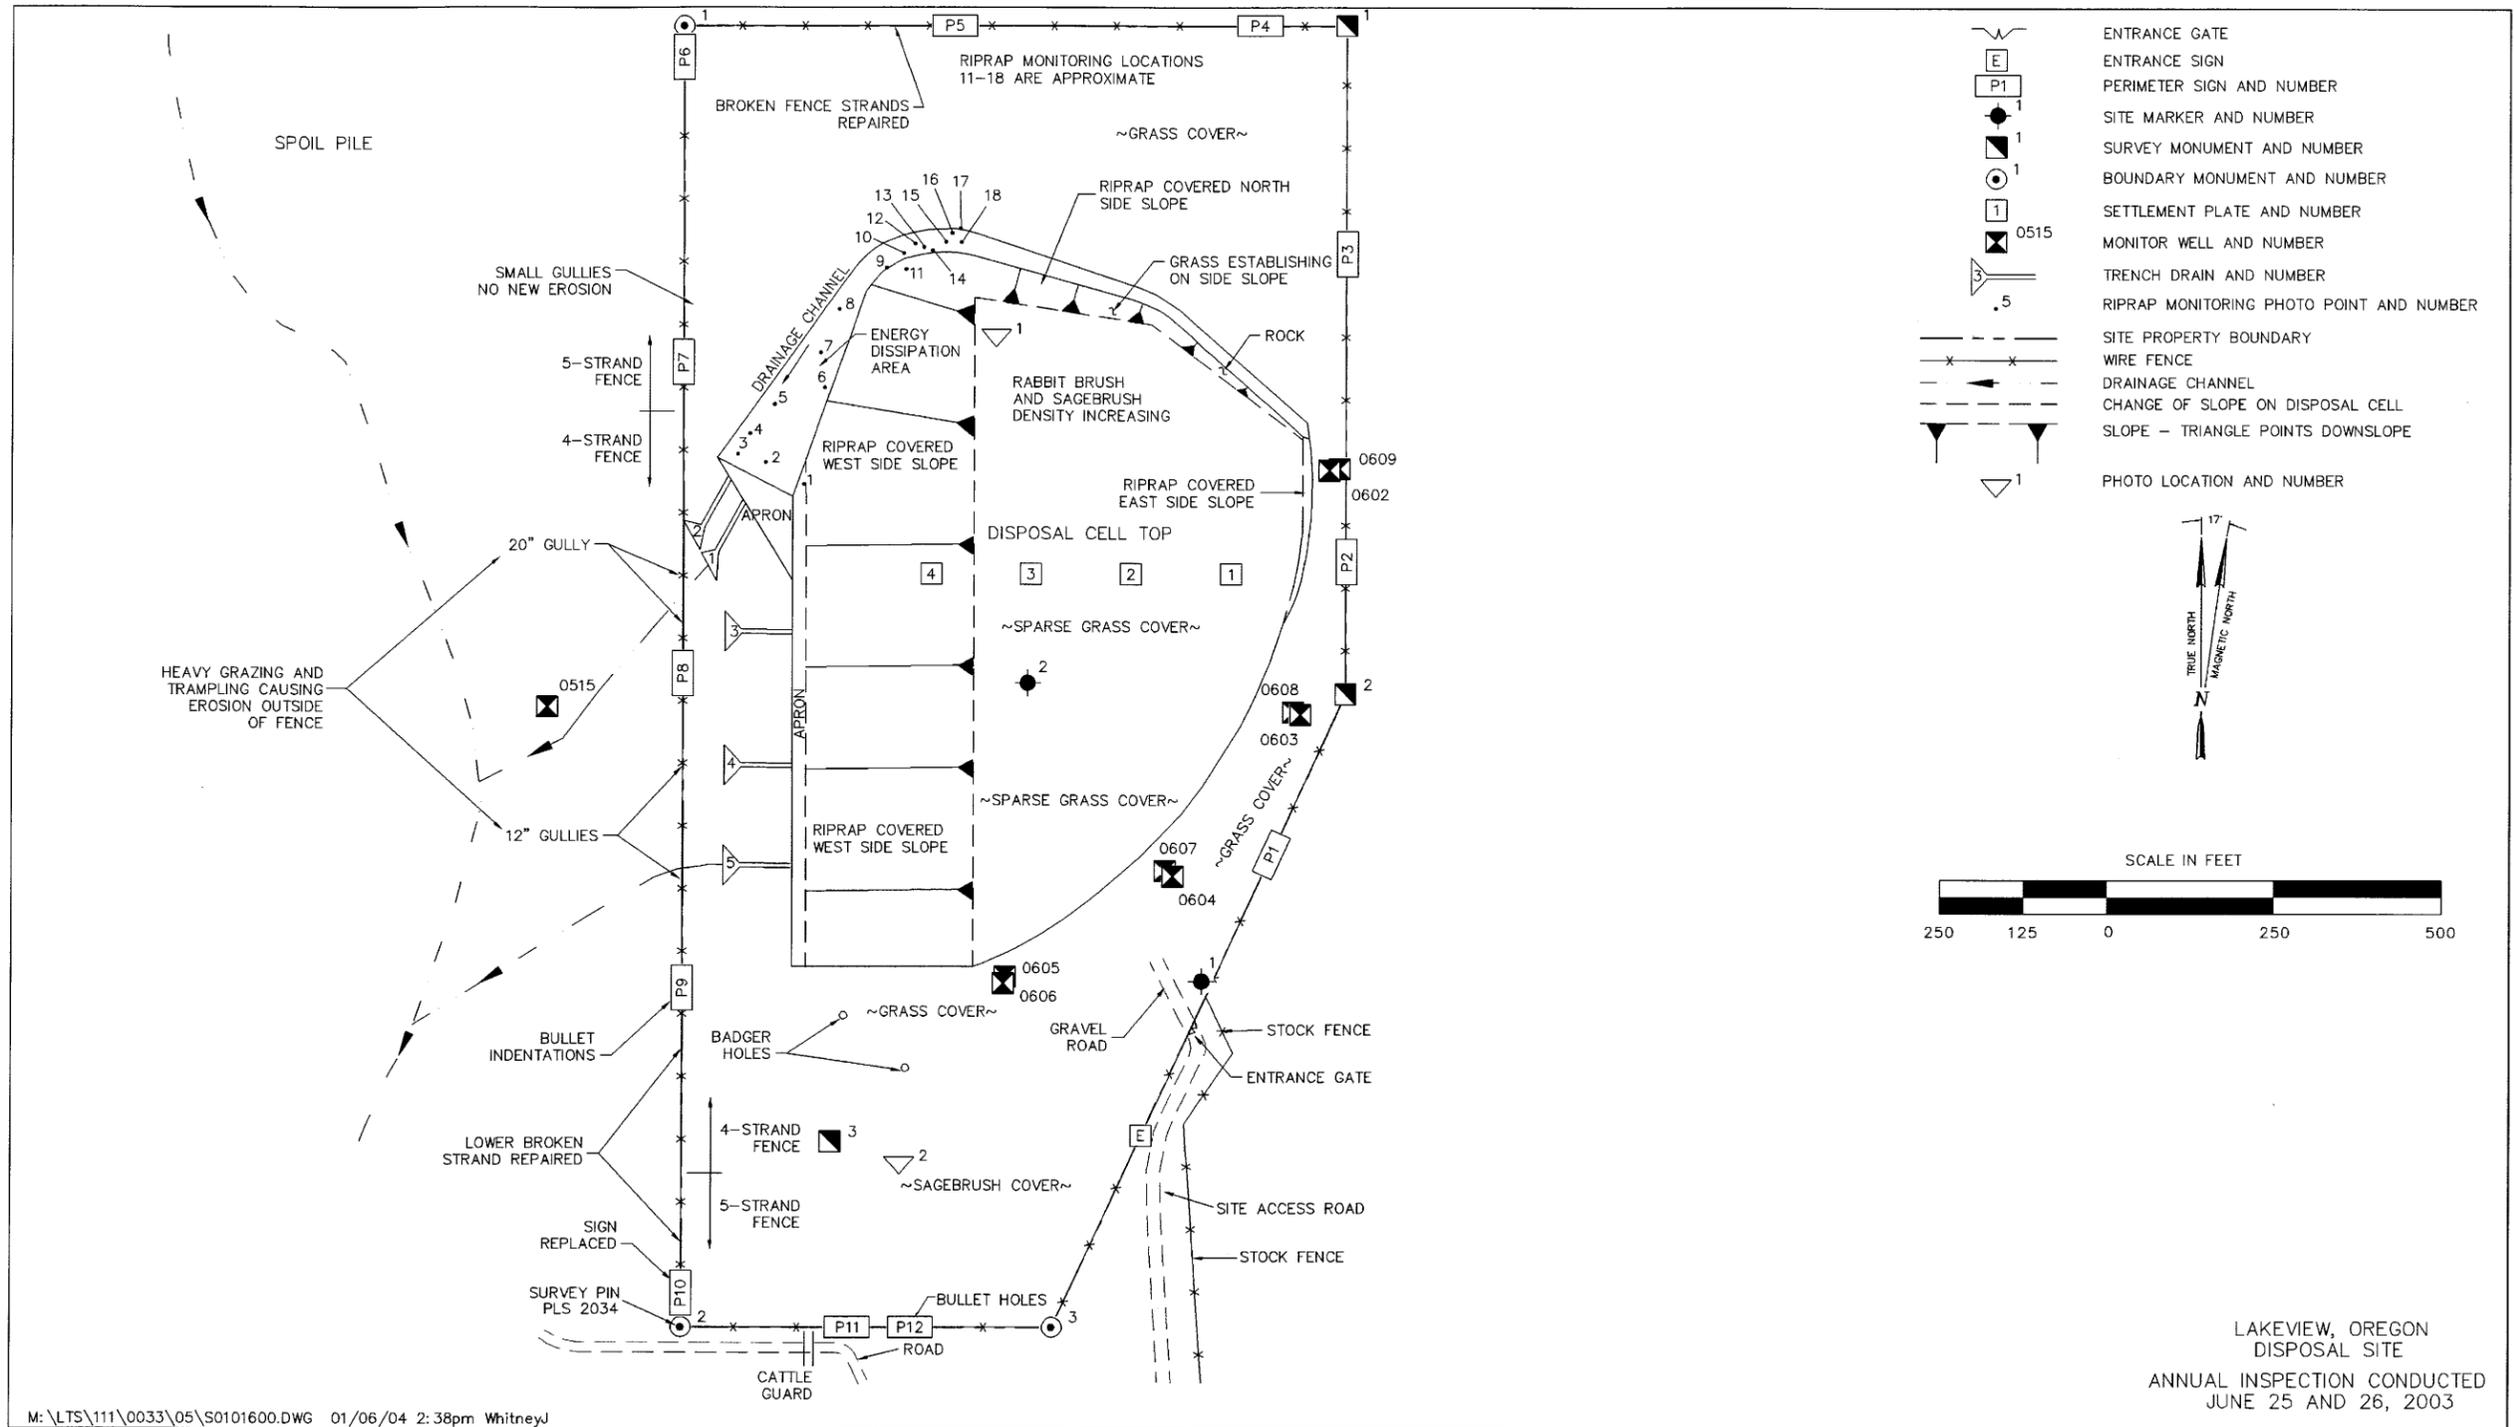
Figure 9-1. 2003 Annual Compliance Drawing for the Lakeview, Oregon, Disposal Site

- 9A A barbed wire boundary fence encompasses the site. Broken strands on the west and north boundary fence were repaired.

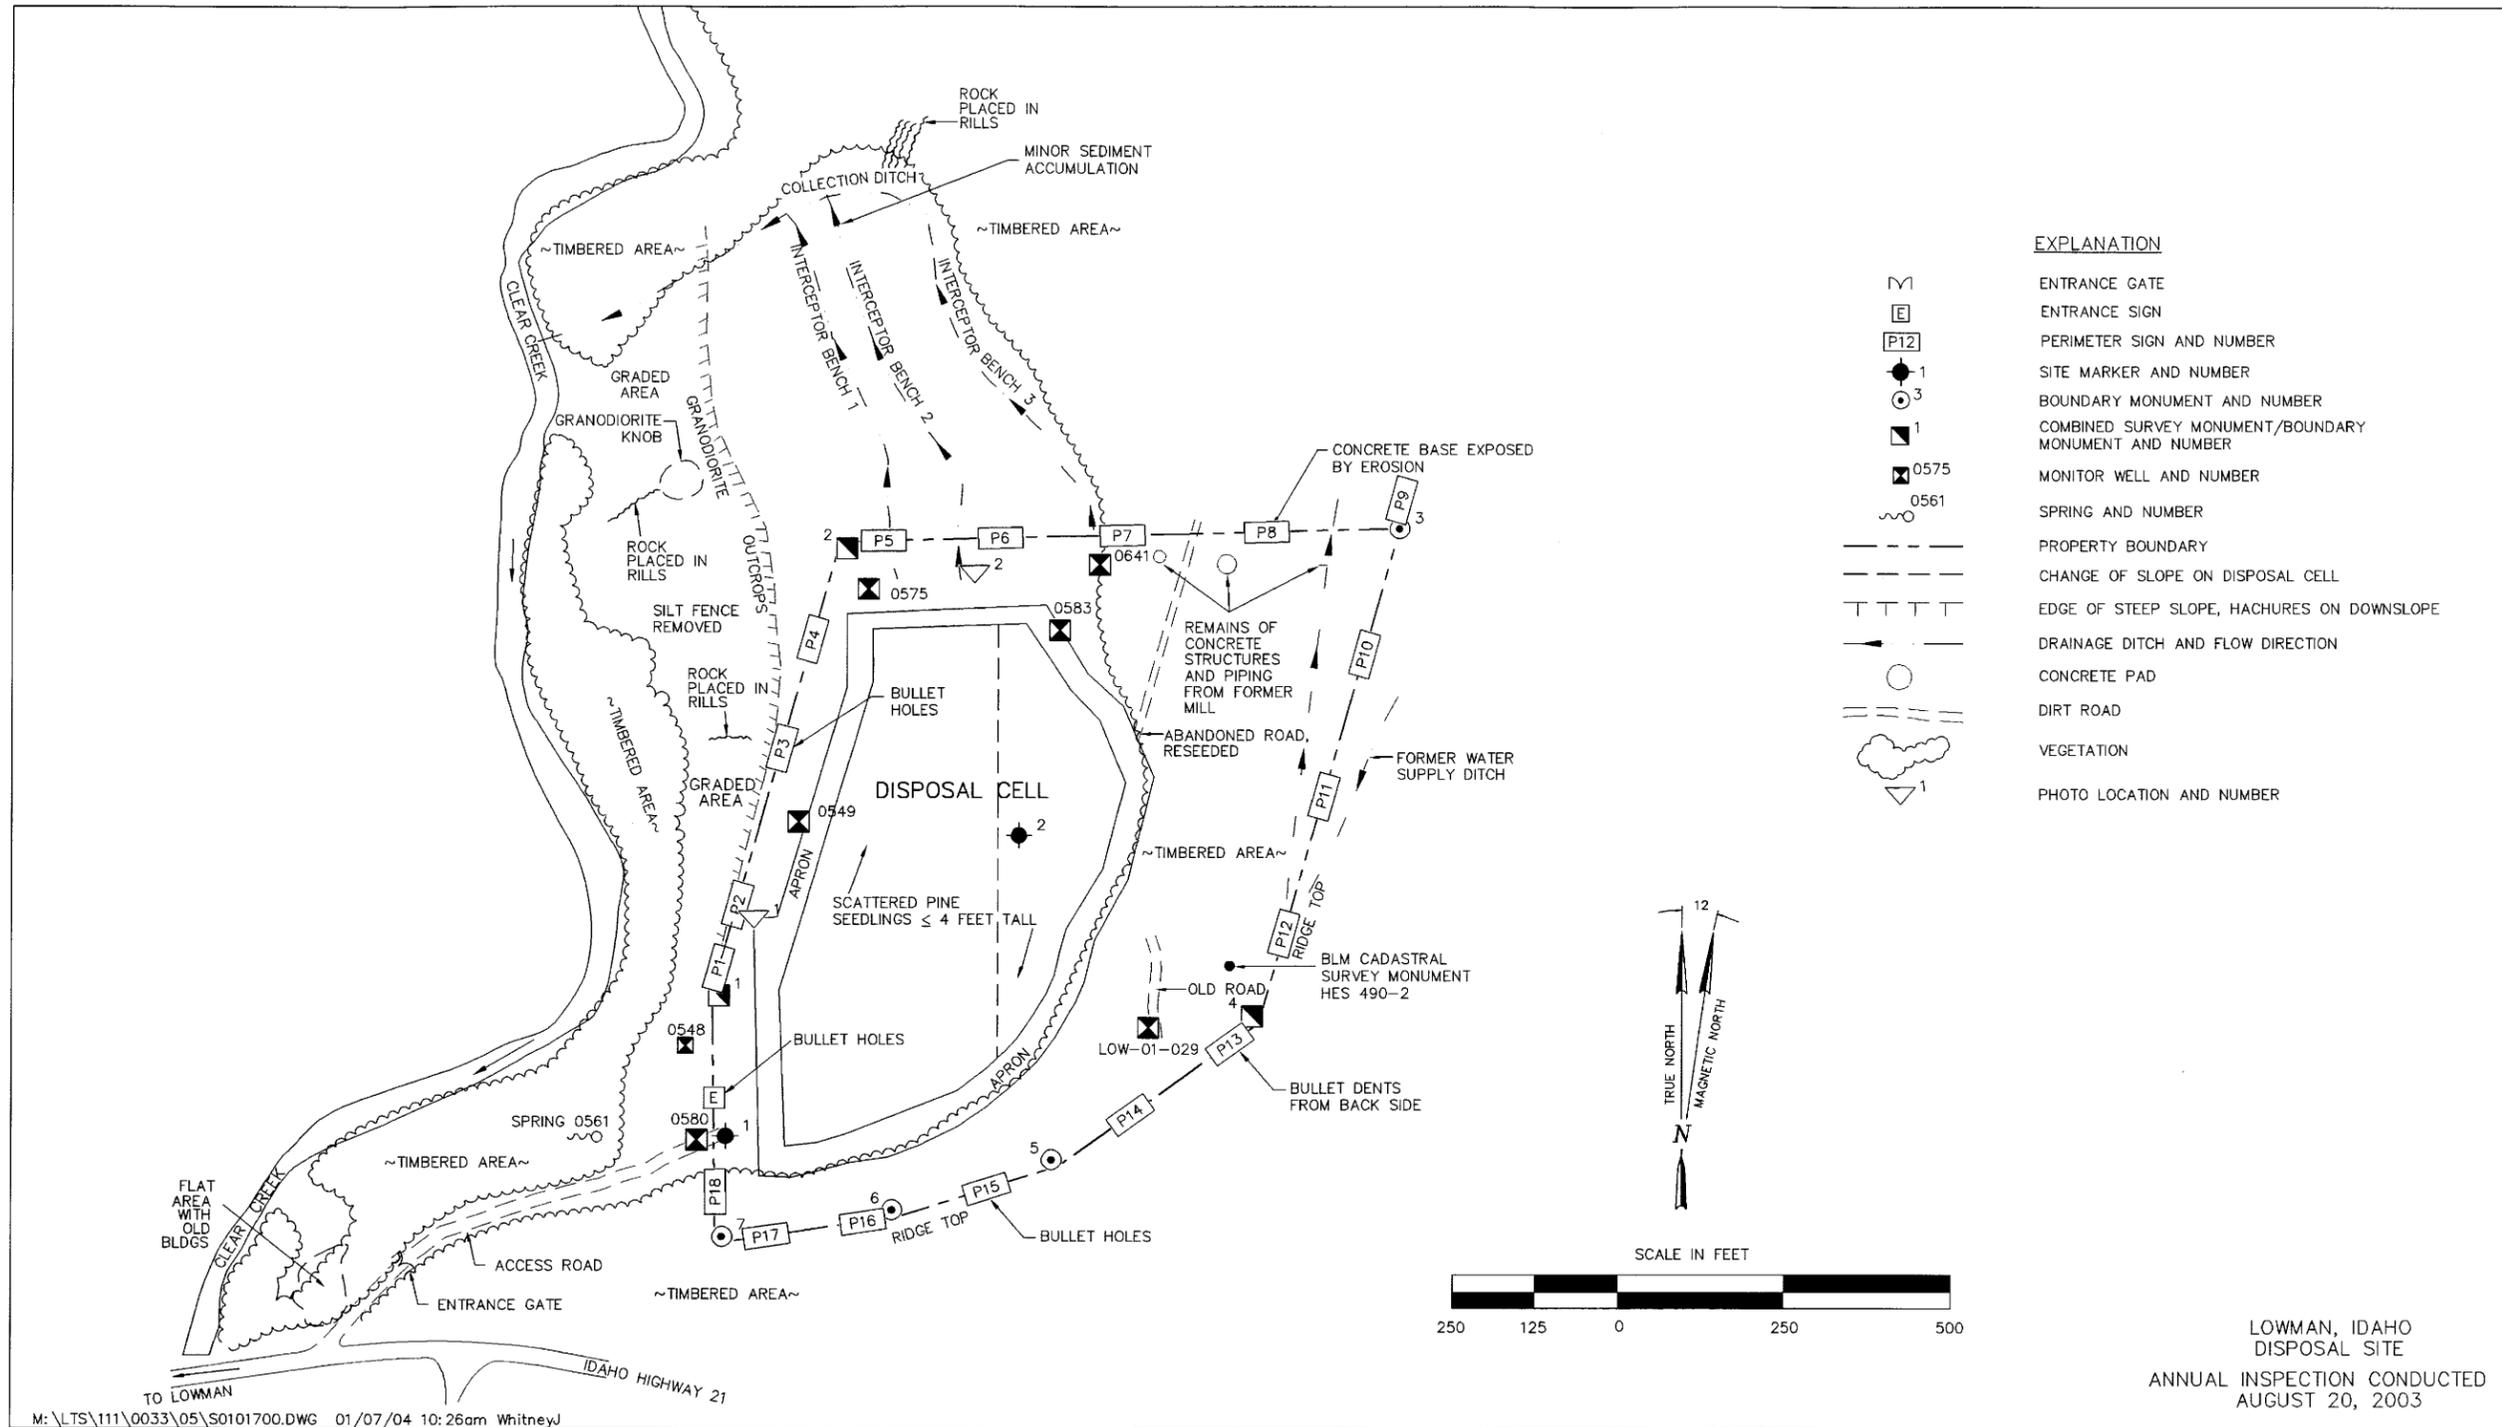
Figure 10-1. 2003 Annual Compliance Drawing for the Lowman, Idaho, Disposal Site

**Area Between the Disposal Cell and the Site Boundary**—The steep slopes east and south of the site were stable with well-established ponderosa pine and grasses. The rills on the slopes immediately north and west of the cell were stable or gone as a result of erosion control and maintenance activities. DOE will continue to monitor this area for erosion.

10B Infestations of several species of noxious weeds continue to be a concern for DOE on and adjacent to the site. Two applications of herbicide were made in 2003, and the success of these treatments will be evaluated in 2004.

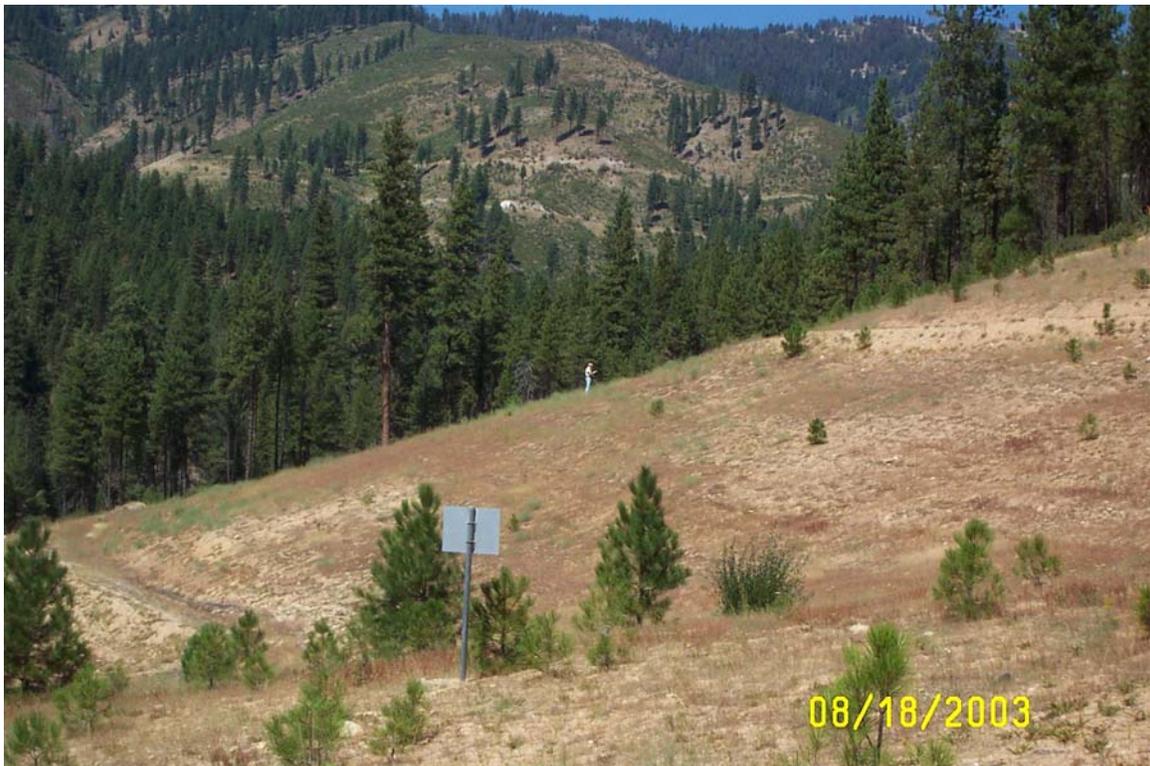
*LOW 8/2003. PL-2. Restored area north of the disposal site.*

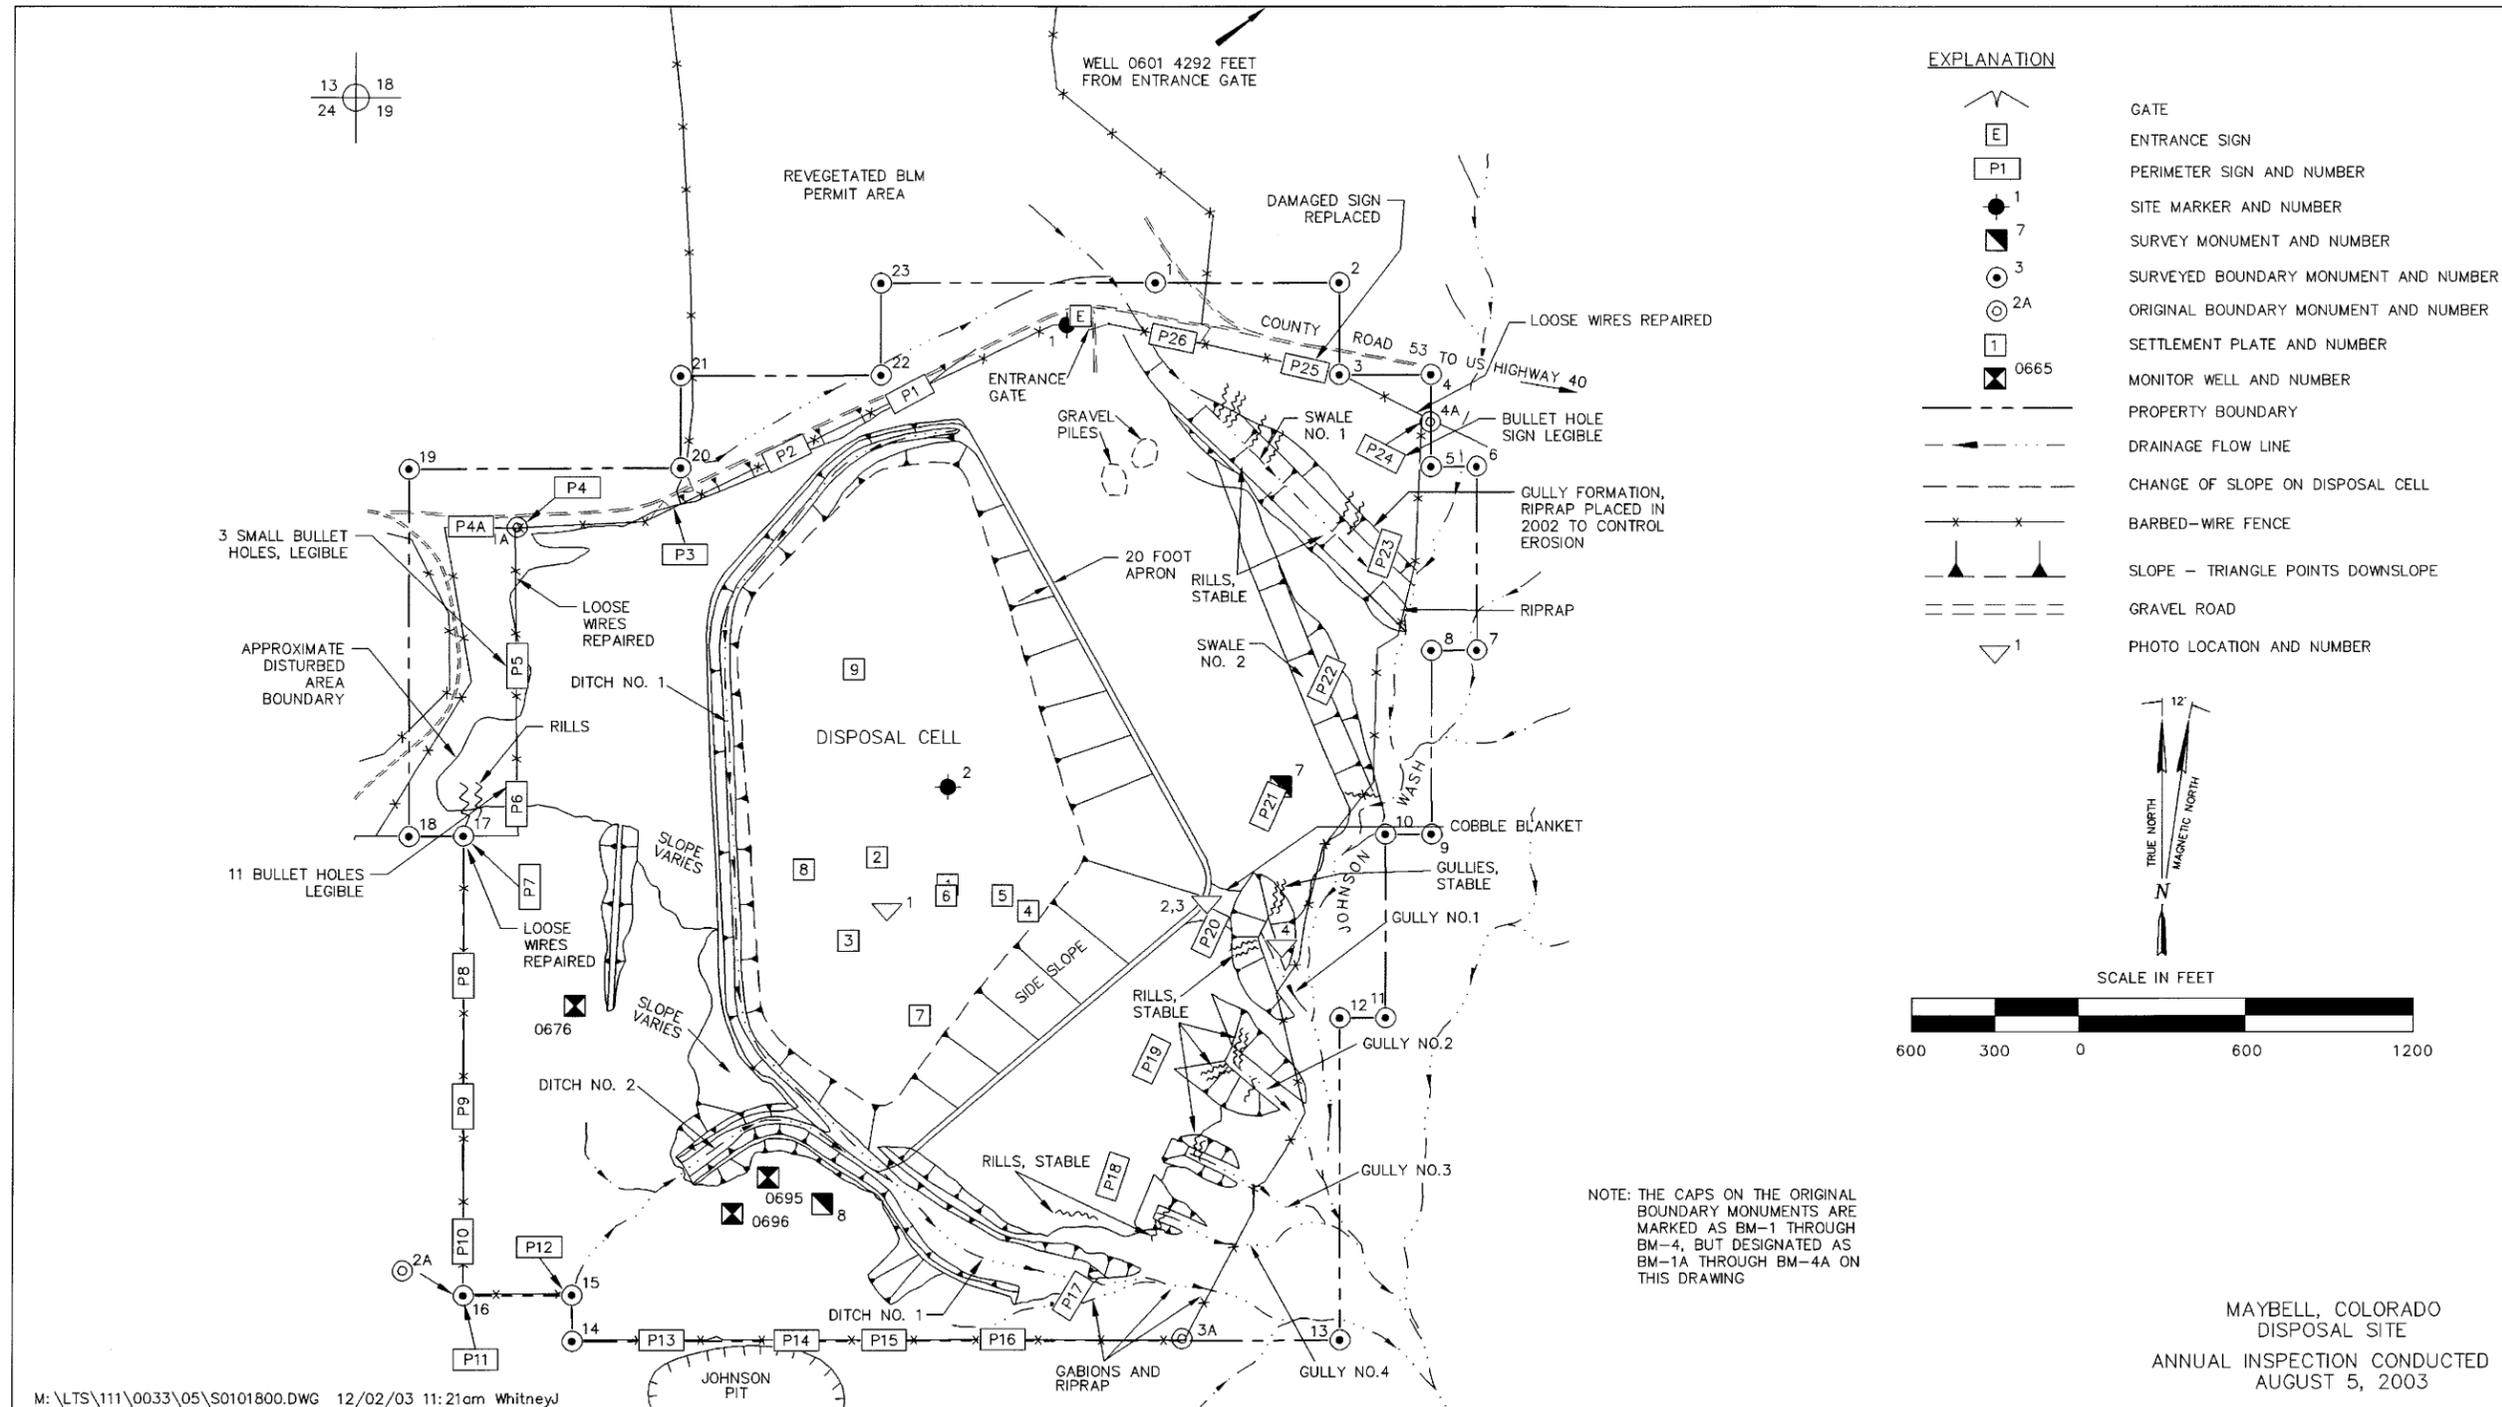
Figure 11-1. 2003 Annual Compliance Drawing for the Maybell, Colorado, Disposal Site

**Disposal Cell**—The disposal cell is armored with rock for erosion protection. No evidence of slumping, settling, erosion, or rock degradation was noted.

11C Occasional plants consisting of deep-rooted species, grasses, and annual weeds were observed on the cell top and side slopes. Deep-rooted plants (tamarisk and rabbitbrush) were cut and their stems were treated with herbicide (PL-1), and patches of unidentified thistle were sprayed with herbicide.

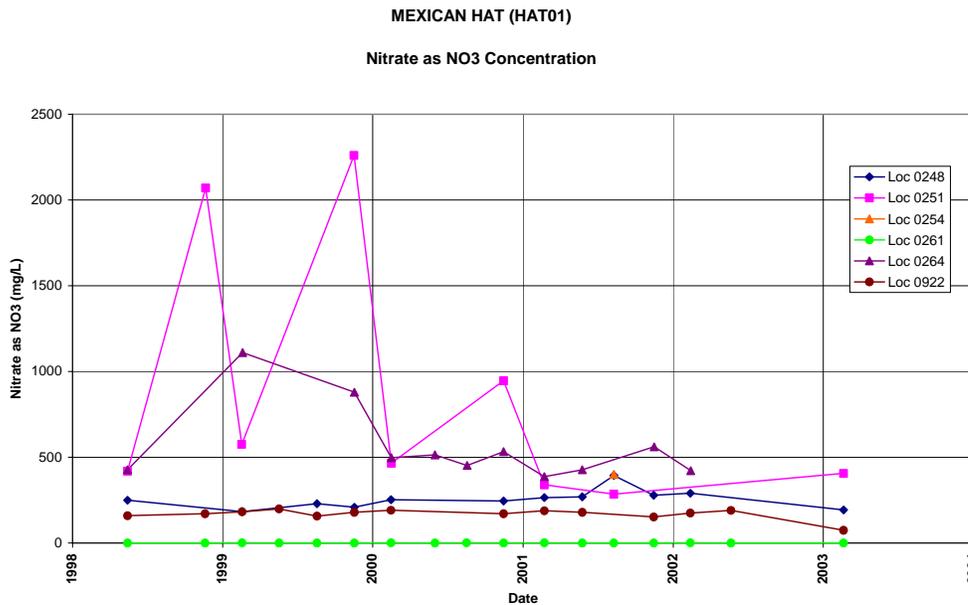
Figure 12–2. Time-Concentration Plots of Nitrate (as NO<sub>3</sub>) in Seep Water at the Mexican Hat, Utah, Disposal Site

Concentrations of nitrate have been variable in the two North Arroyo seeps for the past several years and have declined substantially from greater than 2,000 mg/L to less than 500 mg/L in the past 3 years (Figure 12–2). Nitrate concentrations have remained relatively stable in the Gypsum Creek seeps for the past 5 years ranging from 150 to 400 mg/L. Concentrations in the background seep remain below 1 mg/L.

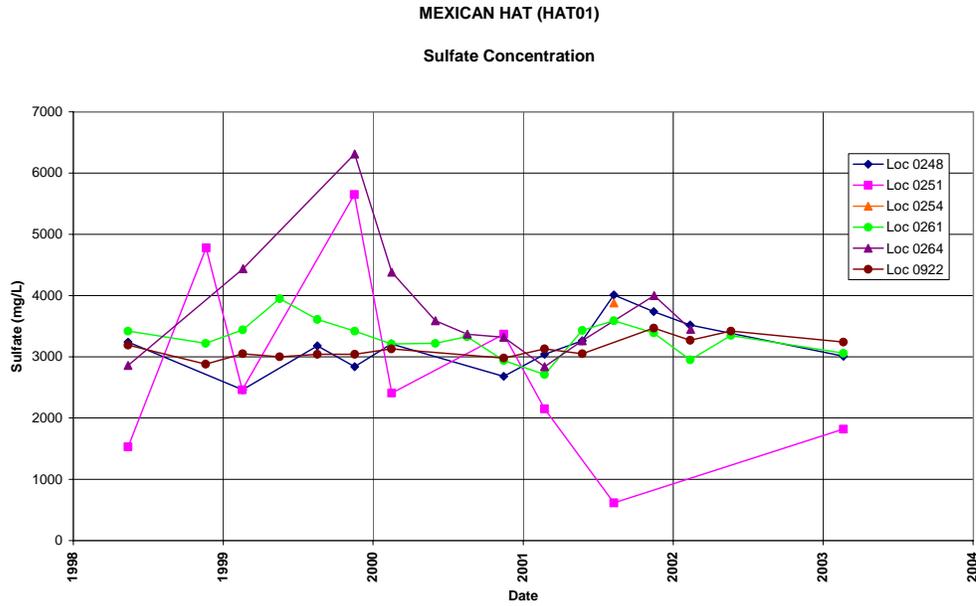
Figure 12–3. Time-Concentration Plots of Sulfate in Seep Water at the Mexican Hat, Utah, Disposal Site

Sulfate concentrations similarly have decreased in the two North Arroyo seeps from greater than 6,000 mg/L to less than 4,000 mg/L since early 2000 (Figure 12–3). Concentrations in the Gypsum Creek seeps and the background seep have remained relatively steady between 3,000 and 4,000 mg/L during this time.

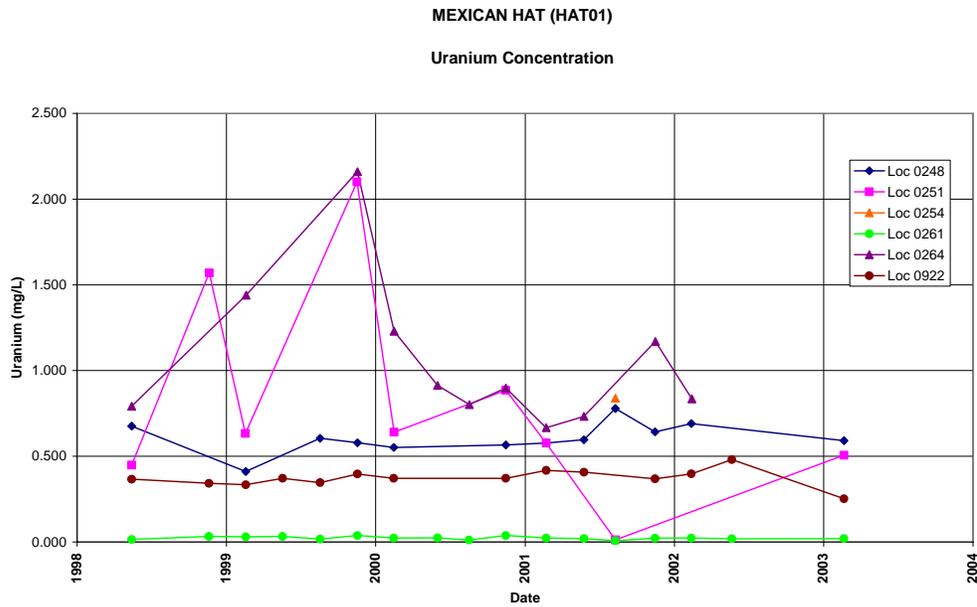
Figure 12–4. Time-Concentration Plots of Uranium in Seep Water at the Mexican Hat, Utah, Disposal Site

Concentrations of uranium in the North Arroyo seeps have decreased from greater than 2.0 mg/L to less than 1.0 mg/L since November 1999 (Figure 12–4). Concentrations remain relatively constant in the Gypsum Creek seeps at approximately 0.5 mg/L. Background levels at seep 0261 averaged 0.024 mg/L for the past several years.

Results of monitoring in 2003 show that concentrations of all target constituents are generally decreasing in the North Arroyo seeps and remaining relatively stable in the Gypsum Creek seeps. No trends of increase in concentrations are evident that would suggest degradation of the disposal cell cover.

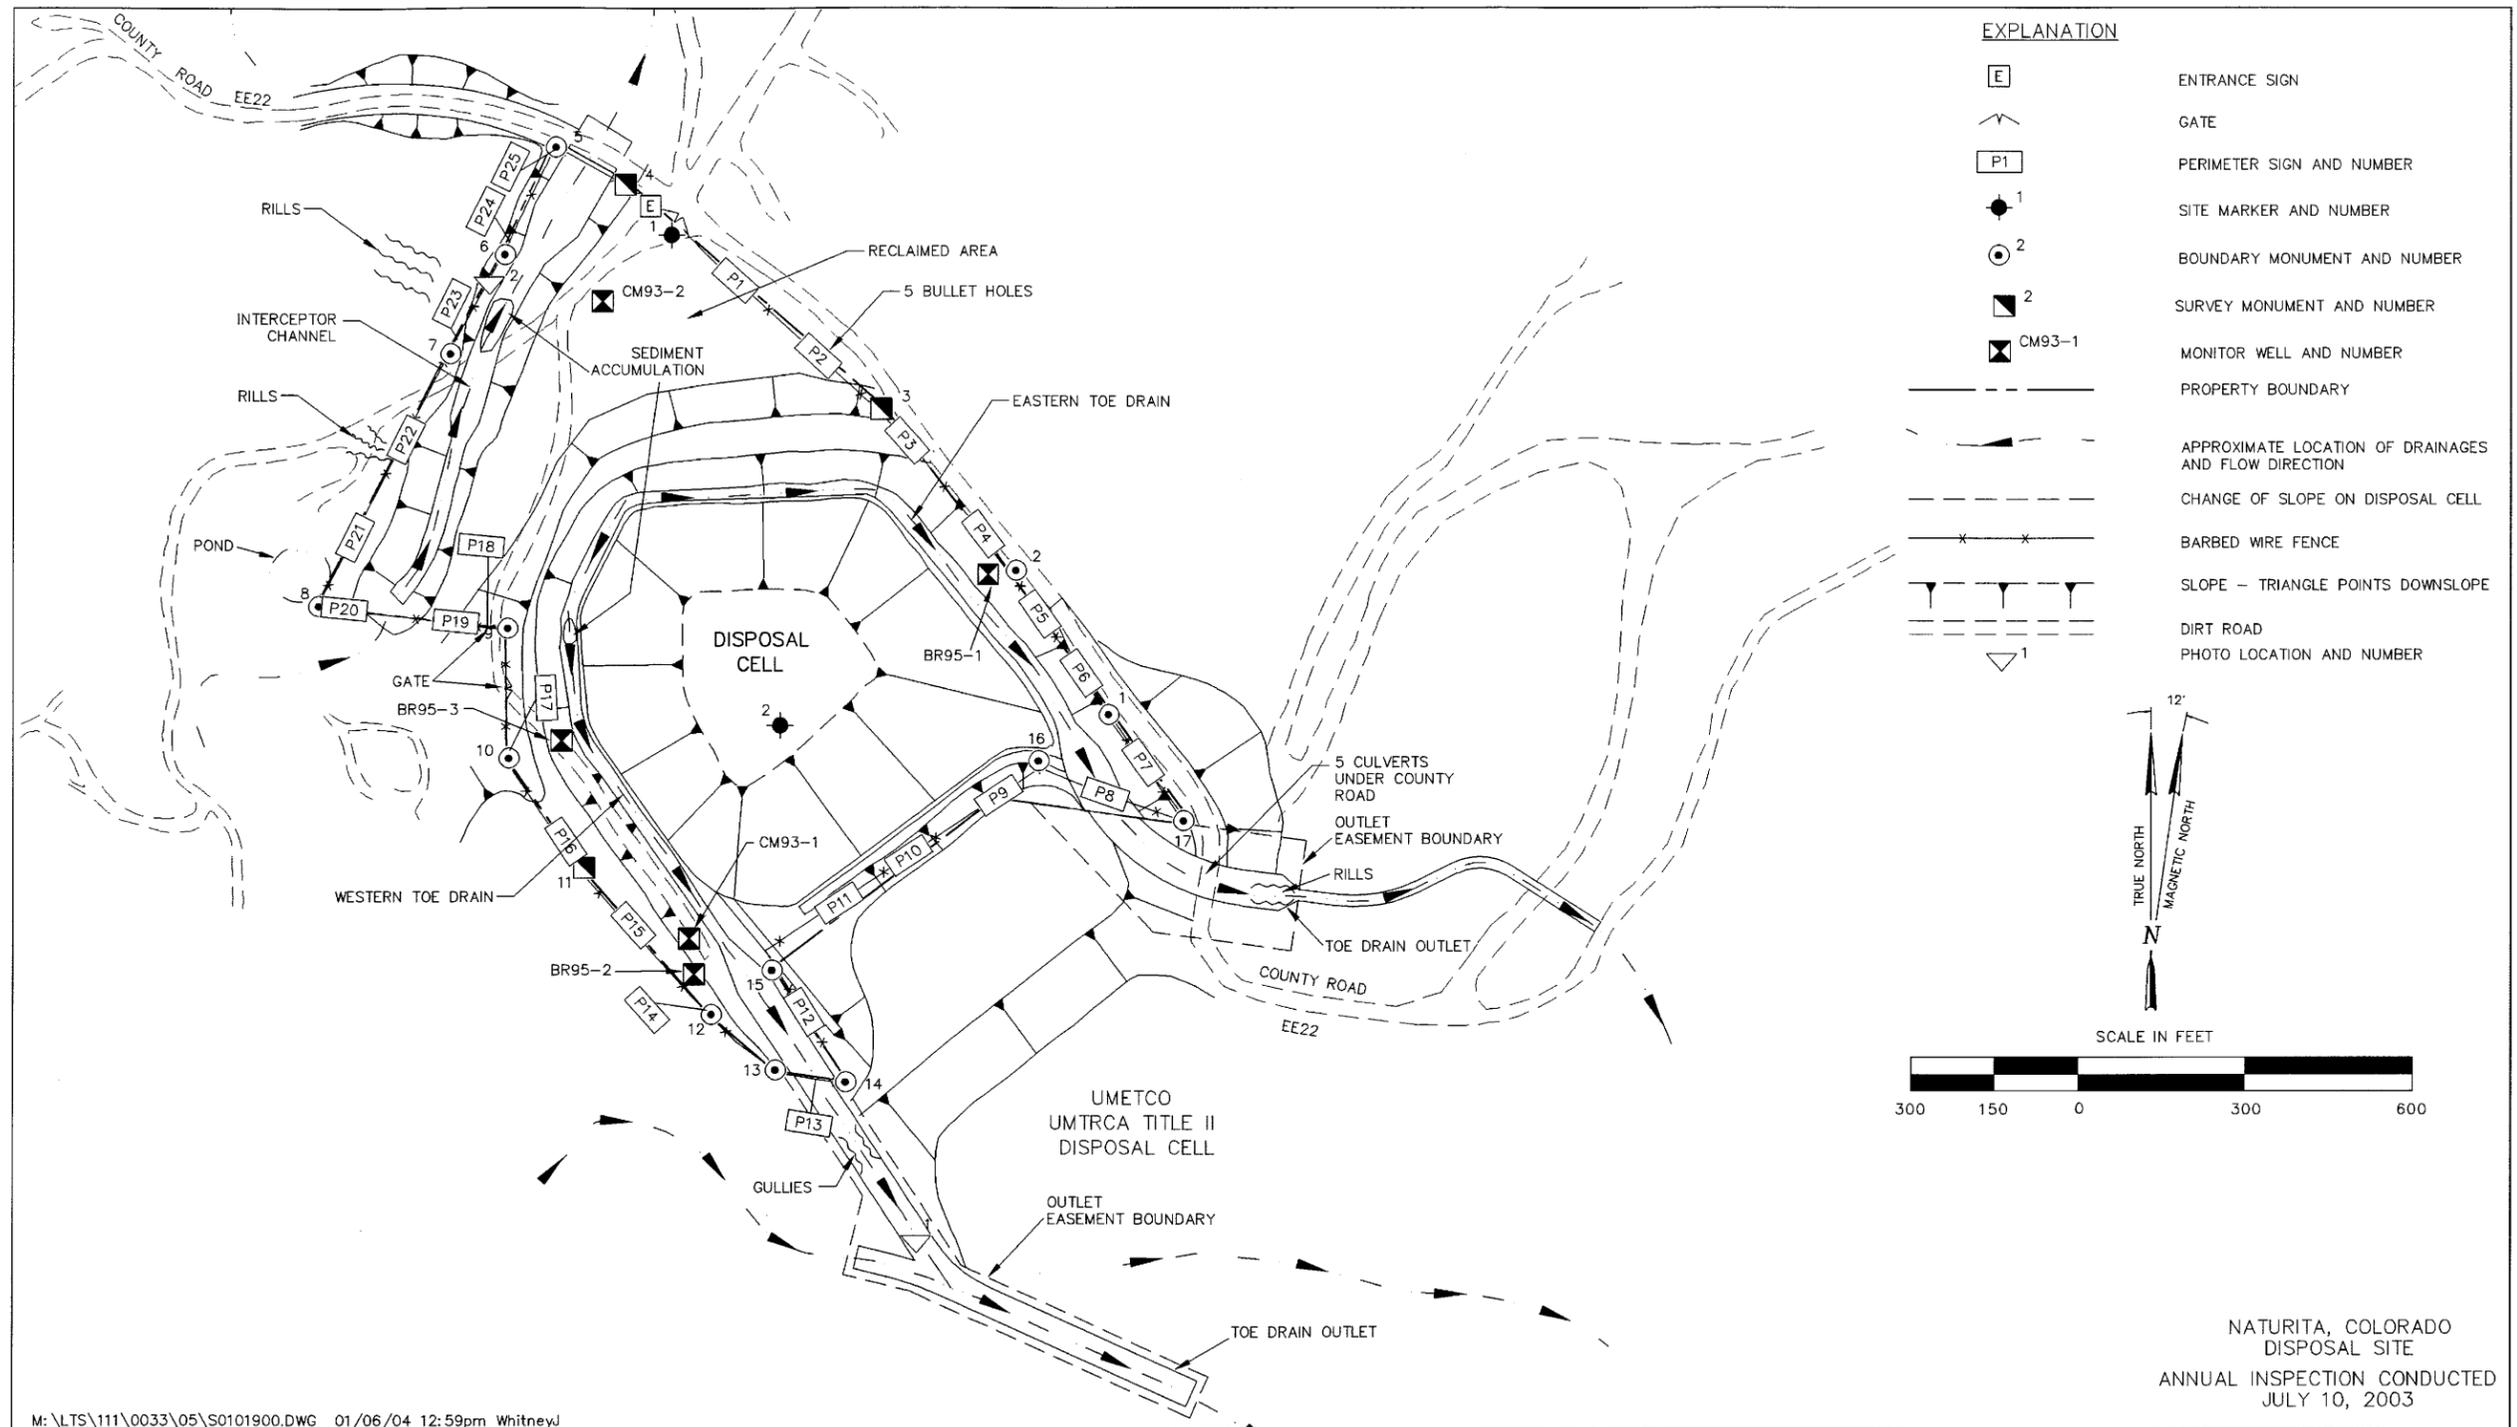
Figure 13-1. 2003 Annual Compliance Drawing for the Naturita, Colorado, Disposal Site

**Toe Drains and Outlets**—Two riprap-filled toe drains collect water from the cell side slopes and divert it to the southeast. The toe drain on the western side of the cell exits through a channel quarried through the wall of the Burbank Pit and into a deep canyon leading to the San Miguel River. Some sediment has accumulated in the upper end of the western toe drain. The eastern toe drain exits through the adjacent UMETCO UMETRCA Title II disposal site and crosses beneath County Road EE22 through five culverts. Some erosion of loose material has occurred in the toe drain outlets, but the underlying sandstone bedrock (PL–1) limits further erosion. Patches of noxious weeds (halogeton and Russian knapweed) were found adjacent to the toe drain outlets; the weeds will be sprayed with herbicide in 2004.

- 13A The U.S. Bureau of Land Management right-of-way permits for the toe drain outlets (the drains extend beyond the property boundary), originally set to expire in 2004, were modified as perpetual easements in 2003. The surveyed easement boundaries are shown on Figure 13-1.
