# 2003 Annual Site Inspection and Monitoring Report for Uranium Mill Tailings Radiation Control Act Title I Disposal Sites

January 2004

Work Performed by S.M. Stoller Corporation under DOE Contract No. DE-AC01-02GJ79491  
for the U.S. Department of Energy, Grand Junction, Colorado

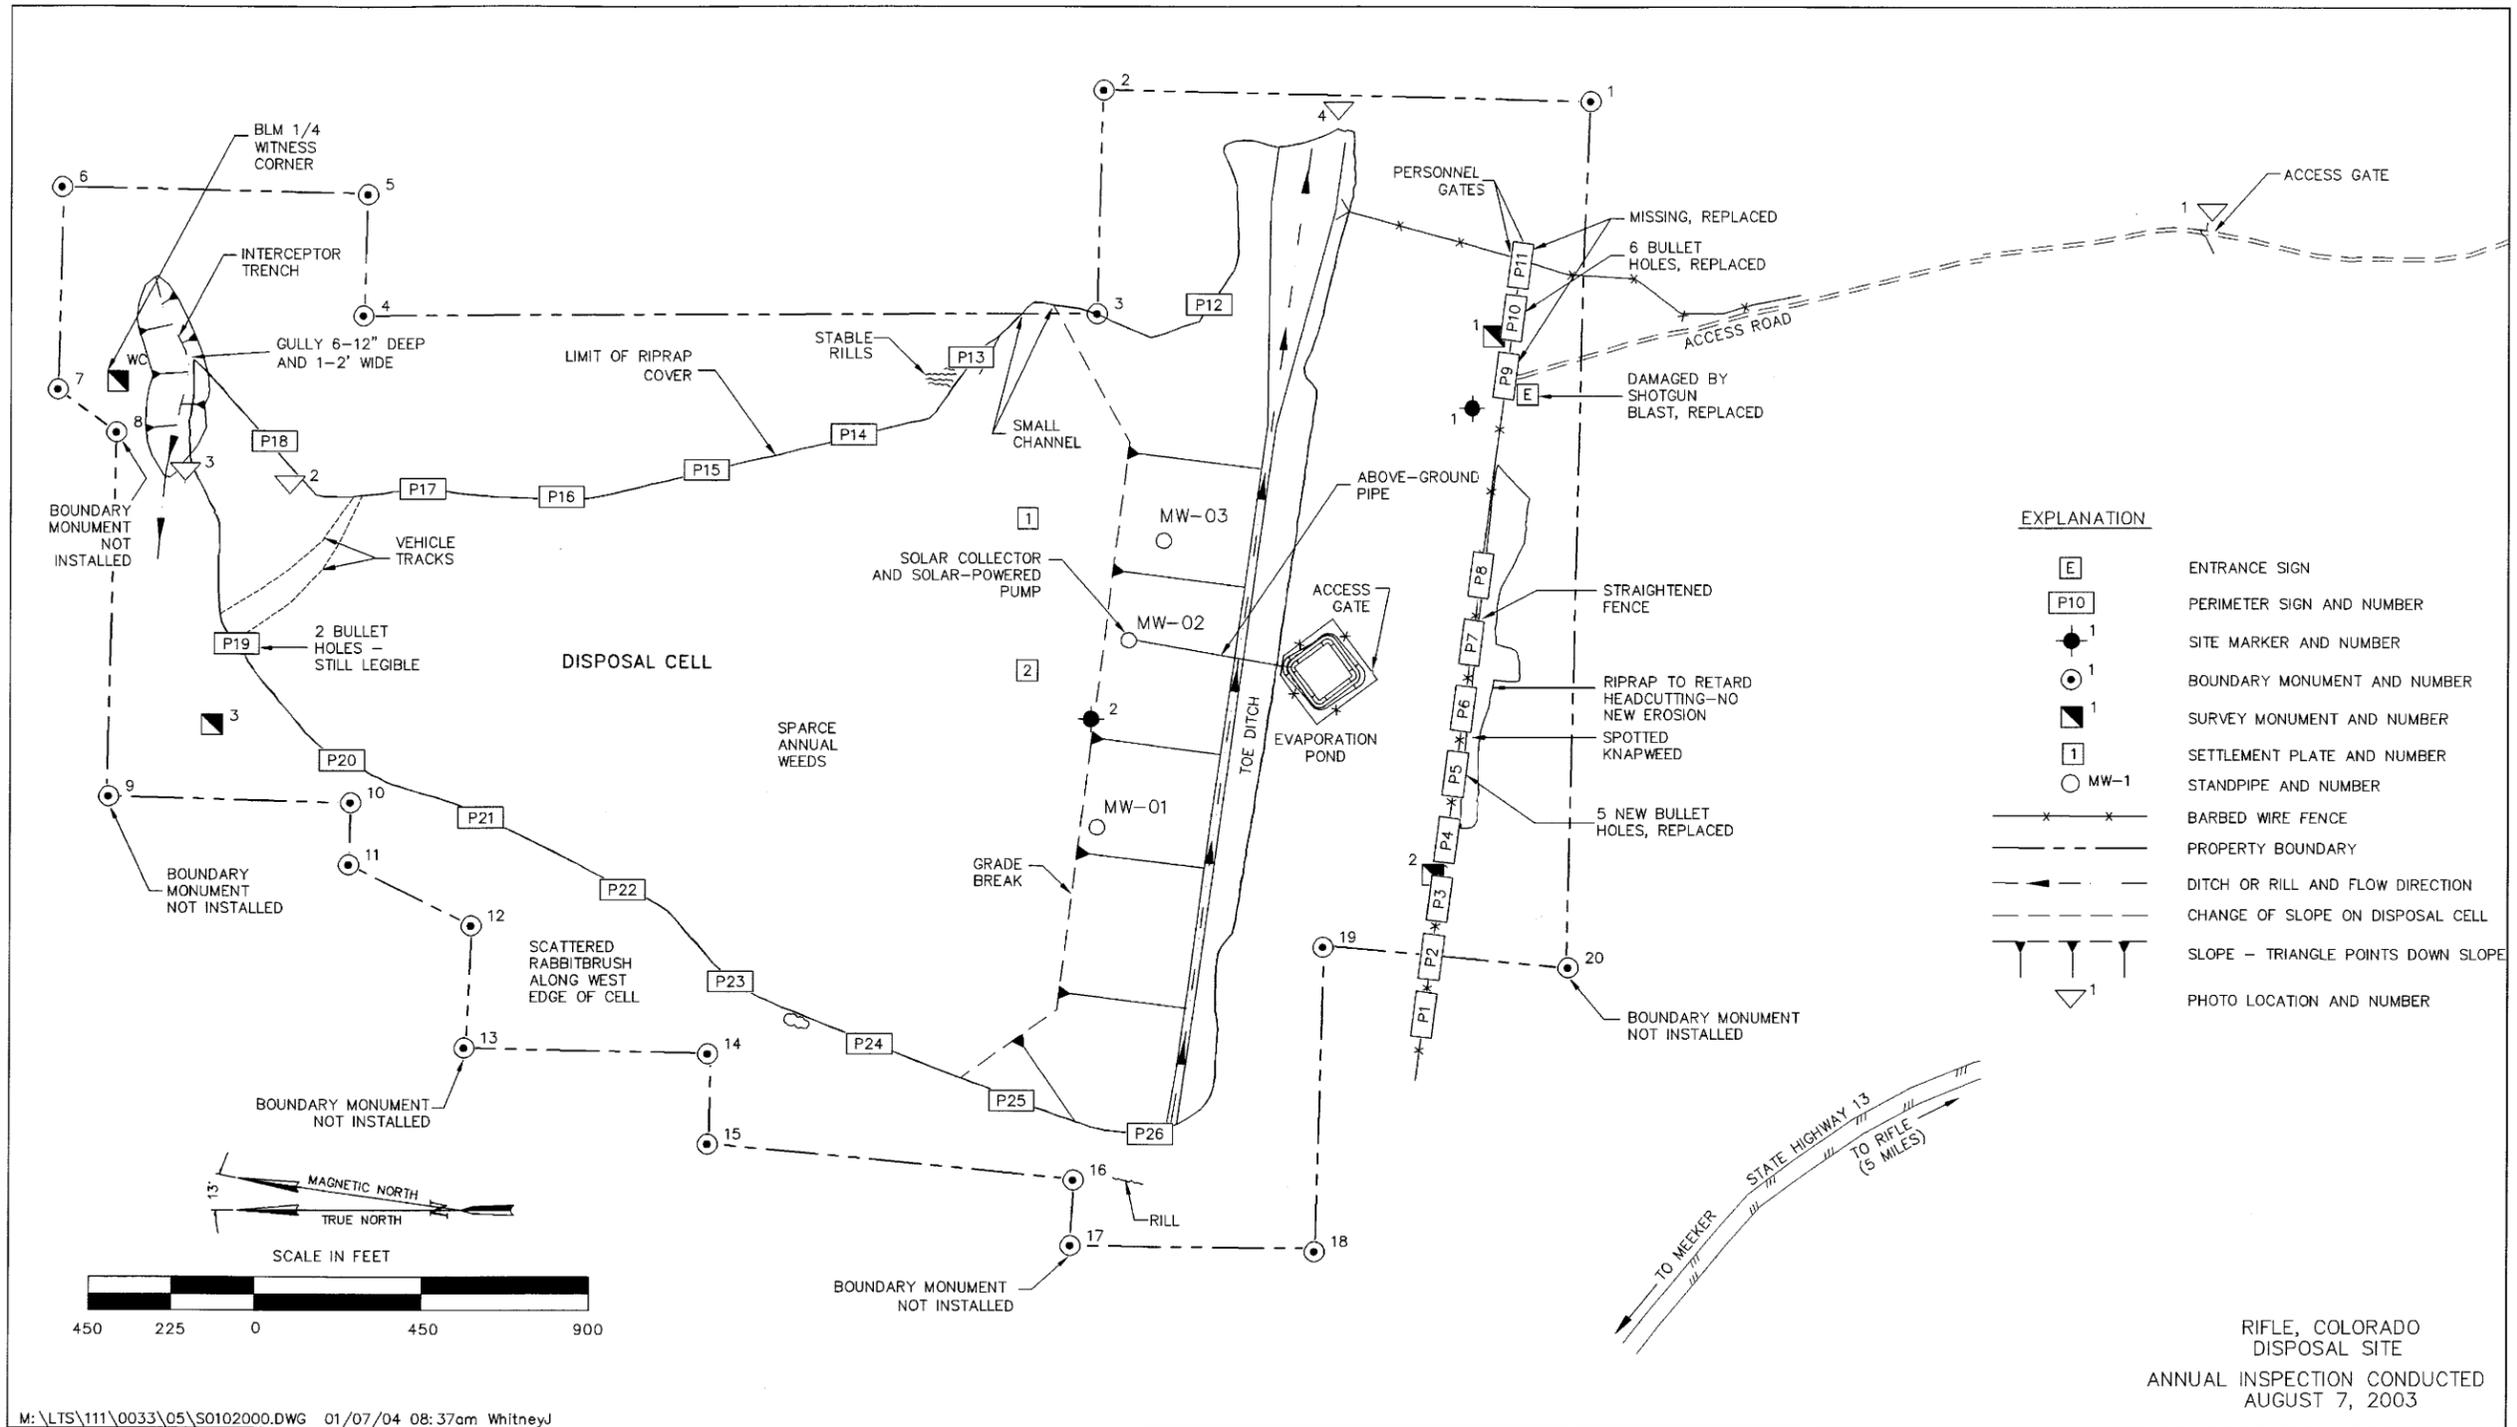
Figure 14-1. 2003 Annual Compliance Drawing for the Rifle, Colorado, Disposal Site

**Standpipes**—The three standpipes, MW-01, MW-02, and MW-03, are located on the south sideslope of the disposal cell. They were undisturbed and in excellent condition. Dataloggers are installed in MW-02 and MW-03 to measure water level fluctuations. There is no data logger in MW-01 because it is too shallow and usually dry. The bottom of MW-01, at elevation 6,021.4 feet, is above the 6,016-foot water level elevation that constitutes the action level for pumping. Dataloggers in standpipes MW-02 and MW-03 are downloaded every 30 days.

A solar-powered pump was installed in MW-02 in 2001 to lower the water level in the cell as specified by the Long-Term Surveillance Plan. The solar collector was in excellent condition at the time of the inspection, and the pump was operating at a rate of 2.9 gallons per minute.

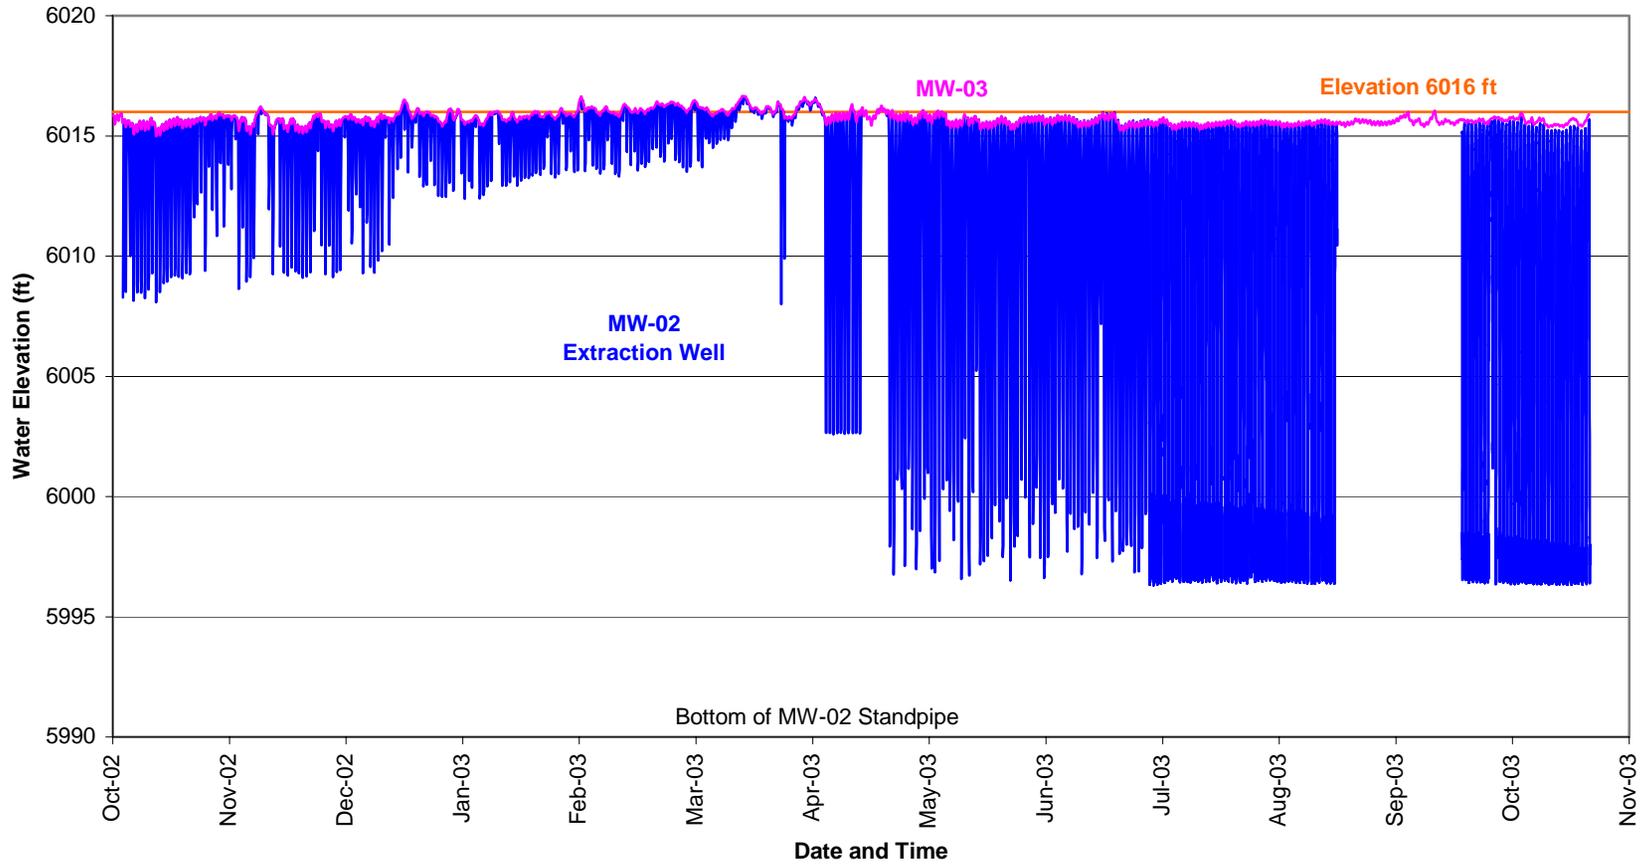
Figure 14-2. Water Levels in Standpipes MW-02 and MW-03 at the Rifle, Colorado, Disposal Site

14F Average water levels (as calculated using linear regression) in MW-02 approached the action level in August 2001. DOE subsequently installed a pump in this standpipe, constructed an evaporation pond, and began pumping from the standpipe to the pond. Since then, a total of approximately 830,000 gallons of water have been extracted from the disposal cell, and water levels have slowly decreased as shown by datalogger measurements (Figure 14-2).

The discharge rate from the solar-powered pump currently averages less than 3 gallons per minute during periods of operation. The oscillation in the datalogger trace for MW-02 in Figure 14-2 represents drawdown in the standpipe during pumping, and recovery of the water level when pumping ceases. The normal recording interval for the dataloggers is every 4 hours. However, to better track activities in the extraction well (MW-02), the interval was changed to every 5 minutes in July 2003. Gaps in the plot for MW-02 reflect periods of datalogger shutdown.

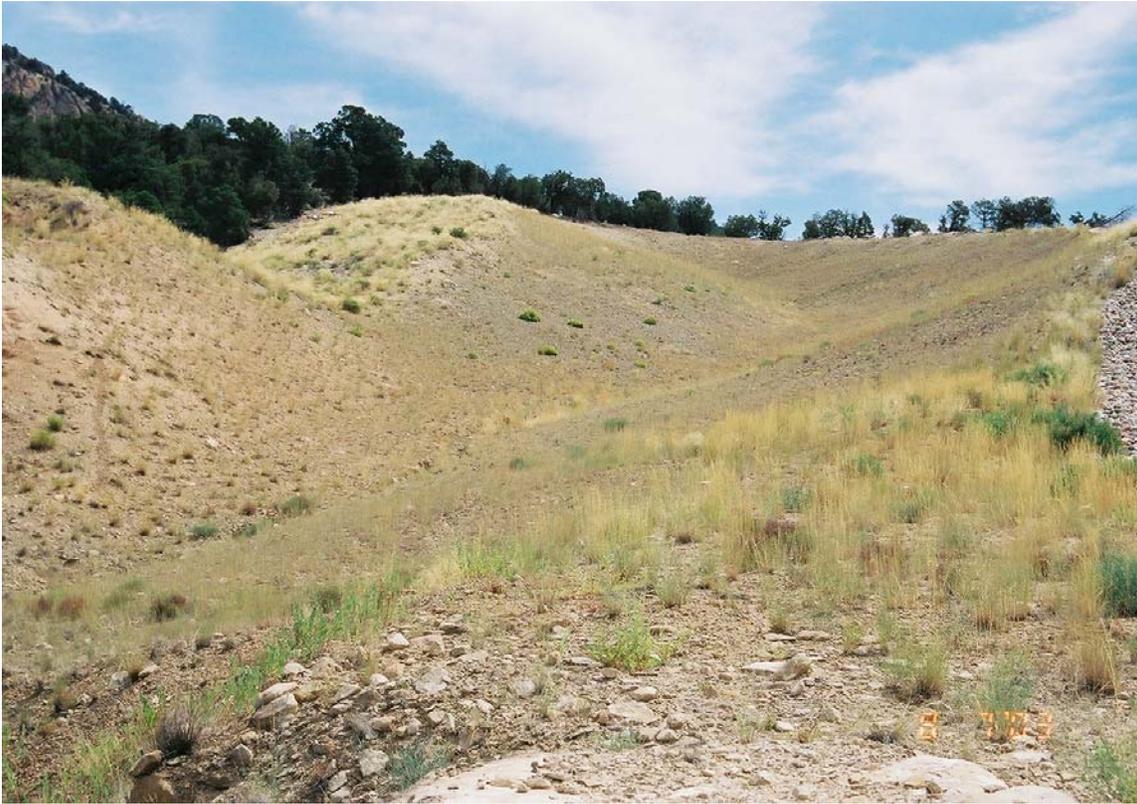
*RFL 8/2003. PL-3. Interceptor trench at the north end of the disposal cell.*

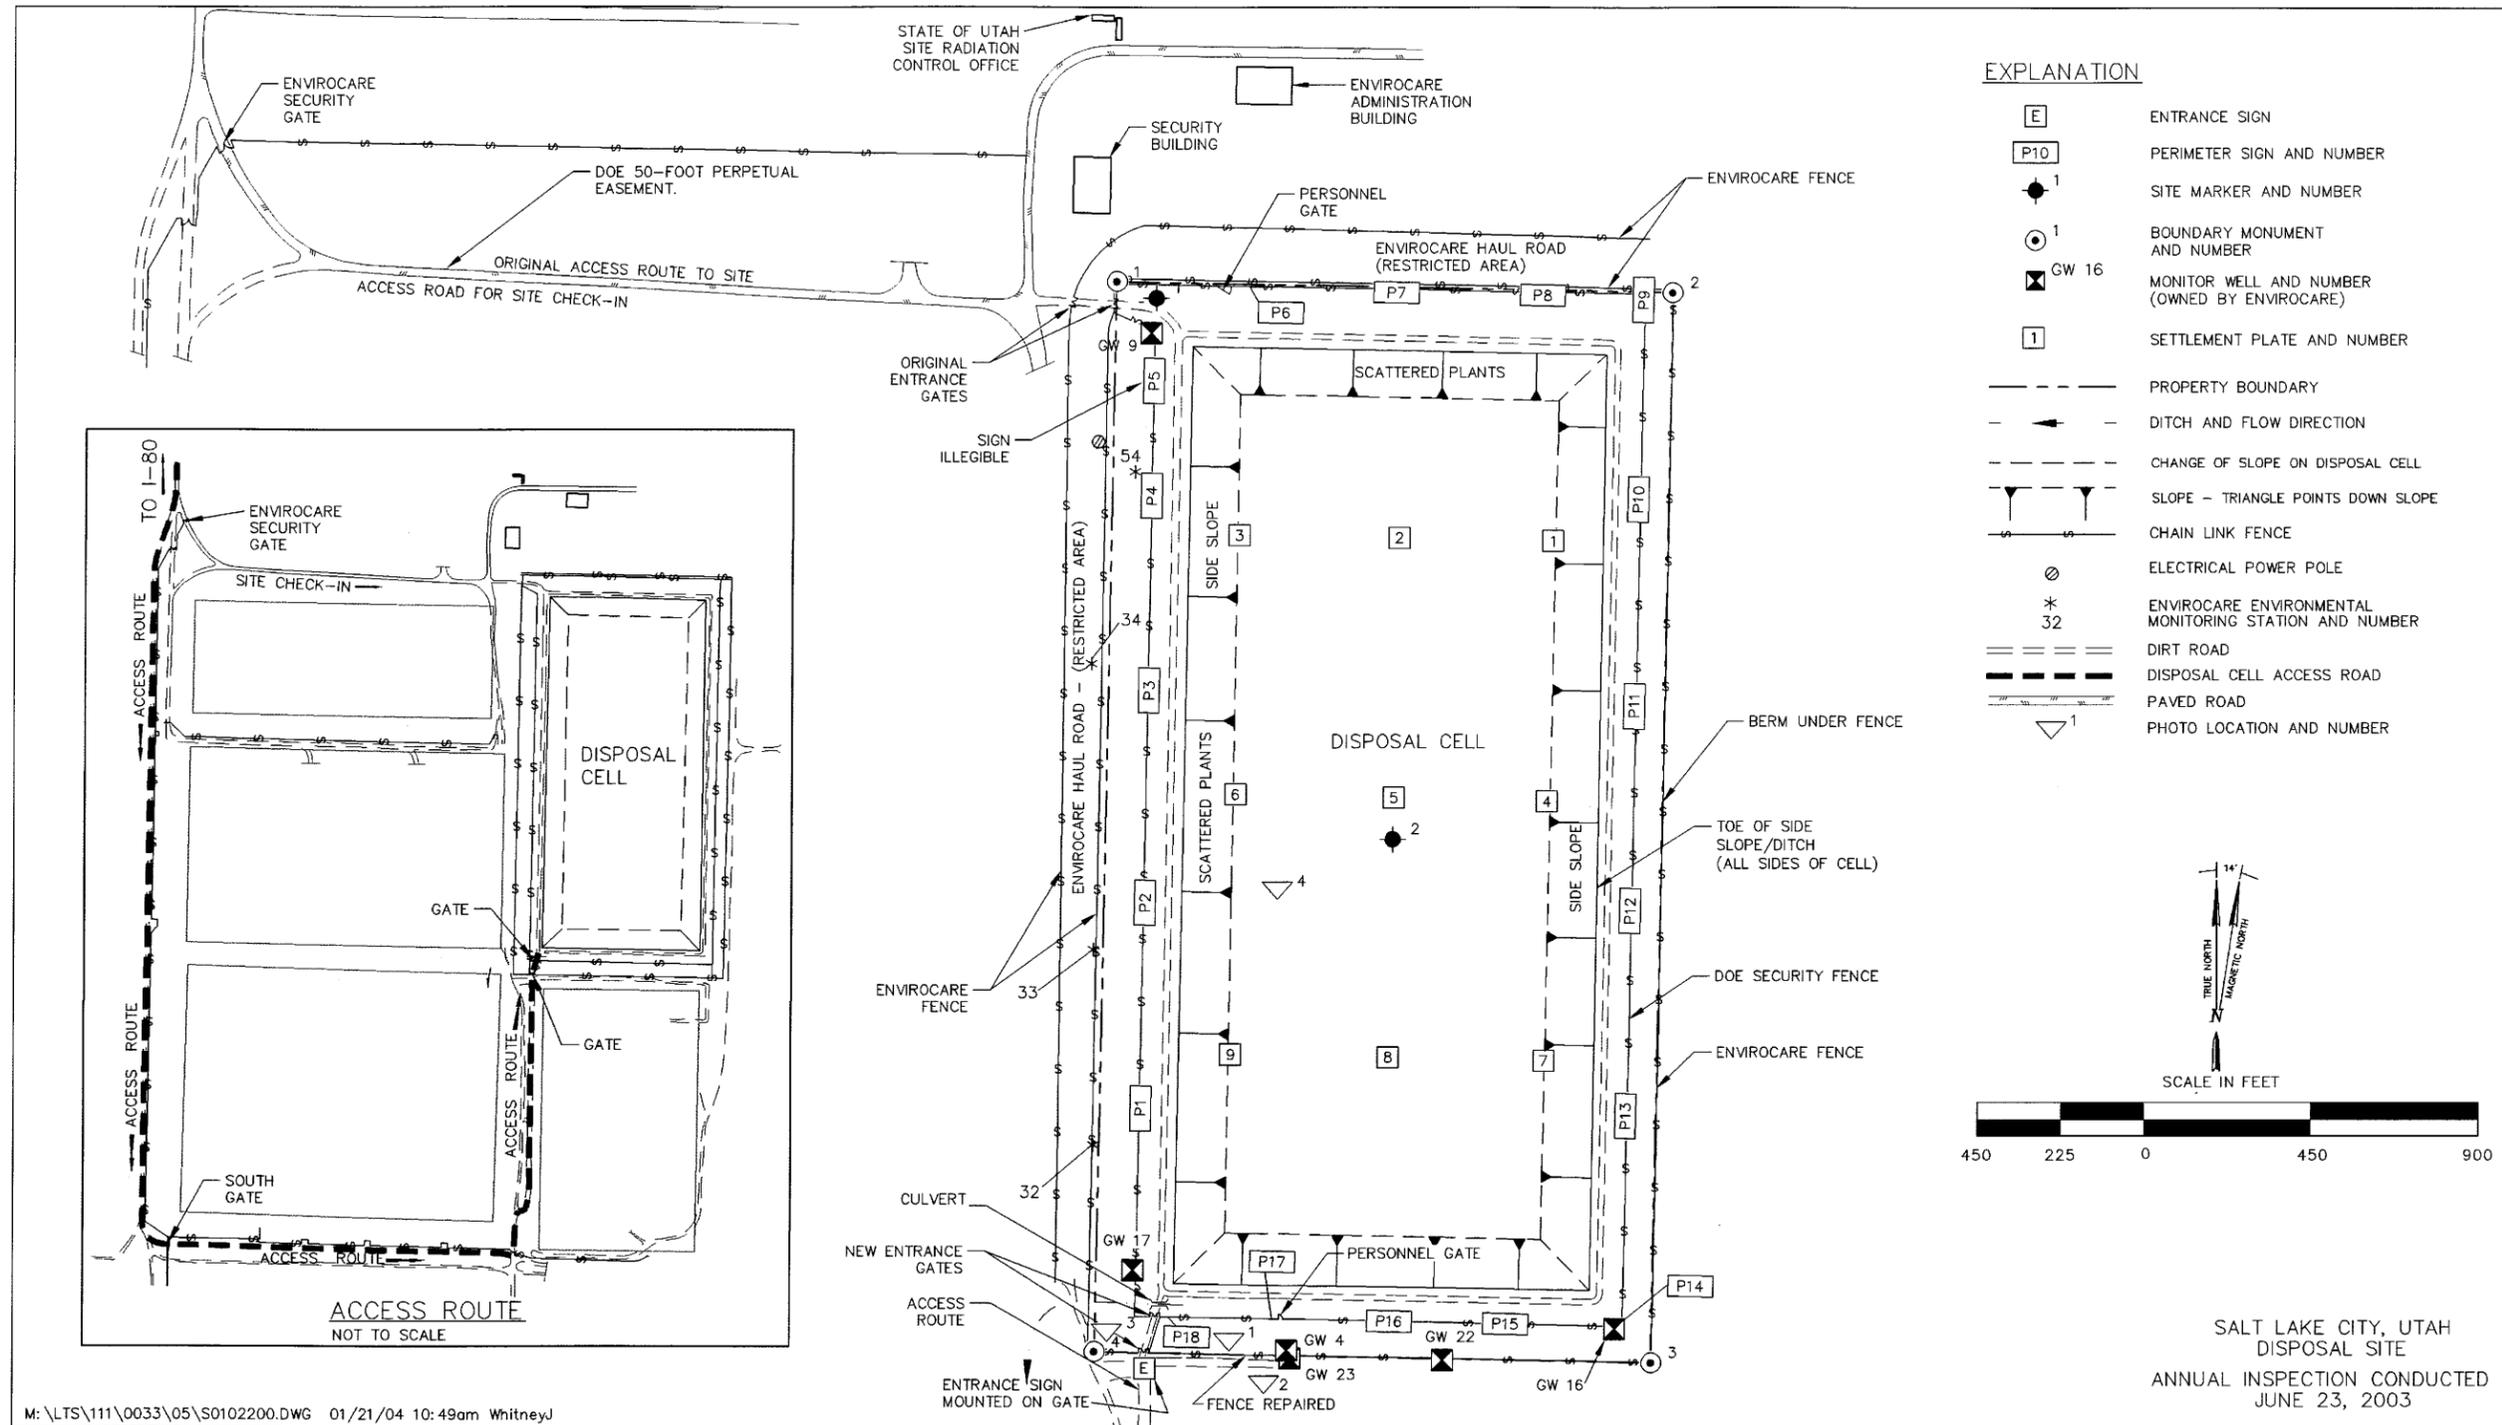
Figure 15-1. 2003 Annual Compliance Drawing for the Salt Lake (South Clive), Utah, Disposal Site

**Top and Side Slopes of the Disposal Cell**—The top and side slopes of the disposal cell are armored with riprap and were in excellent condition. Inspectors found no evidence of settling, slumping, or instability on the side slopes. Sparse vegetation was present on the side slopes but currently does not pose a problem.

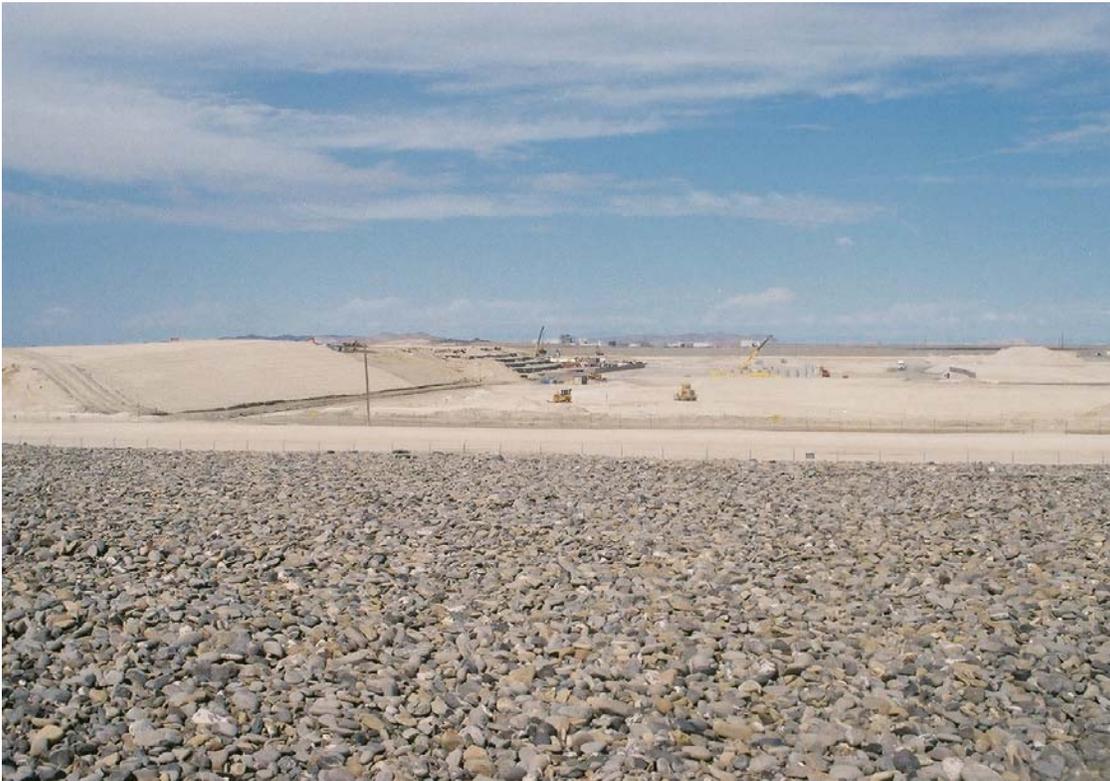
*SLC 6/2003. PL-4. Envirocare Class A cell under construction west of the DOE disposal cell.*

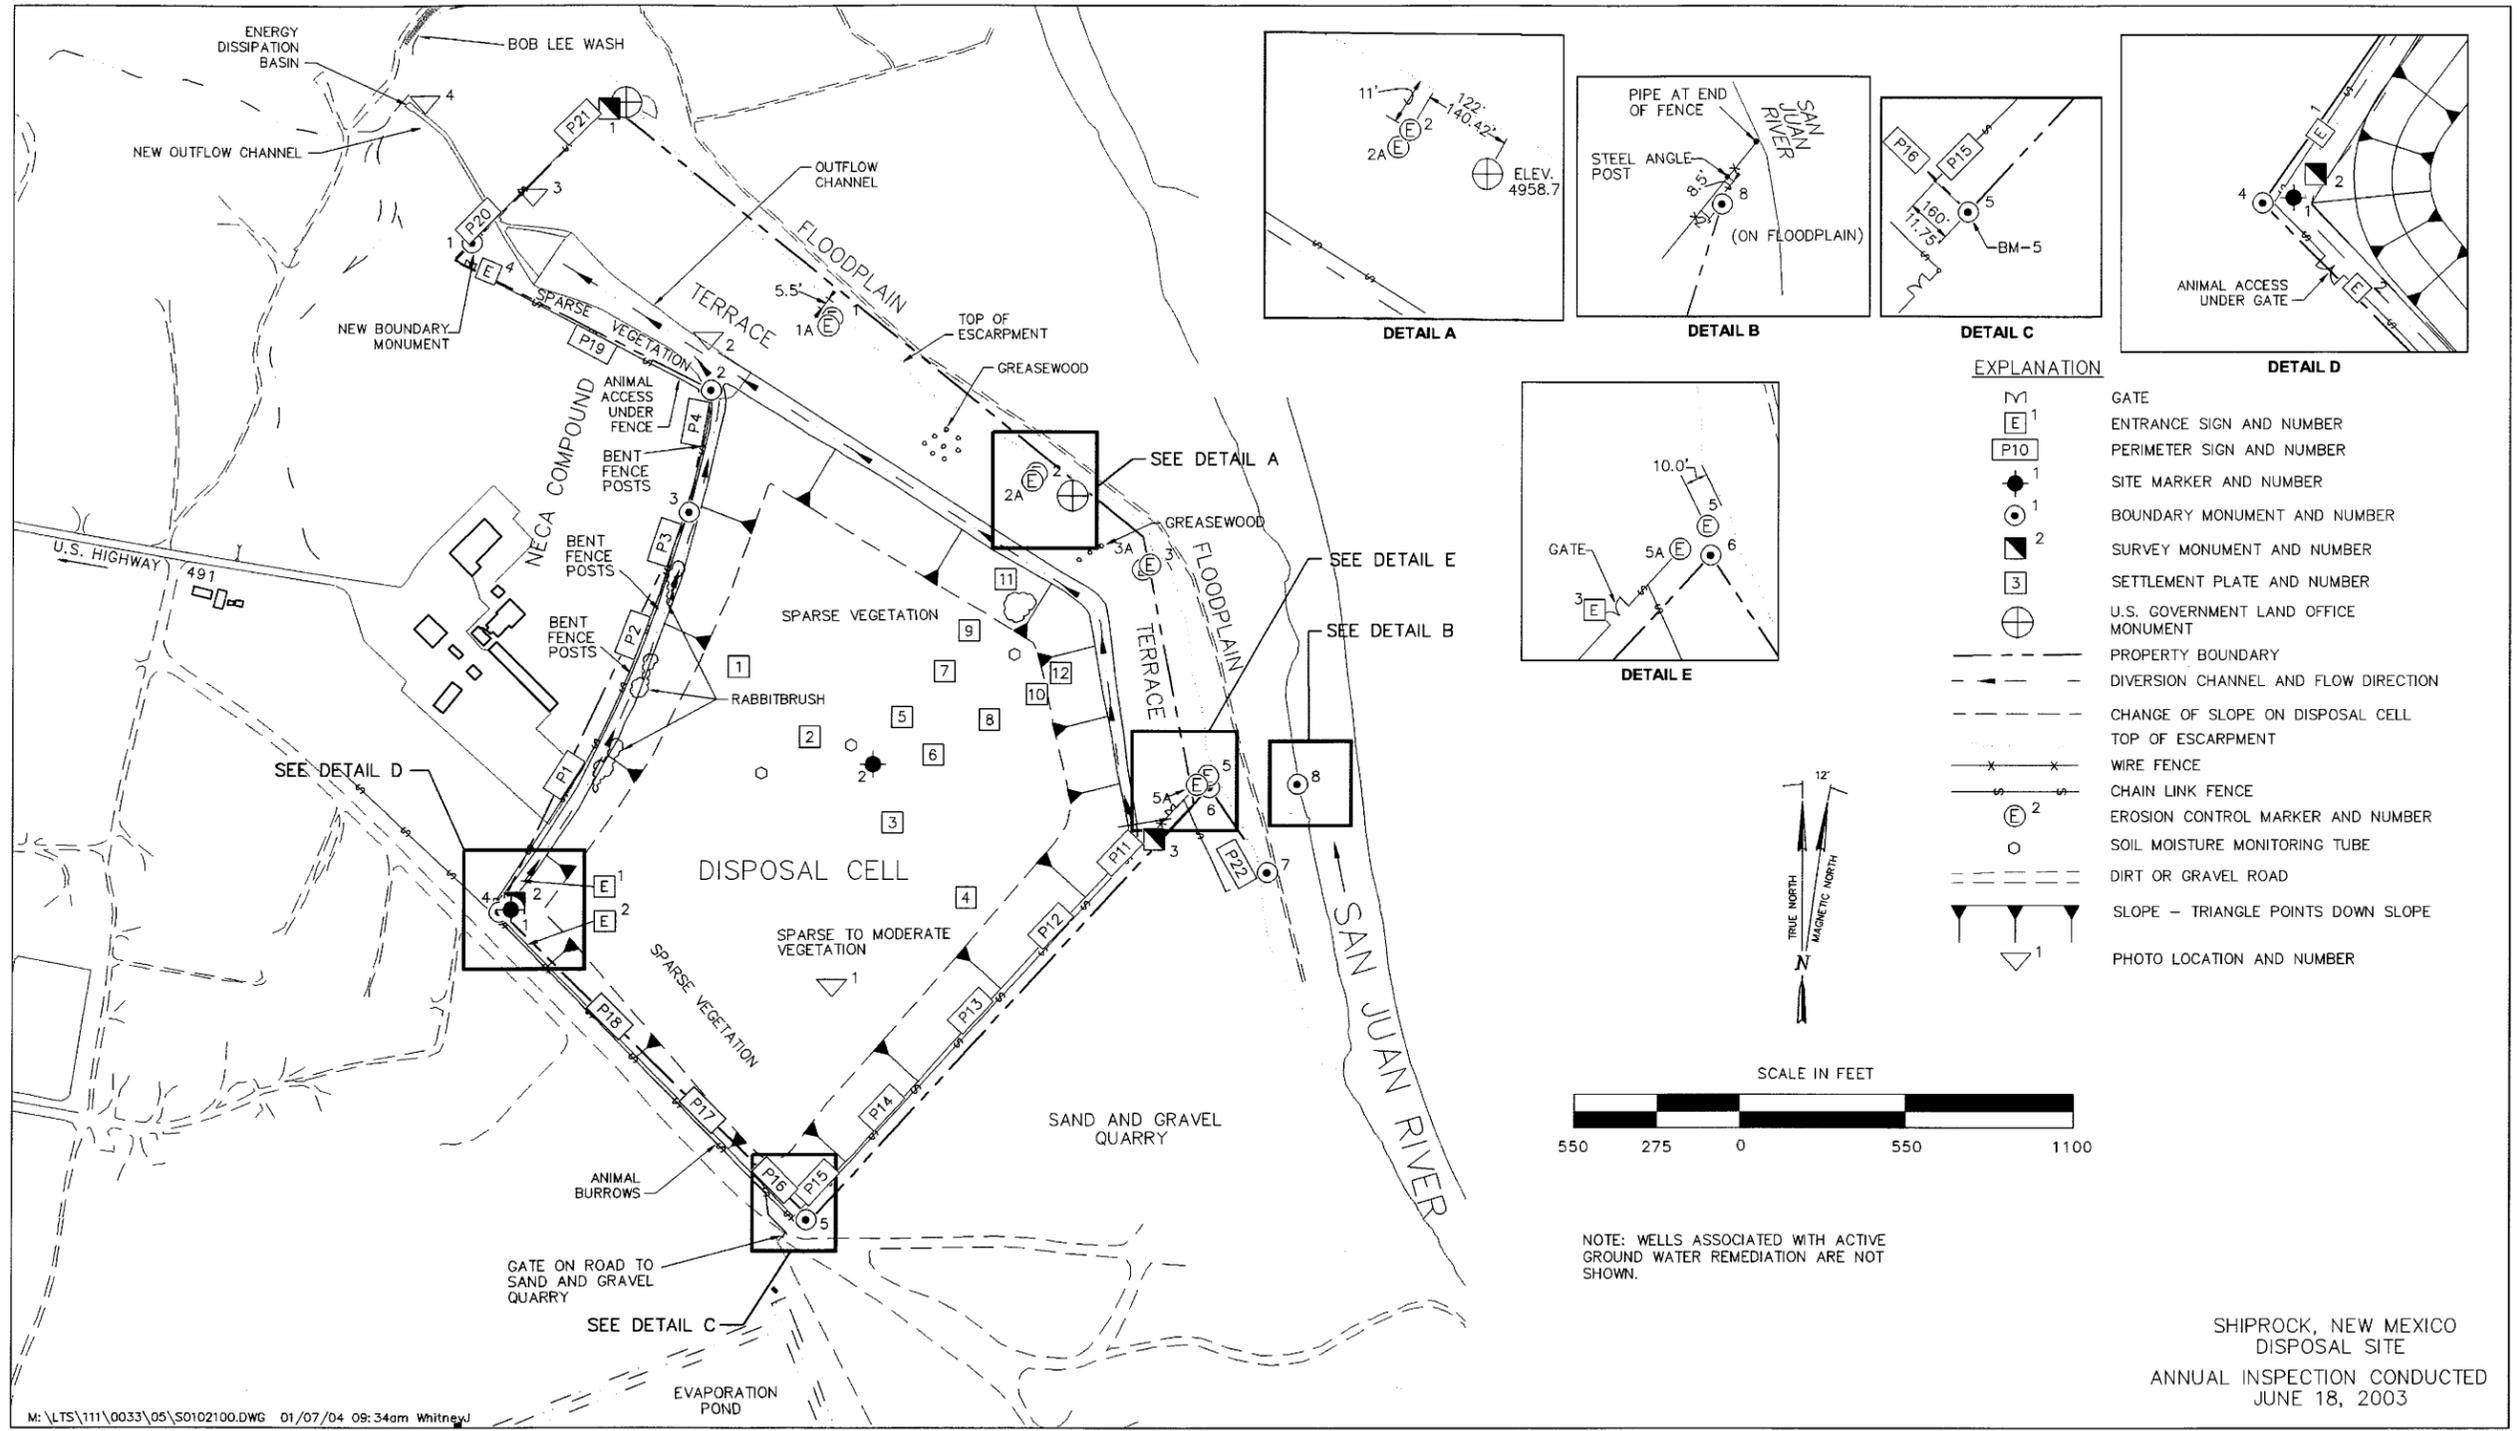
Figure 16-1. 2003 Annual Compliance Drawing for the Shiprock, New Mexico, Disposal Site

16C Significant vegetation growth has been noted during past inspections on the cell top and the east, northeast, and northwest side slopes. These areas were sprayed in June 2001 in a continuing effort to reduce the seed source and control future plant encroachment on the disposal cell. Numerous patches of annual grasses and weeds were present on the cell top and the side slopes in 2003. Several deep-rooted woody shrubs were found on the cell top and were cut and treated with herbicide (PL-1). The population of woody shrubs growing on the cell side slopes continues to increase. The DOE will continue to monitor and control vegetation growth to maintain the performance of the cell.

Diversion channels around the base of the disposal cell were in good condition. Site drainage is ultimately directed toward the outflow channel at the northwest corner of the site. Rock cover in the outflow channel was in good condition. Vegetation is increasing in the diversion and outflow channels (PL-2); however, the performance of the channels is not impaired.

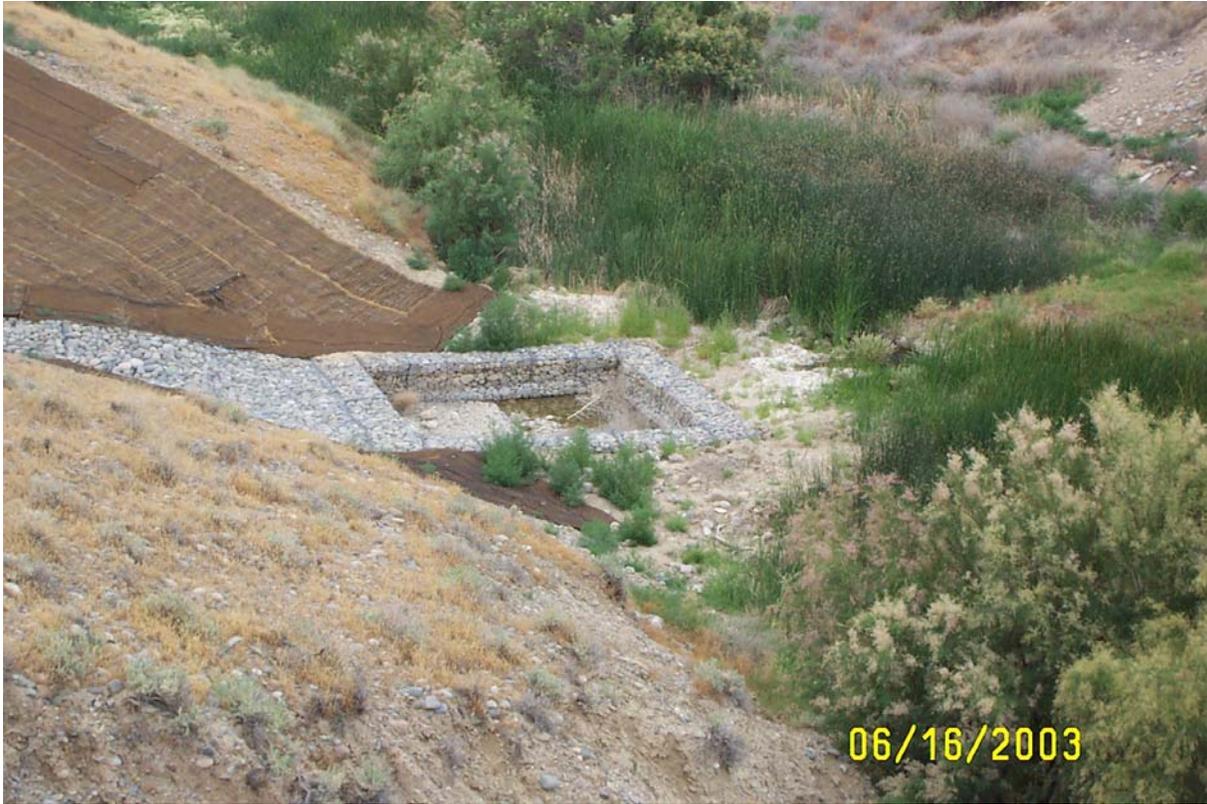
*SHP 6/2003. PL-4. Energy dissipation basin at the mouth of the outflow channel in Bob Lee Wash.*

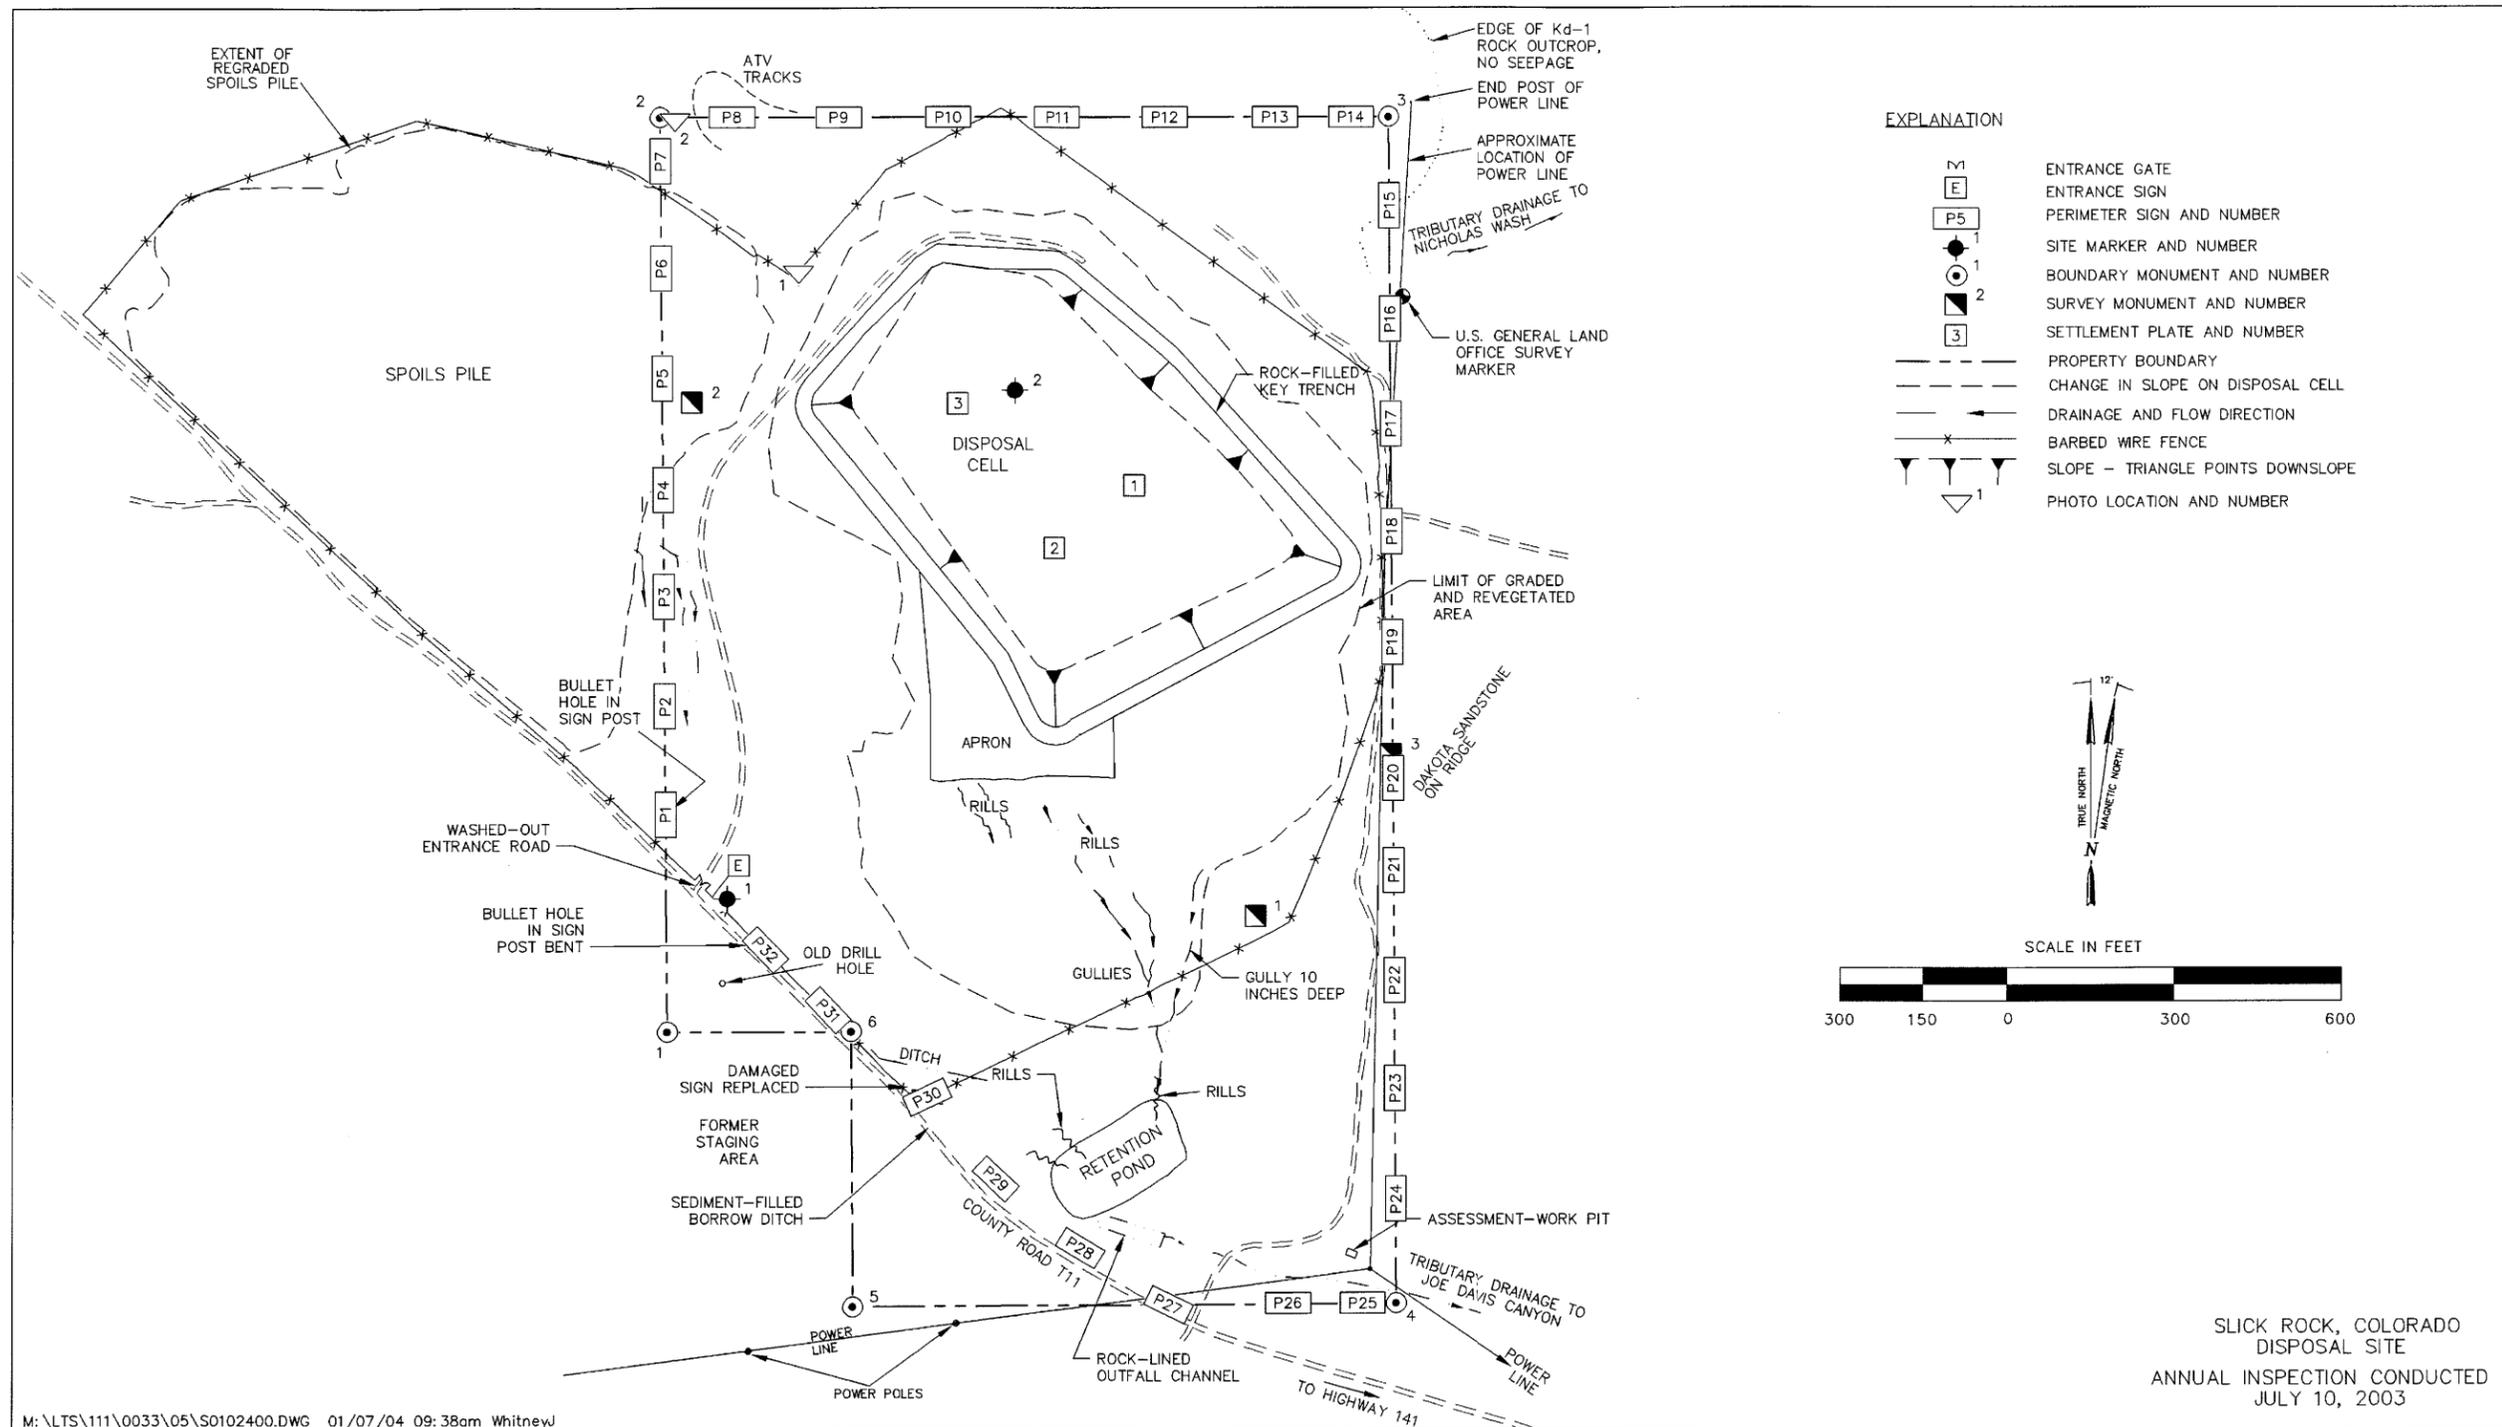
Figure 17-1. 2003 Annual Compliance Drawing for the Slick Rock, Colorado, Disposal Site

**Disposal Cell**—The disposal cell, side slopes, key trench, and apron are armored with rounded cobble- and pebble-sized rock. The rock was in excellent condition. No evidence of settling, slumping, or erosion was observed on any of the rock-covered surfaces of the disposal cell.

**Area Between the Disposal Cell and the Site Boundary**—The area around the disposal cell includes a retention pond and graded and reseeded areas. Surface drainage from the disposal cell flows south into the retention pond, which is constructed in a channel tributary to Joe Davis Canyon. An outflow channel below the pond is lined with rounded cobblestones for a short distance. The pond, which was dry at the time of the inspection, and outflow channel were in excellent condition.

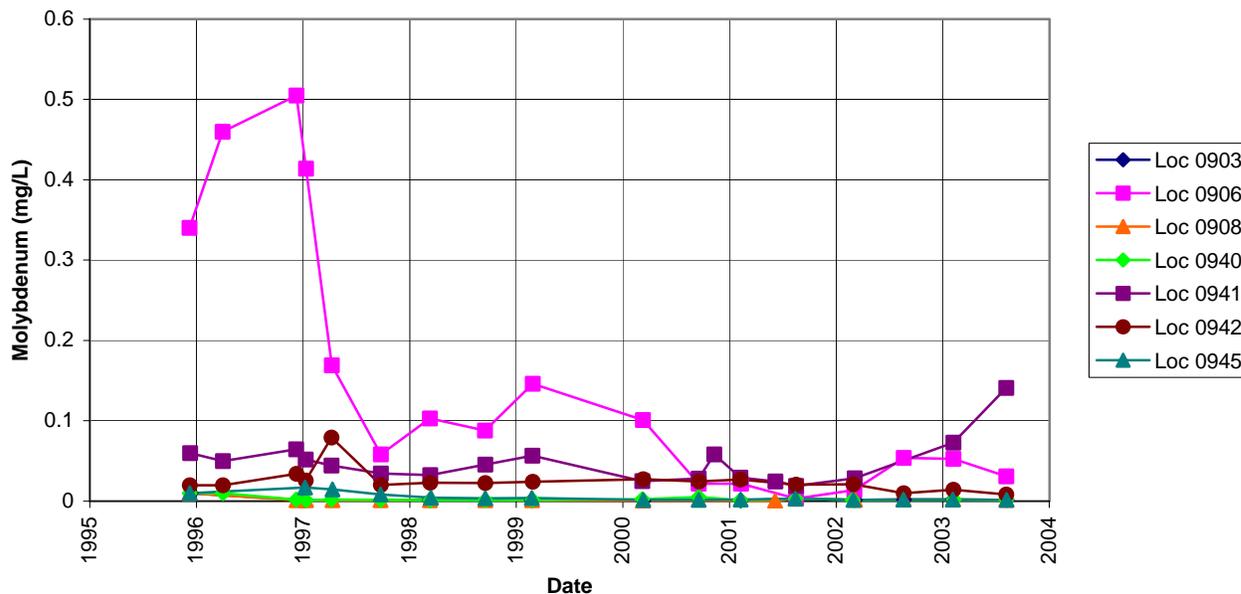
Figure 19–2. Time-Concentration Plots of Molybdenum in Ground Water at the Tuba City, Arizona, Disposal Site

Molybdenum concentrations exceeded the 0.1 milligram per liter (mg/L) standard in the sample from monitor well MW–0941 in 2003. Except at MW–0906, molybdenum concentrations have not varied significantly in the last 8 years (Figure 19–2). Samples from MW–0906 typically have had higher and more variable molybdenum concentrations in the past than samples from other wells.

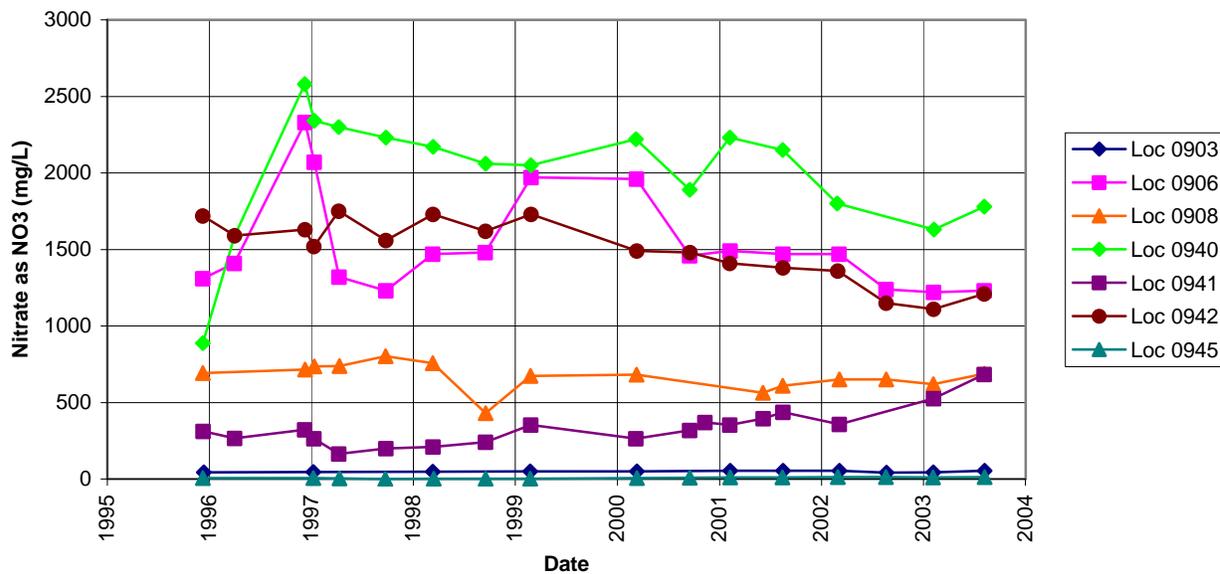
Figure 19–3. Time-Concentration Plots of Nitrate (as NO<sub>3</sub>) in Ground Water at the Tuba City, Arizona, Disposal Site

In 2003, concentrations of nitrate (as NO<sub>3</sub>) exceeded the 44 mg/L standard in samples from all monitor wells except background well MW–0945. Between 2002 and 2003, no significant increases or decreases in concentrations were observed in samples from any well, although concentrations varied considerably—by more than two orders of magnitude—from well to well (Figure 19–3).

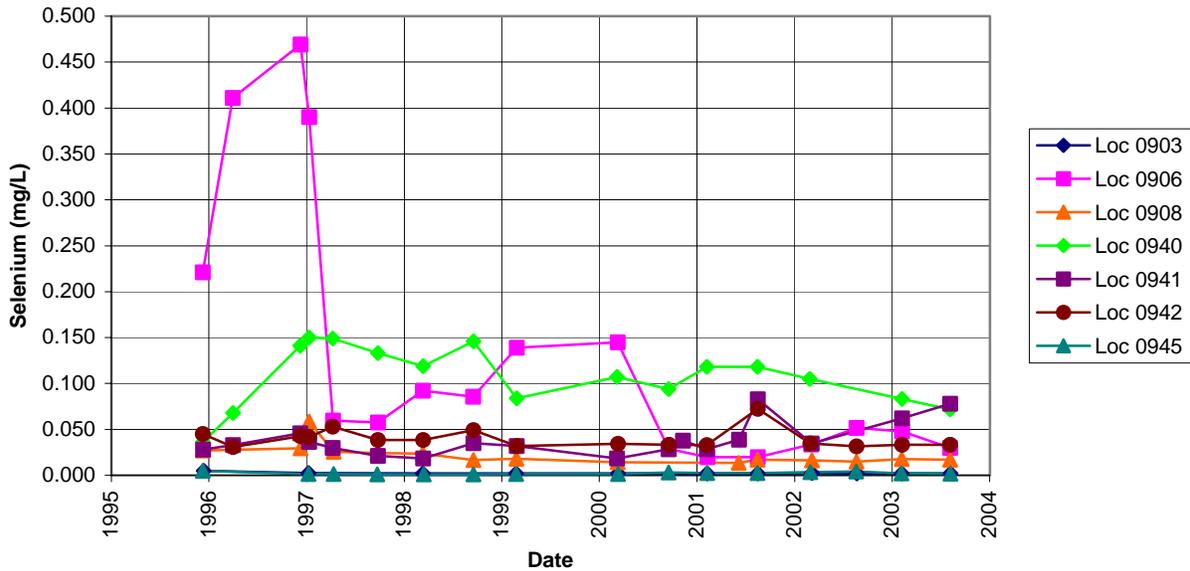
Figure 19-4. Time-Concentration Plots of Selenium in Ground Water at the Tuba City, Arizona, Disposal Site

Consistent with historical data, selenium concentrations exceeded the 0.01 mg/L standard in 2003 in samples from all wells except background well MW–0945 and off-site, downgradient well MW–0903. Selenium values have remained fairly consistent in samples from all wells except MW–0906 and MW–0940 (Figure 19–4).

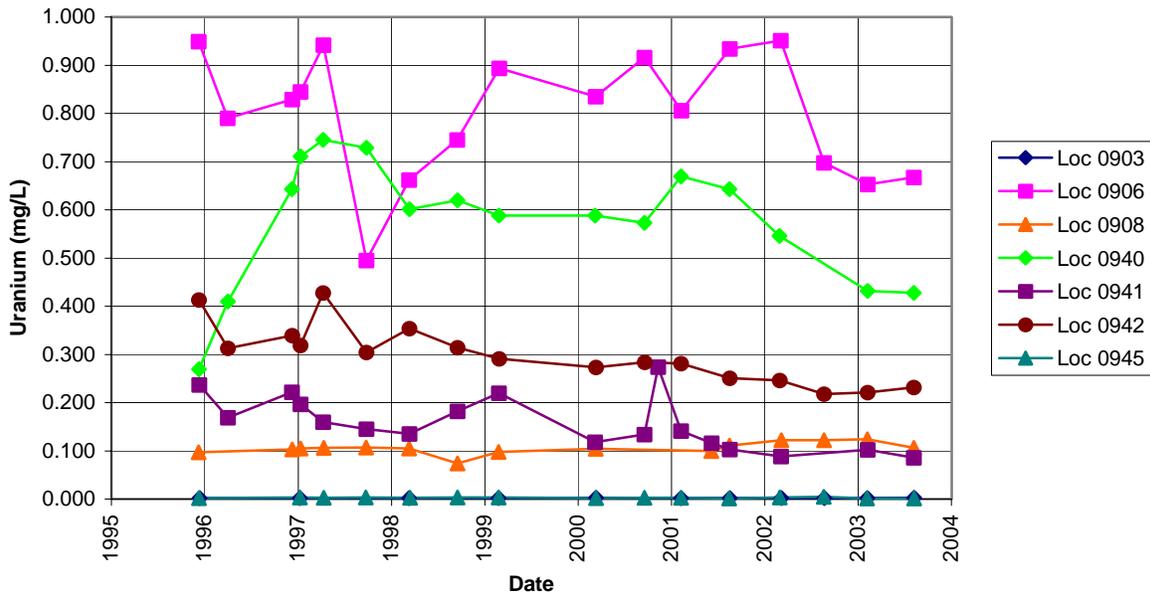
Figure 19-5. Time-Concentration Plots of Uranium in Ground Water at the Tuba City, Arizona, Disposal Site

Uranium concentrations exceeded the 0.044 mg/L standard in 2003 samples from all wells except background well MW–0945 and off-site, downgradient well MW–0903. Concentrations have remained fairly constant over time in samples from all wells except MW–0906 and MW–0940 (Figure 19–5).
