# 2003 Annual Site Inspection and Monitoring Report for Uranium Mill Tailings Radiation Control Act Title I Disposal Sites

January 2004

Work Performed by S.M. Stoller Corporation under DOE Contract No. DE-AC01-02GJ79491  
for the U.S. Department of Energy, Grand Junction, Colorado

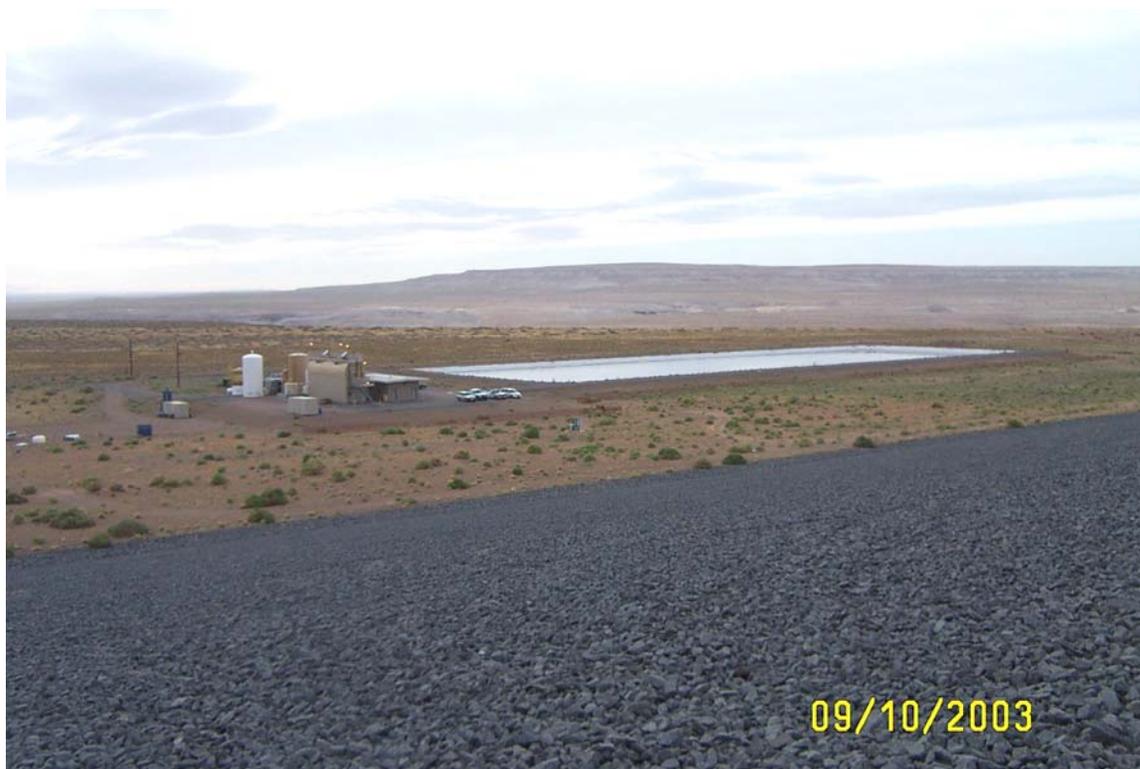
*TUB 9/2003. PL–1. East side slope of the cell and adjacent ground water remediation facilities.*
