# **Trip Report**

## **2003 Annual Inspection of the Hallam Nuclear Power Facility, Hallam, Nebraska, D&D Site**

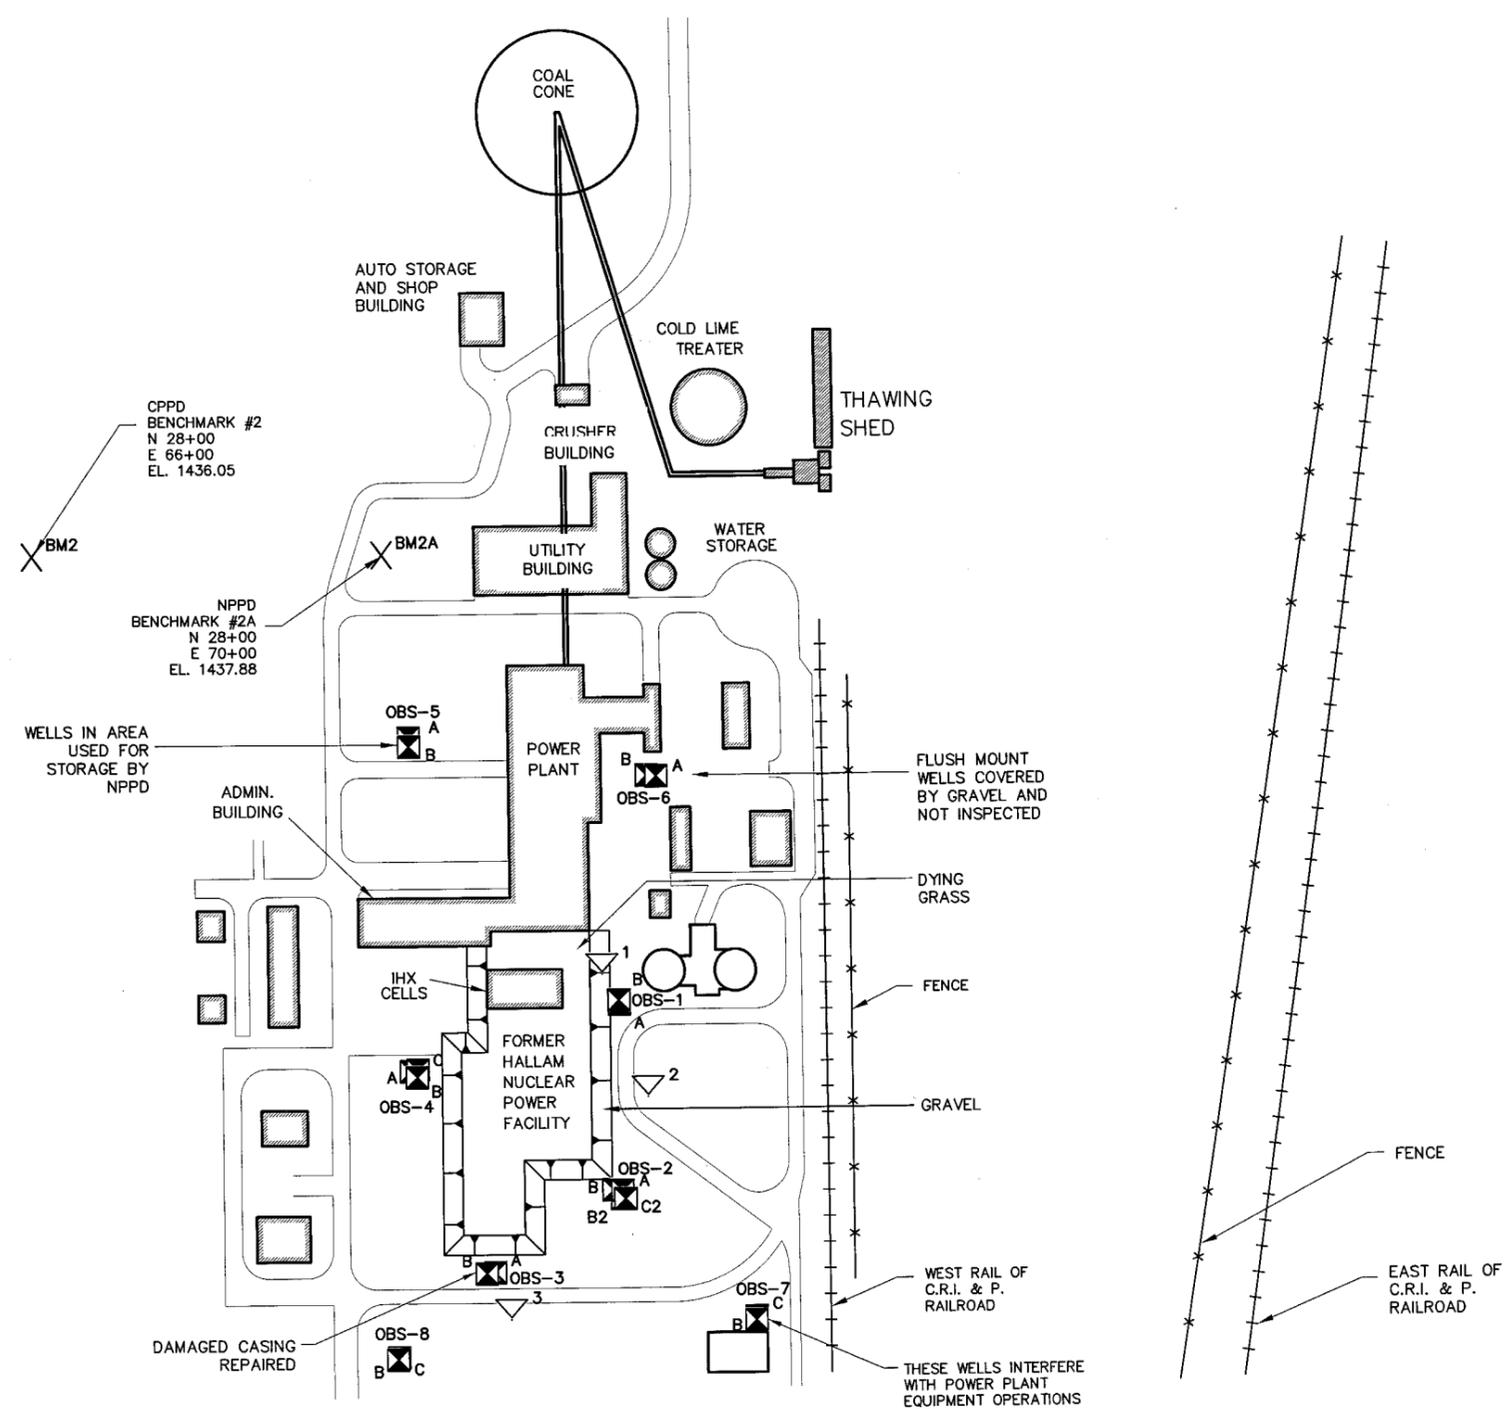
Monitor well OBS 3B had a damaged casing cover at the time of the 2002 inspection. NPPD personnel repaired the damage to this well casing and painted all of the above ground well casings bright red to make them more visible (PL-3). Flush mounted wells in high traffic areas (e.g., OBS 5A and OBS 5B) are covered with gravel and are difficult to locate. All wells are in excellent condition.

HAL 03/2003. PL-3. Repaired and repainted well casings.
